# **Paul Michael Visual Building Inspection Report**

by  
**Allen M. Taylor, P.E.**

**Prepared for Van Zandt County  
Canton, TX 75103**

February 25, 2025

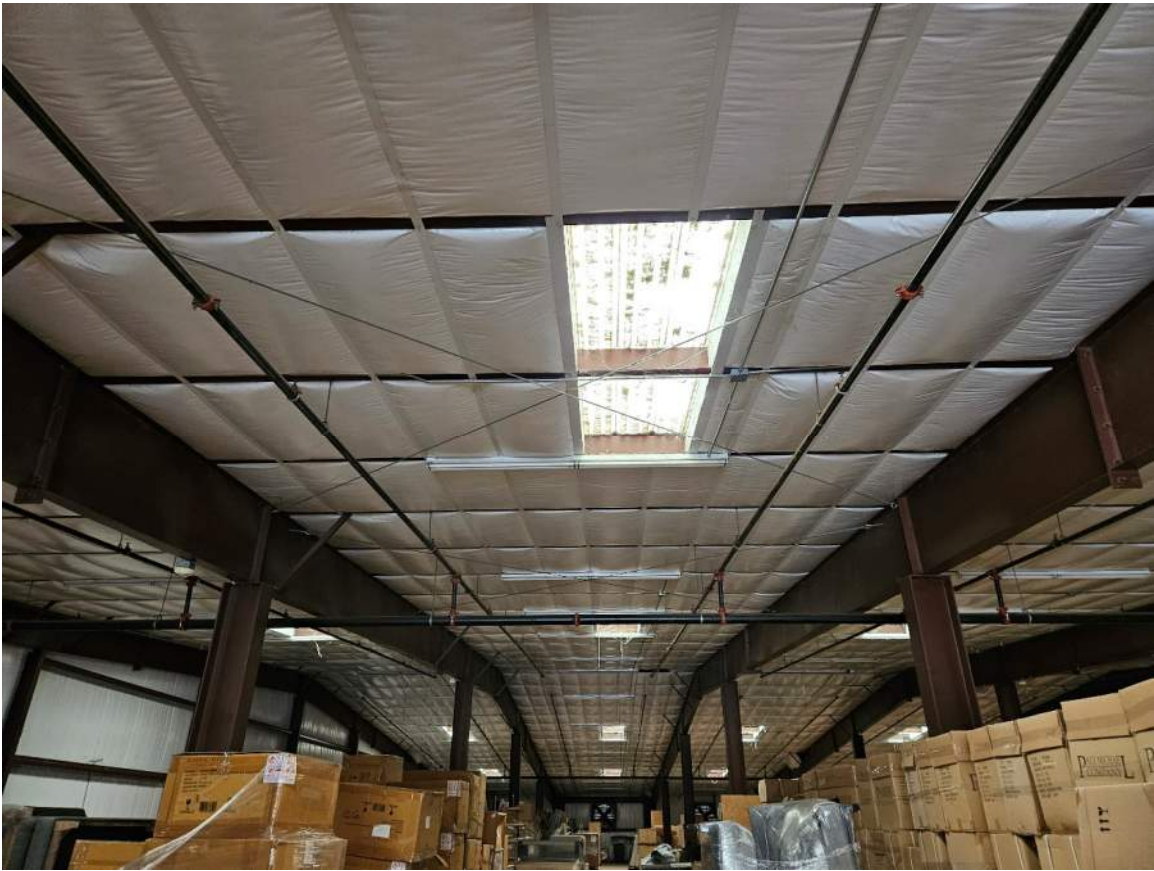
During the visual inspection of building 1 it was observed that the overall structure was in very good condition and no severe structural damage was present. The roof "X" bracing and portal frames were in place (See Photos 1-6). It did not appear that any damage or cutting or changes were made to either of the "X" bracing or the portal frames. The connections of the interior columns to the rafters seemed to be adequate and undamaged, as did the connections of the floor beams to the columns (See Photos 7 and 8). The columns bear on concrete pedestals that, according to the existing drawings, are supported on isolated spread footings (See Photos 9 & 10). There was no indication of significant movement, settling or damage that could be seen around the pedestals. There was some minor cracking in the slab (See Photos 11-15). The concrete slab appeared to be in very good condition. The covered concrete area to the north of building 1 had the roof "X" bracing present, as well as, the portal frame for stabilization (See Photos 16-18). This area showed no areas of concern from a structural standpoint.

Photo #1 (Roof "X" Bracing – Building 1)

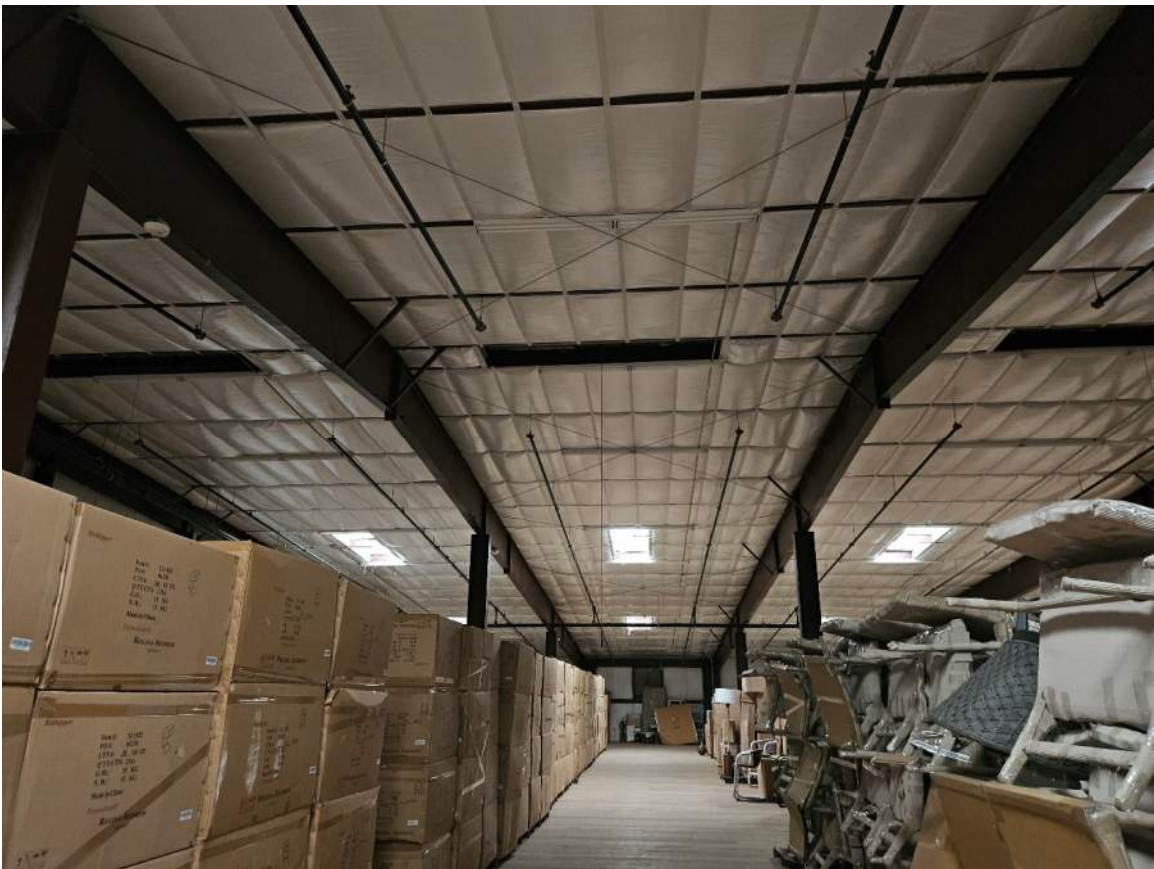
Photo #2 (Roof "X" Bracing – Building 1)

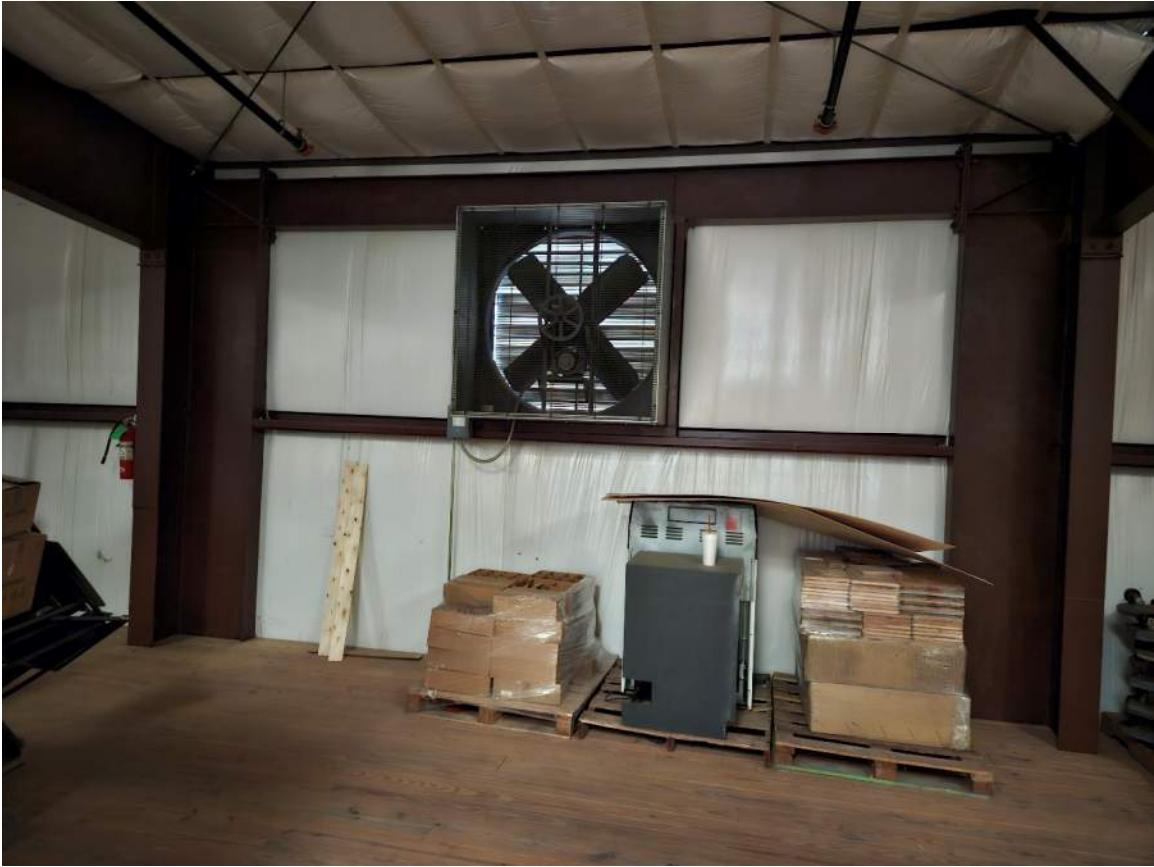
Photo #3 (Portal Frame – Building 1)

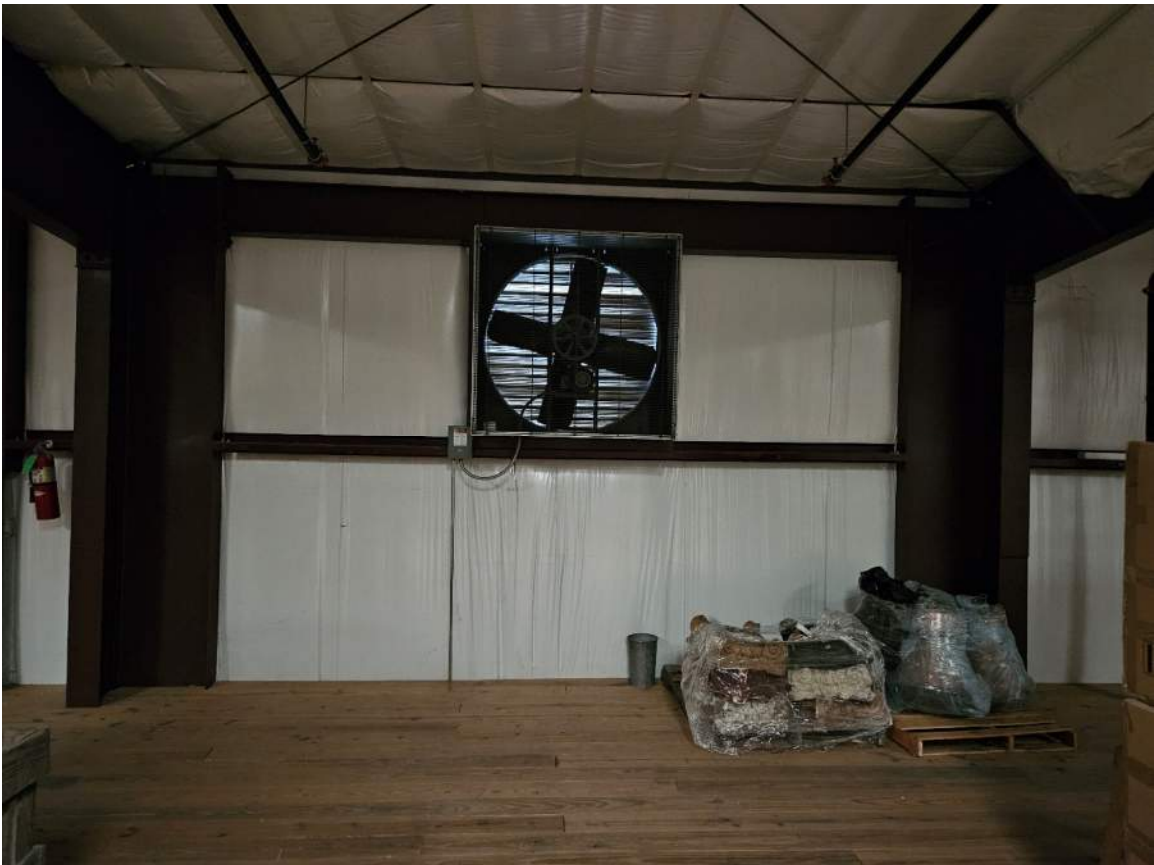
Photo #4 (Portal Frame – Building 1)

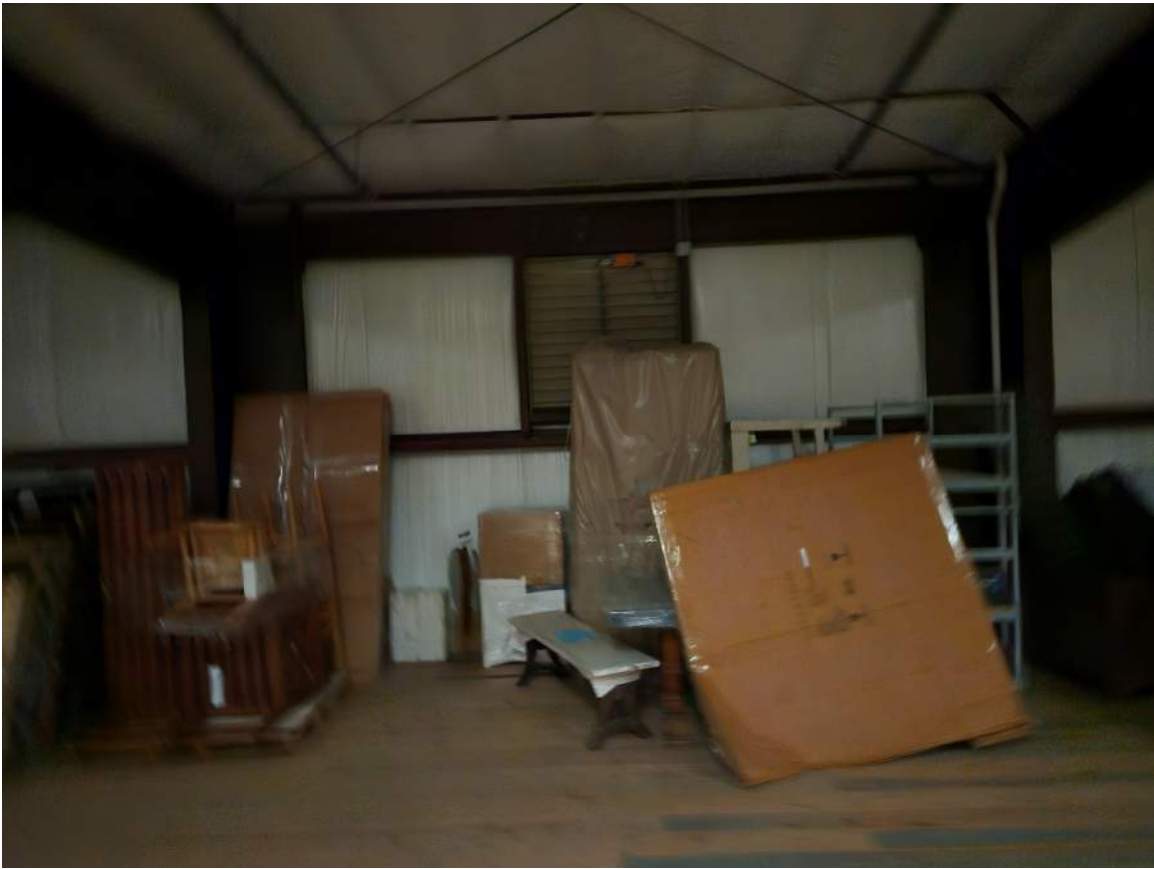
Photo #5 (Portal Frame – Building 1)

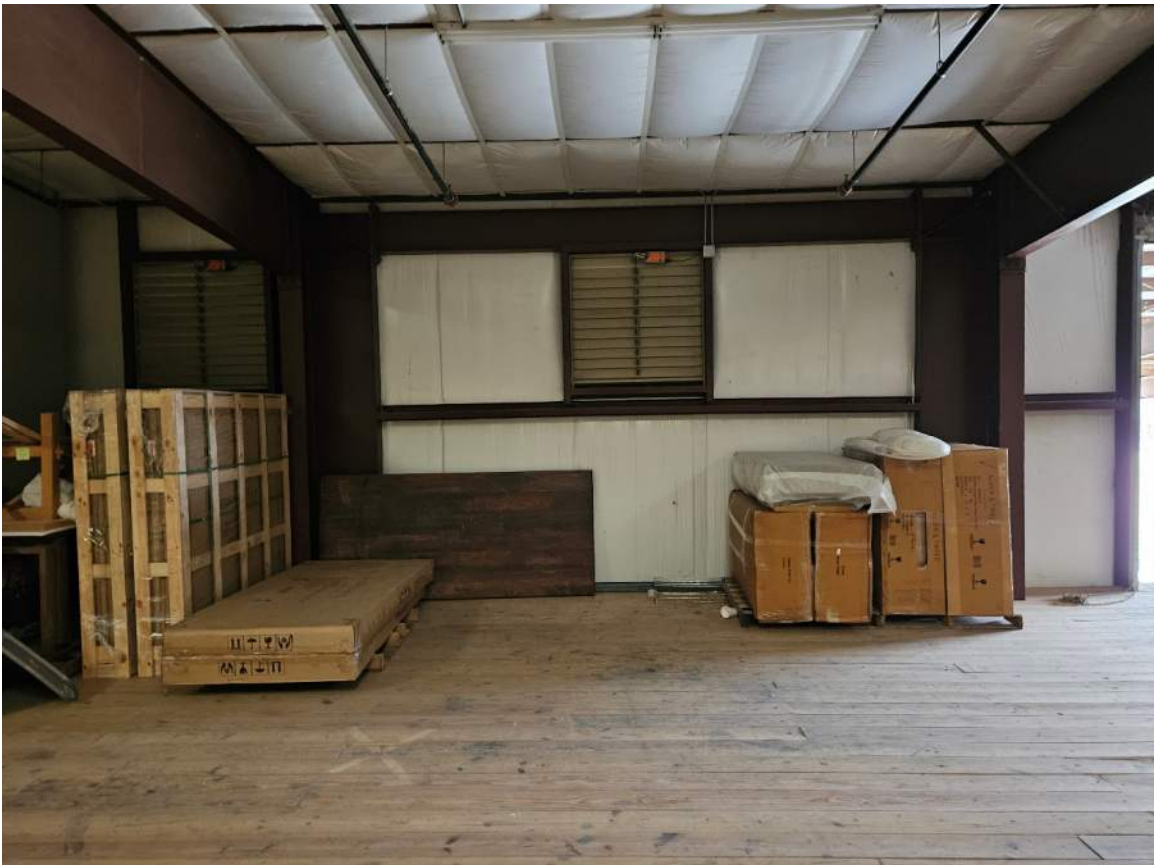
Photo #6 (Portal Frame – Building 1)

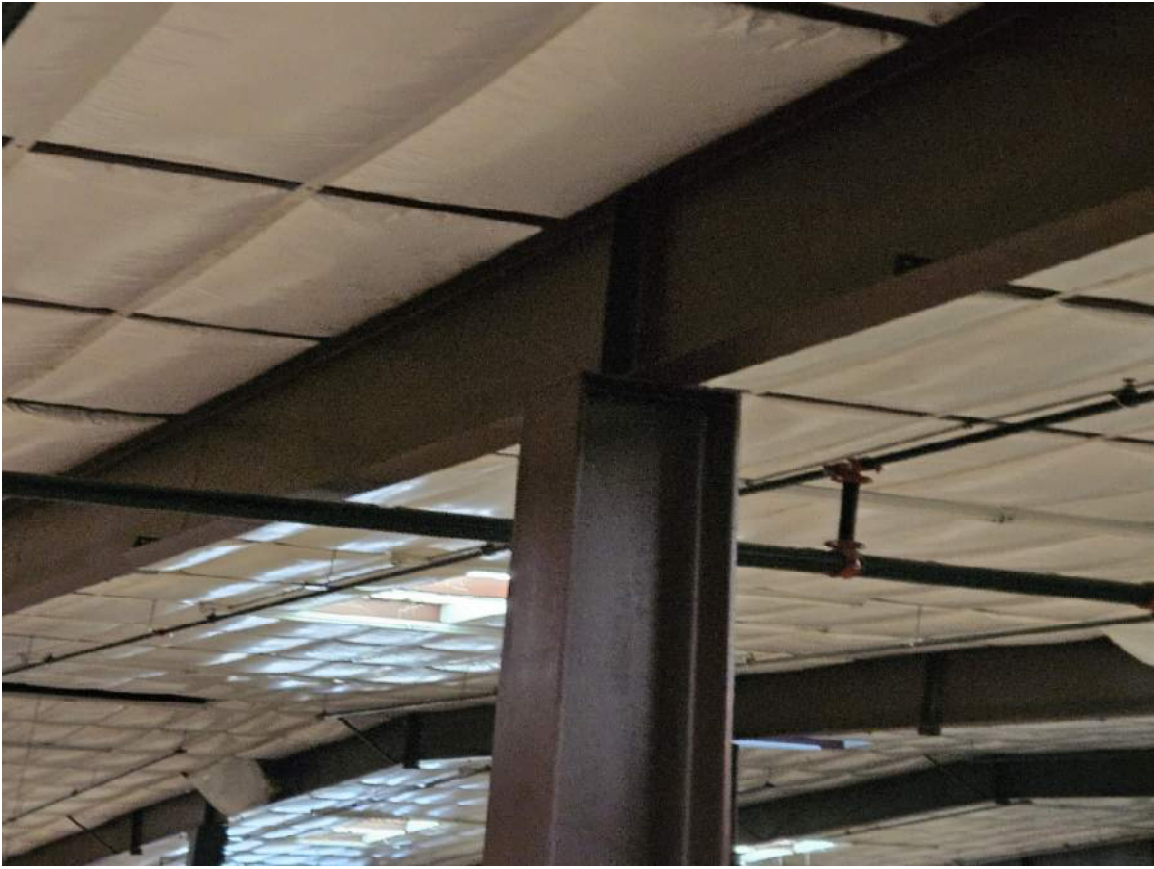
**Photo #7 (Typical Interior Column to Rafter Connection – Building 1)**

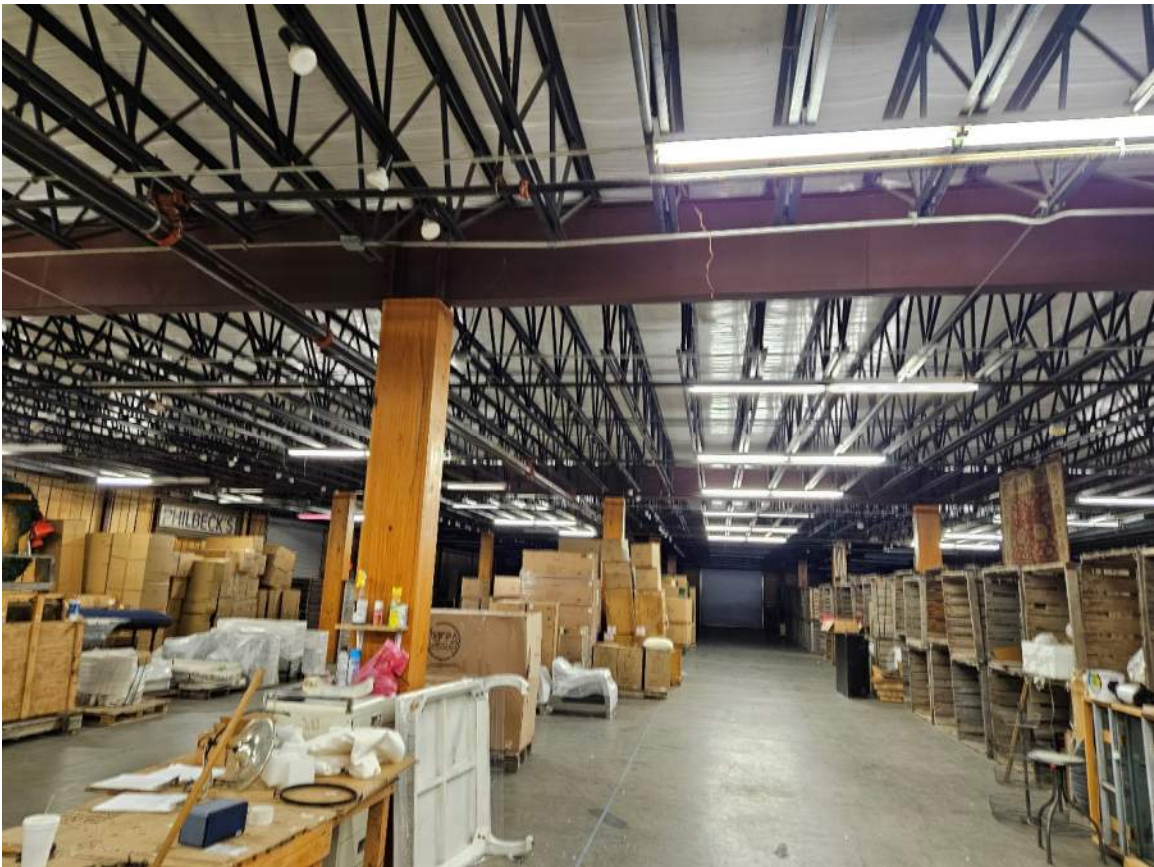
**Photo #8 (Typical Second Floor Beam to Interior Column Connection – Building 1)**

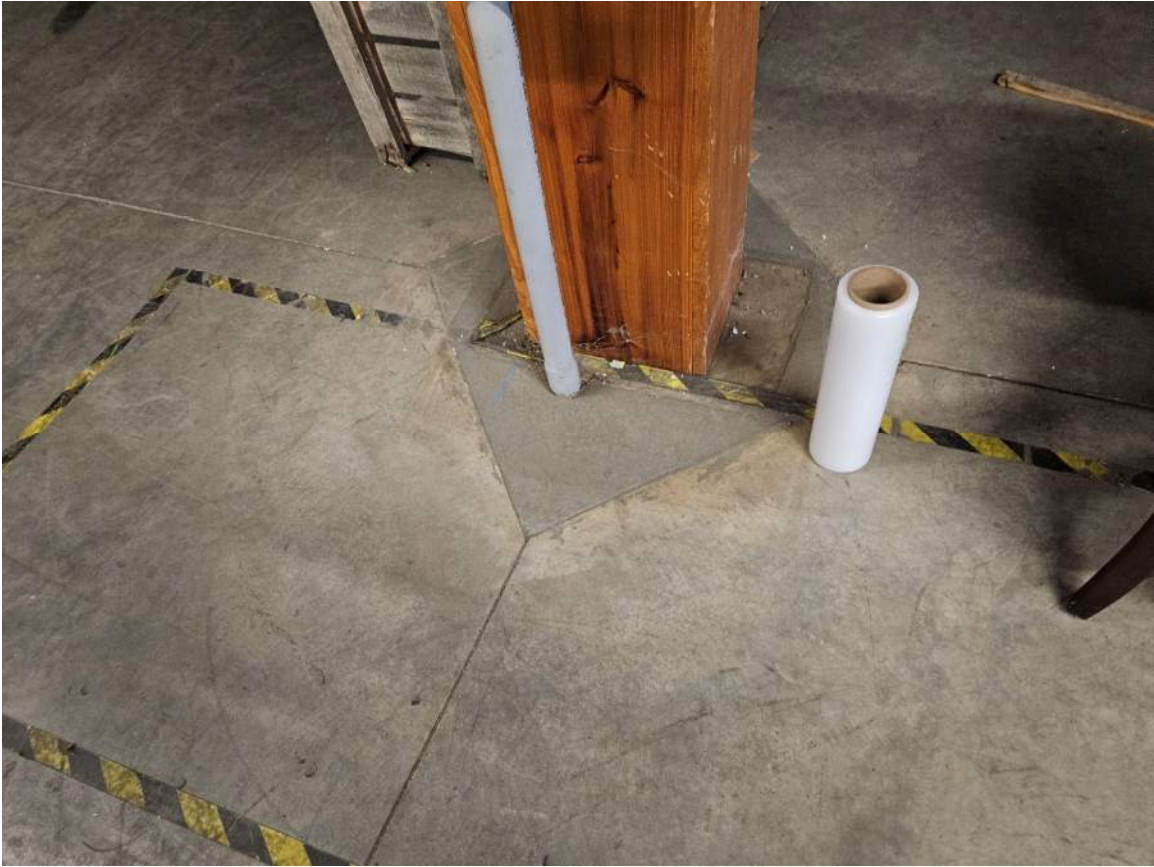
**Photo #9 (Typical Interior Column Pedestal Condition – Building 1)**

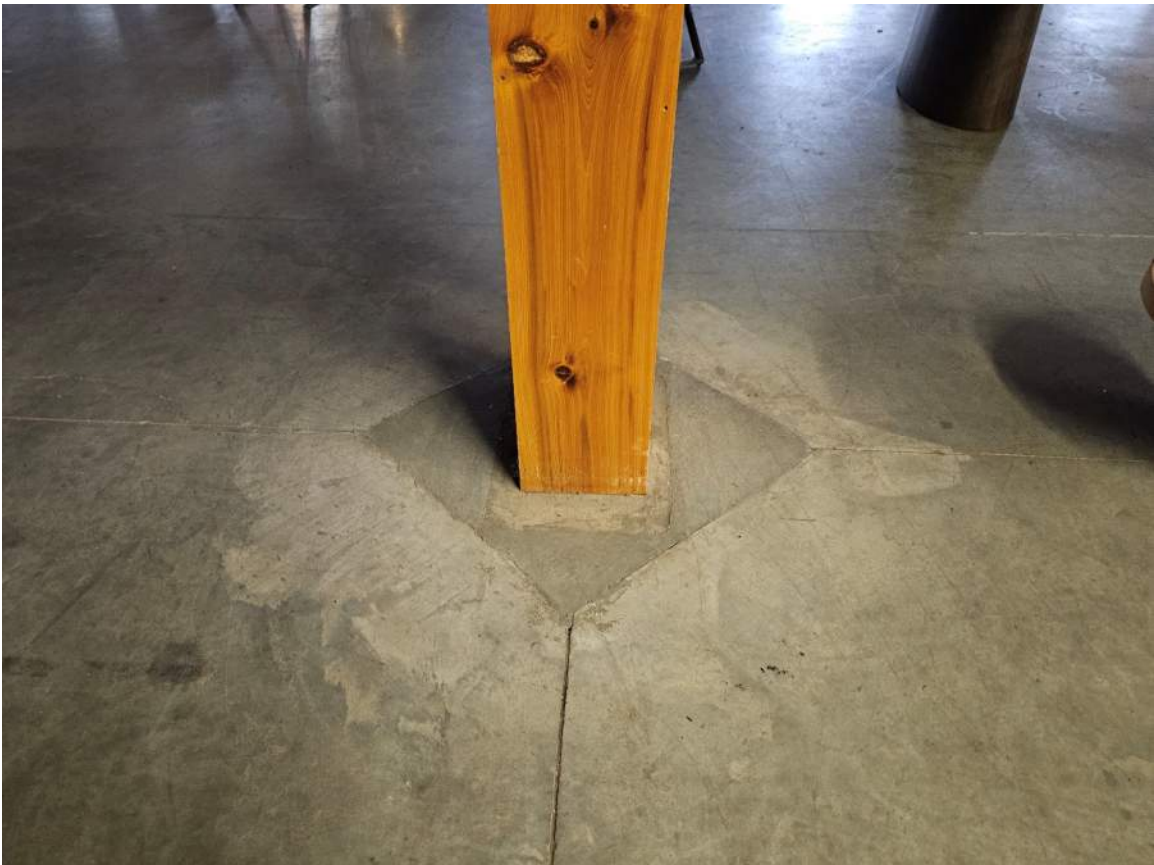
**Photo #10 (Typical Interior Column Pedestal Condition – Building 1)**

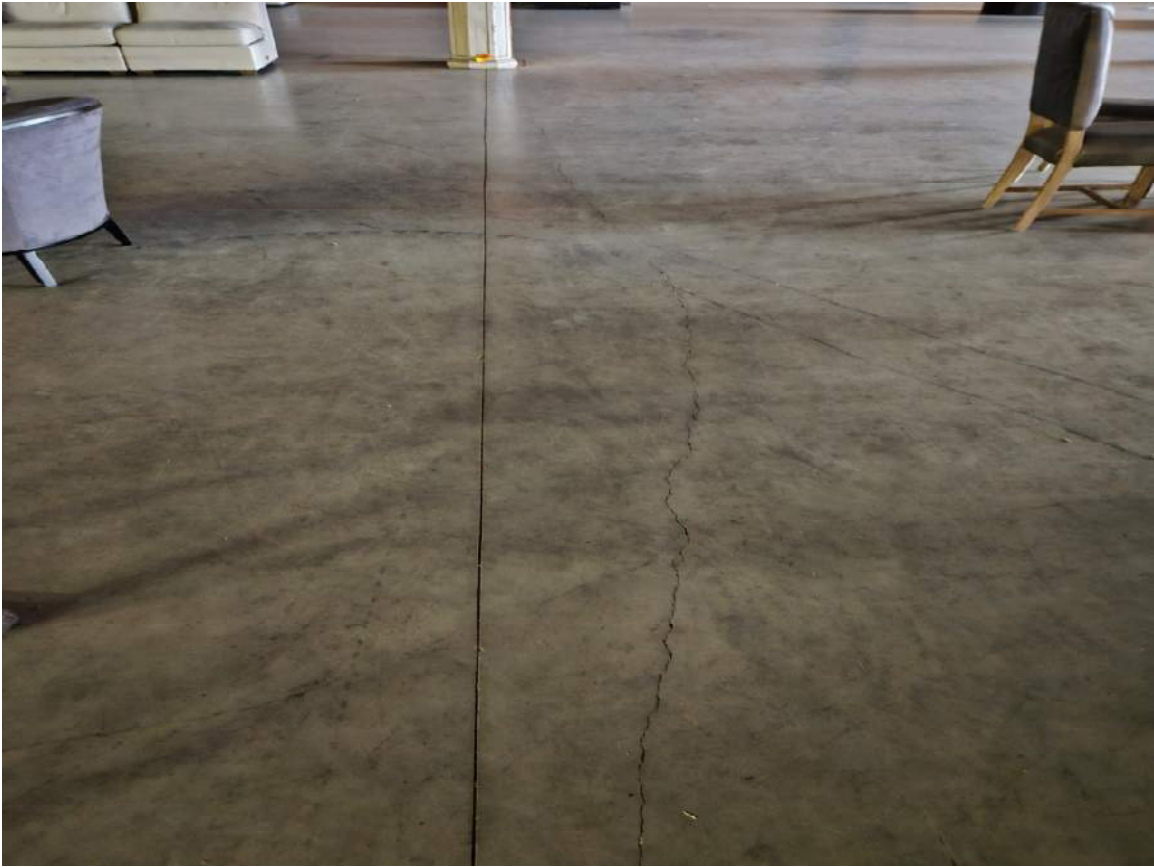
After performing the visual inspection of building 1 and the covered concrete area both appeared to be very good condition. The cracking seen in the slab is typical minor aesthetic cracking and not structural in nature. The concrete slab is six inches thick and should be adequate to handle the storing of files without structural damage. The second floor is rated for 125 pounds per square foot and should be adequate for office use and light storage.

**Photo #11 (Concrete Slab Cracking – Building 1)**

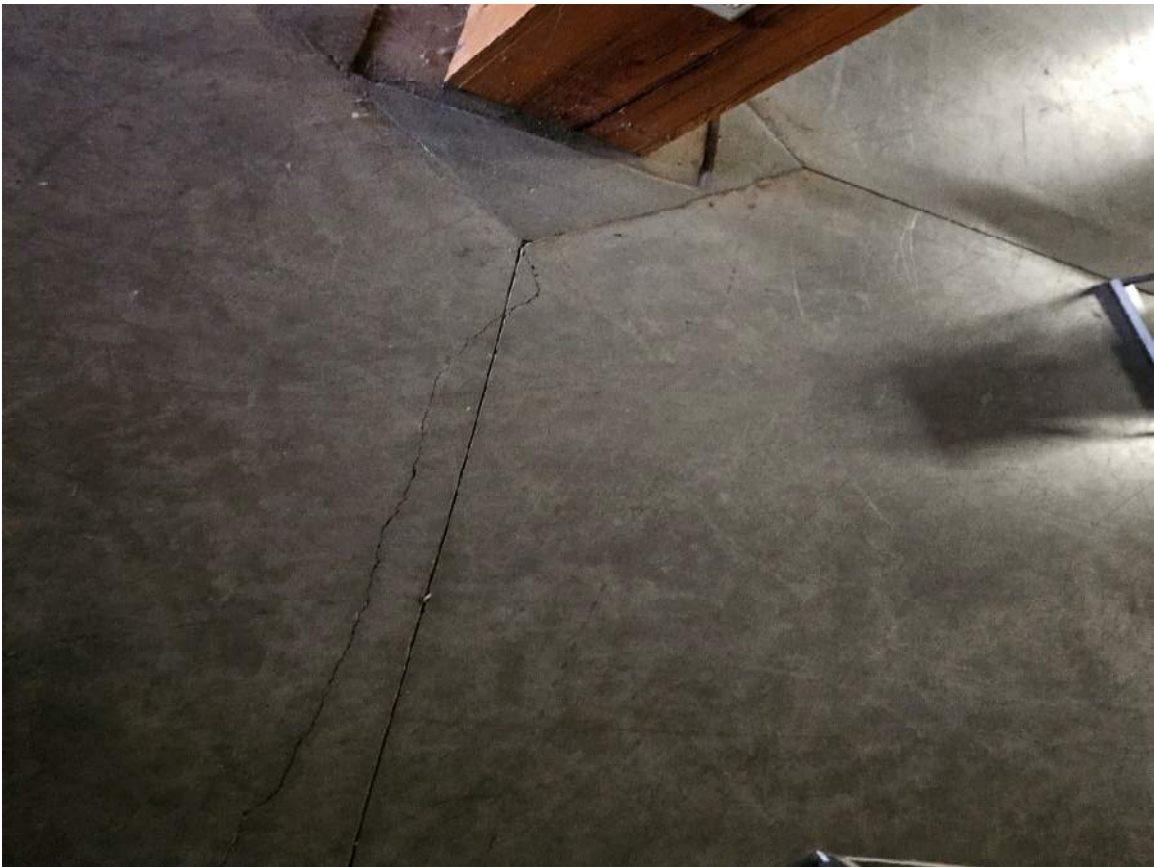
**Photo #12 (Concrete Slab Cracking – Building 1)**

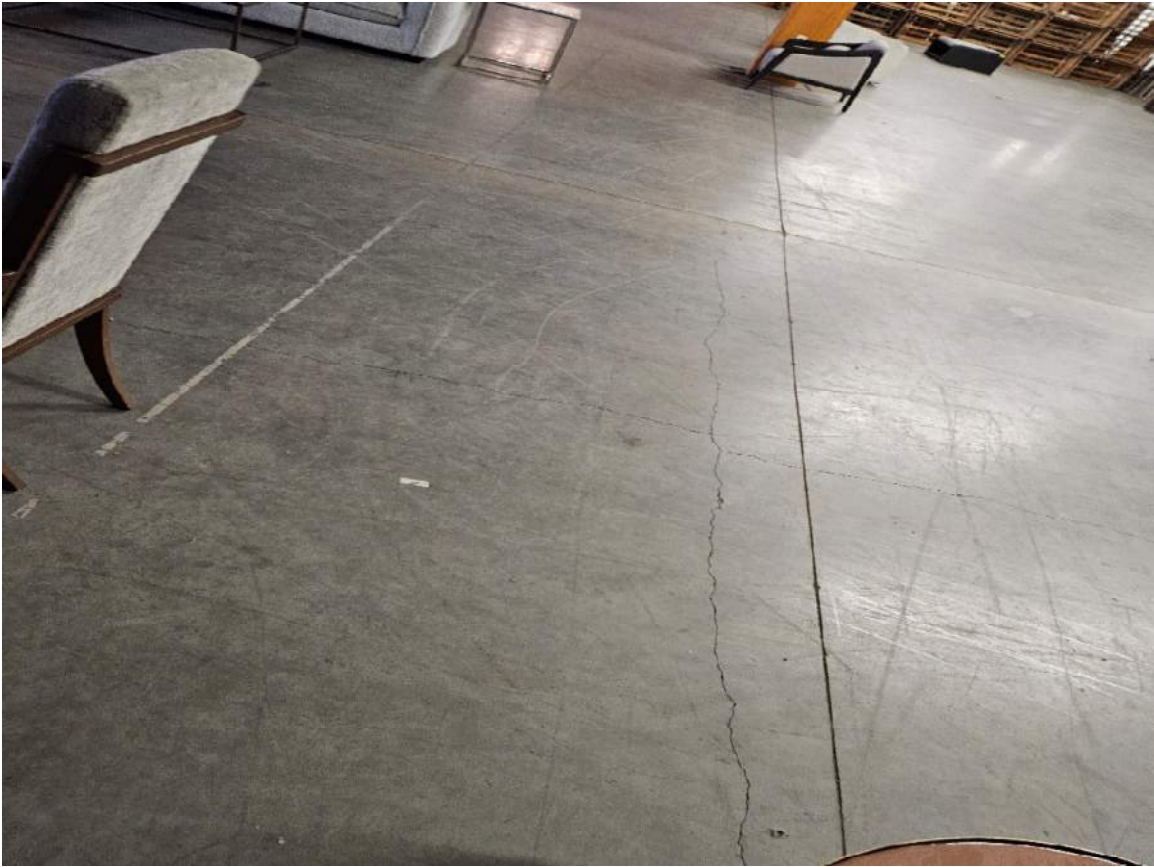
**Photo #13 (Concrete Slab Cracking – Building 1)**

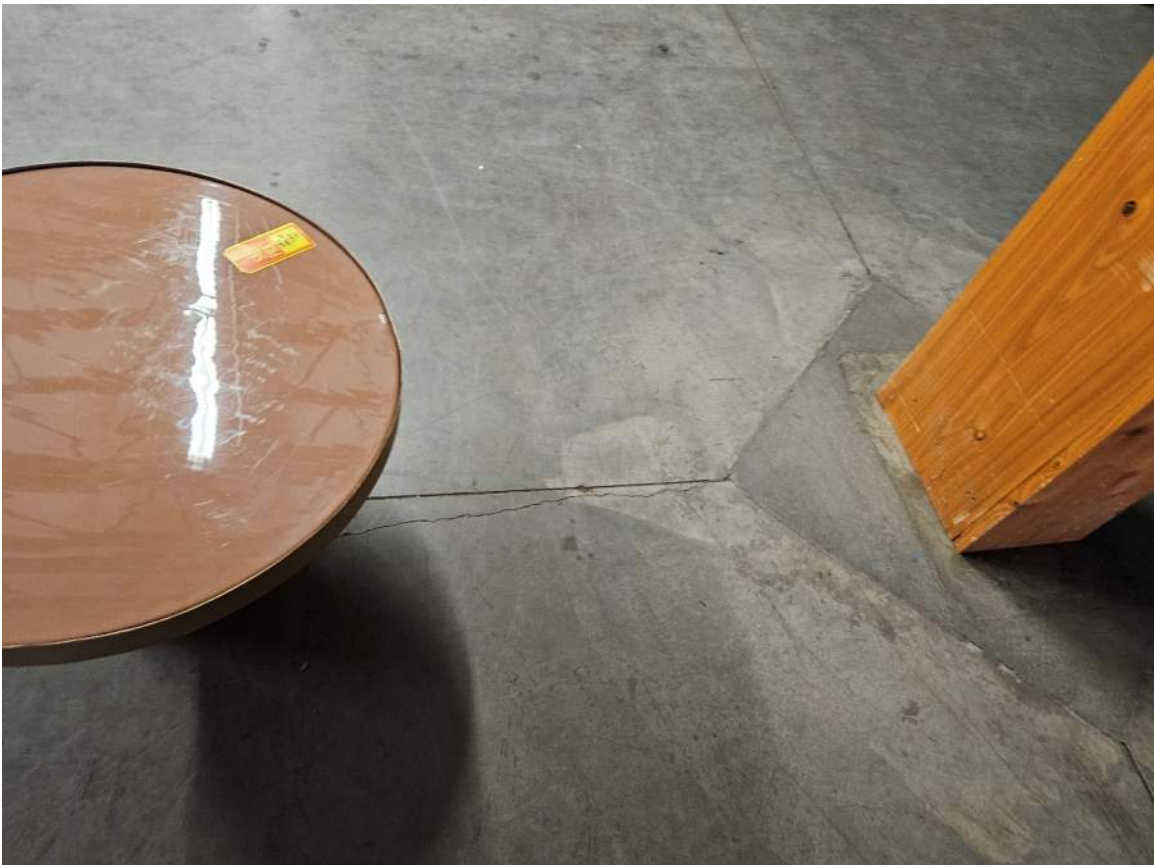
**Photo #14 (Concrete Slab Cracking – Building 1)**

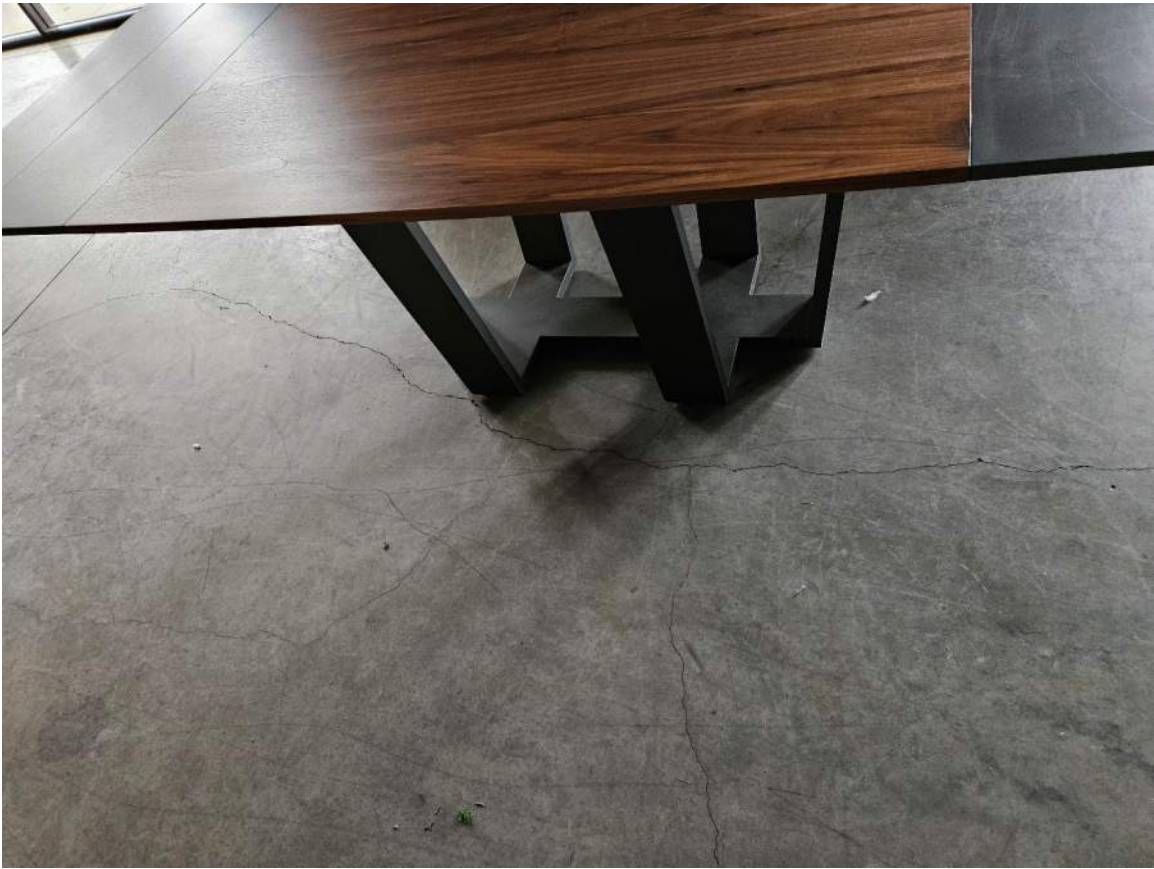
**Photo #15 (Concrete Slab Cracking – Building 1)**

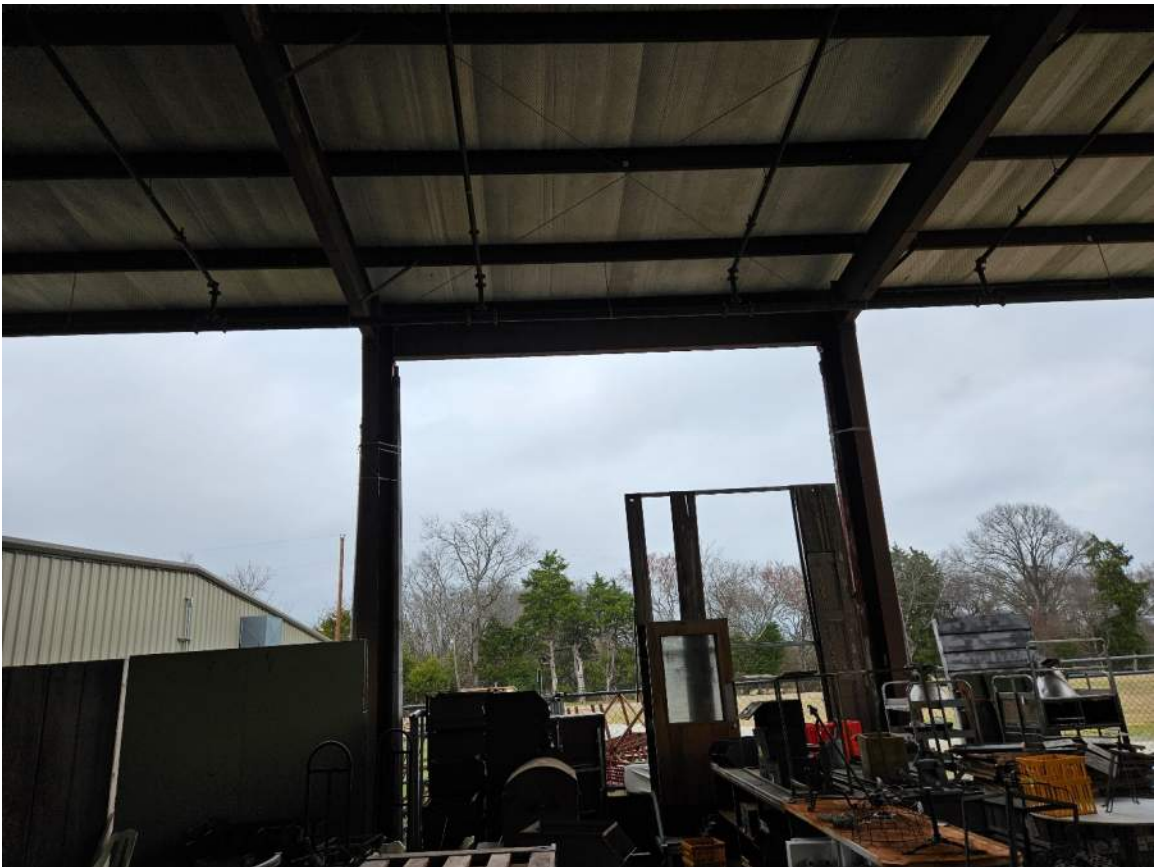
**Photo #16 (Portal Frame & Roof "X" Bracing @ Covered Concrete Area – Building 1)**

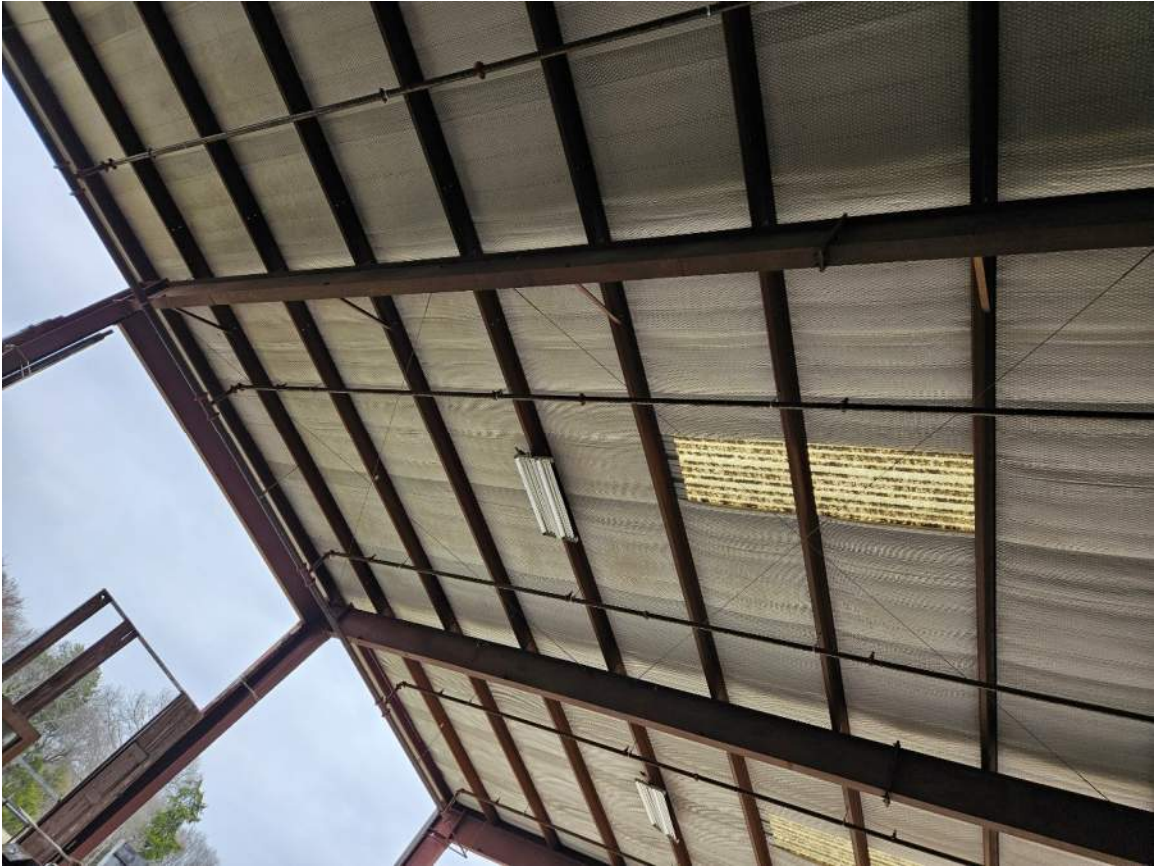
Photo #17 (Portal Frame & Roof "X" Bracing @ Covered Concrete Area – Building 1)

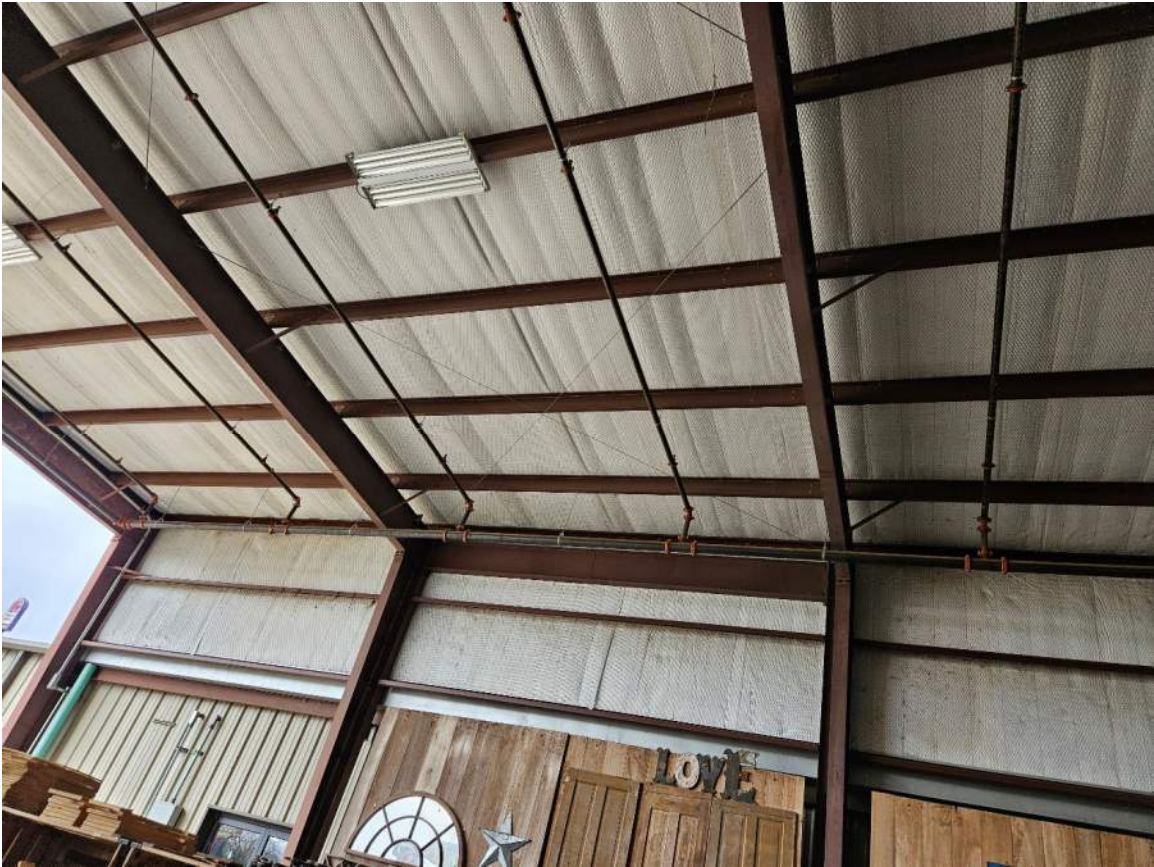
Photo #18 (Portal Frame & Roof "X" Bracing @ Covered Concrete Area – Building 1)

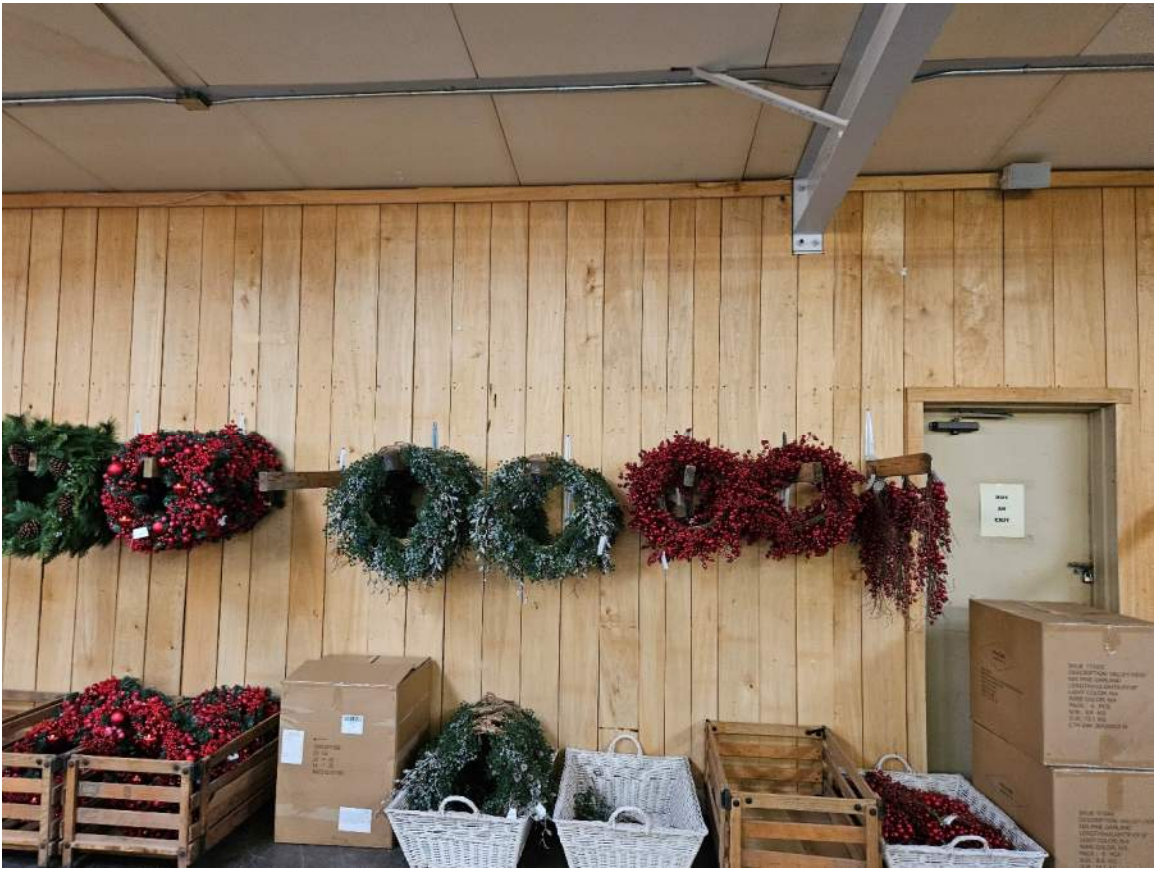
After performing the visual inspection of building 2 it appears to be in good condition with no structural damage observed. The presence of wall bracing, either "X" bracing or portal framing, should be confirmed. The popping noises are an indication of the building moving/drifted excessively or the occurrence of differential movement. This would be the different portions of the building (built at separate times) moving different amounts or even in different directions. This may be due to the lack of roof and/or wall bracing in each portion. The typical scenario that is seen in this case is that each portion or add-on has its own lateral bracing or framing. It is my suggestion that bracing be added in the portions that are without any bracing. If bracing is added in these areas the movement would be minimized. Similar to building 1, the cracking in the slab is typical minor aesthetic cracking and not structural in nature. My assumption is that the concrete slab is at least four inches thick which would be adequate for courtroom use.

Photo #19 (Walls not exposed therefore couldn't see any bracing if present – Building 2)

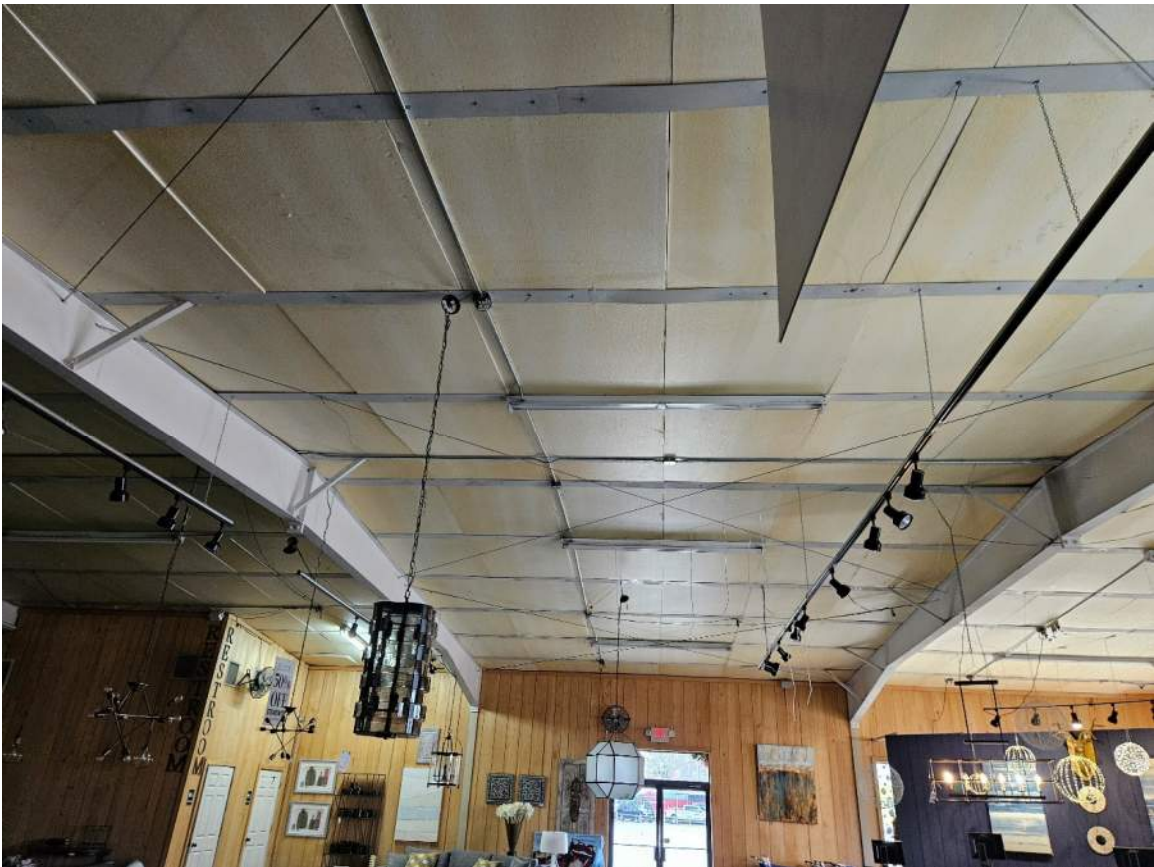
Photo #20 (Roof "X" bracing in one portion – Building 2)

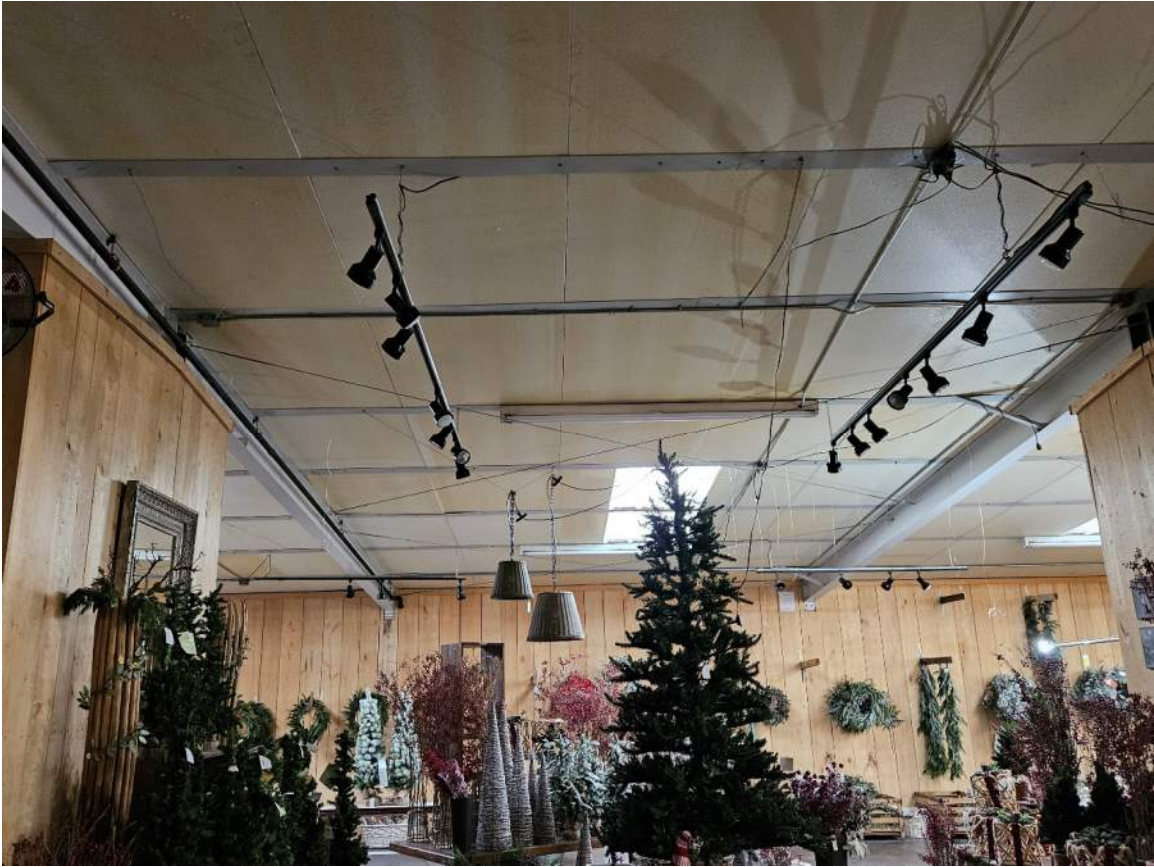
**Photo #21 (Roof "X" bracing stops instead of continuing – Building 2)**
