# **Paul Michael Visual Building Inspection Report**

by  
**Allen M. Taylor, P.E.**

**Prepared for Van Zandt County  
Canton, TX 75103**

February 25, 2025

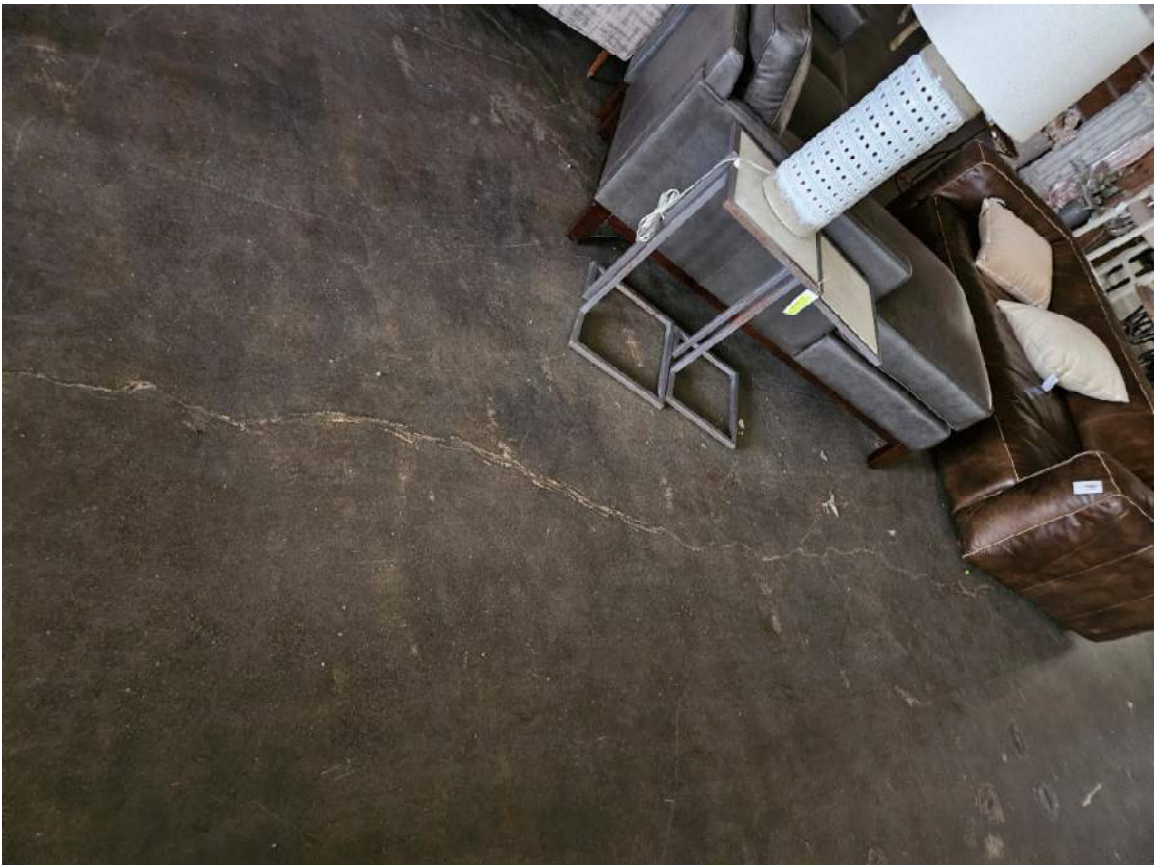
During the visual inspection of building 2 it was observed that the overall structure was in good condition and no severe structural damage was present. It appears that the building was built in 3 or 4 sections (add-ons) as there was different framing patterns in different portions of the building (See Photos 23-26). The wall framing was not exposed, so it could not determine if any "X" bracing or portal framing was located in the walls (See Photo 19). There was only roof "X" bracing seen in two locations, but one of the locations showed the "X" bracing stopping instead of being continuous to the other side of the building (See Photos 20 and 21). Both these locations were in one portion of the building with no other portion or add-on build having any visible roof bracing. It is customary to see some form of roof bracing in each area as they act independently of each other. There were noticeable popping noises occurring at the time of the visual inspection. The concrete slab showed signs of minor cracking (See Photo 22). The concrete slab appeared to be in good condition.

**Photo #22 (Typical concrete slab cracking – Building 2)**

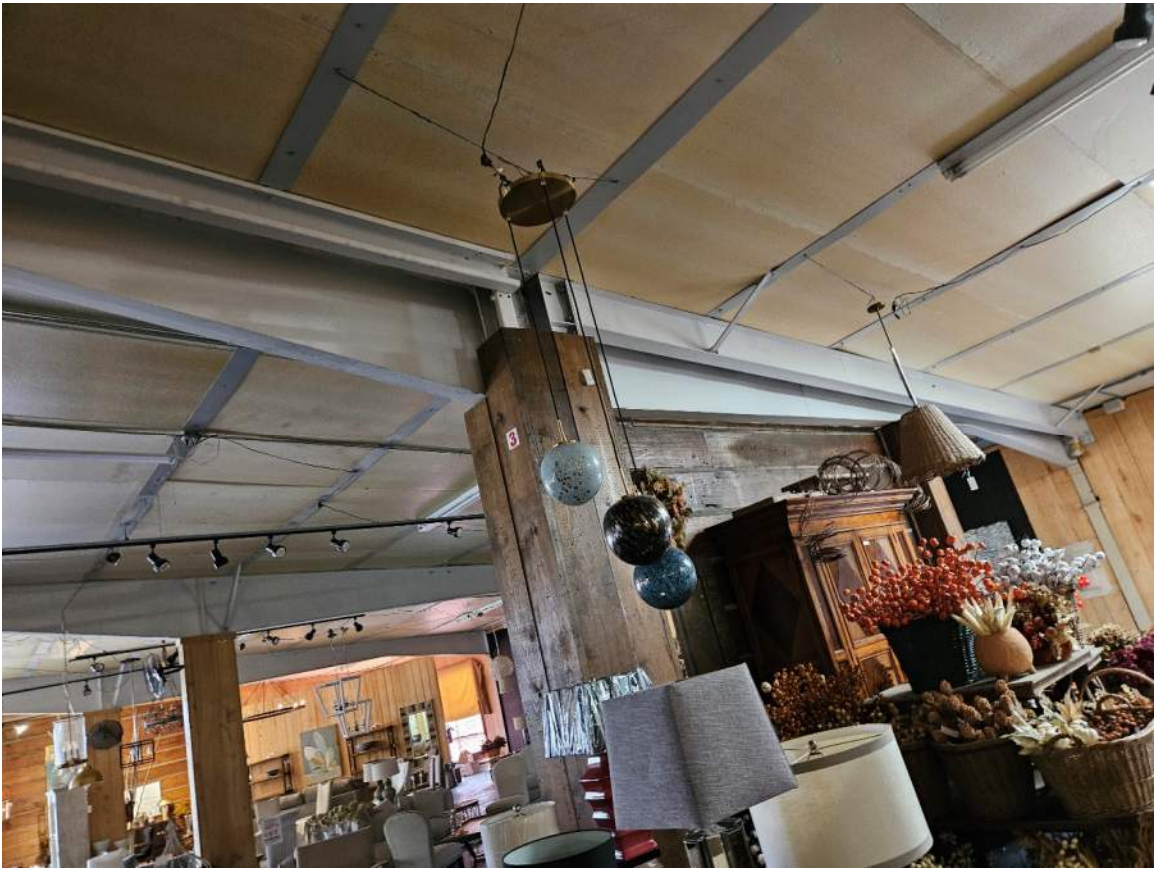
Photo #23 (Indication of add-on or separate build – Building 2)

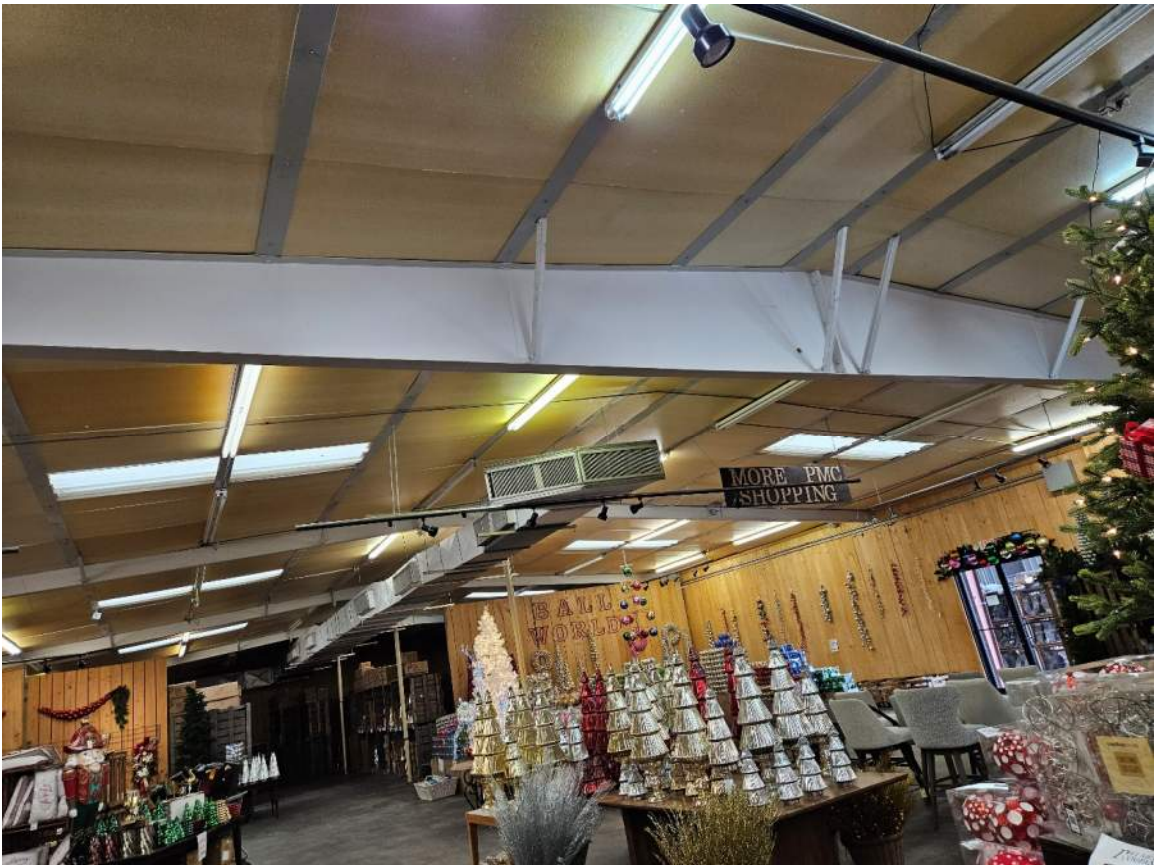
Photo #24 (Indication of add-on or separate build – Building 2)

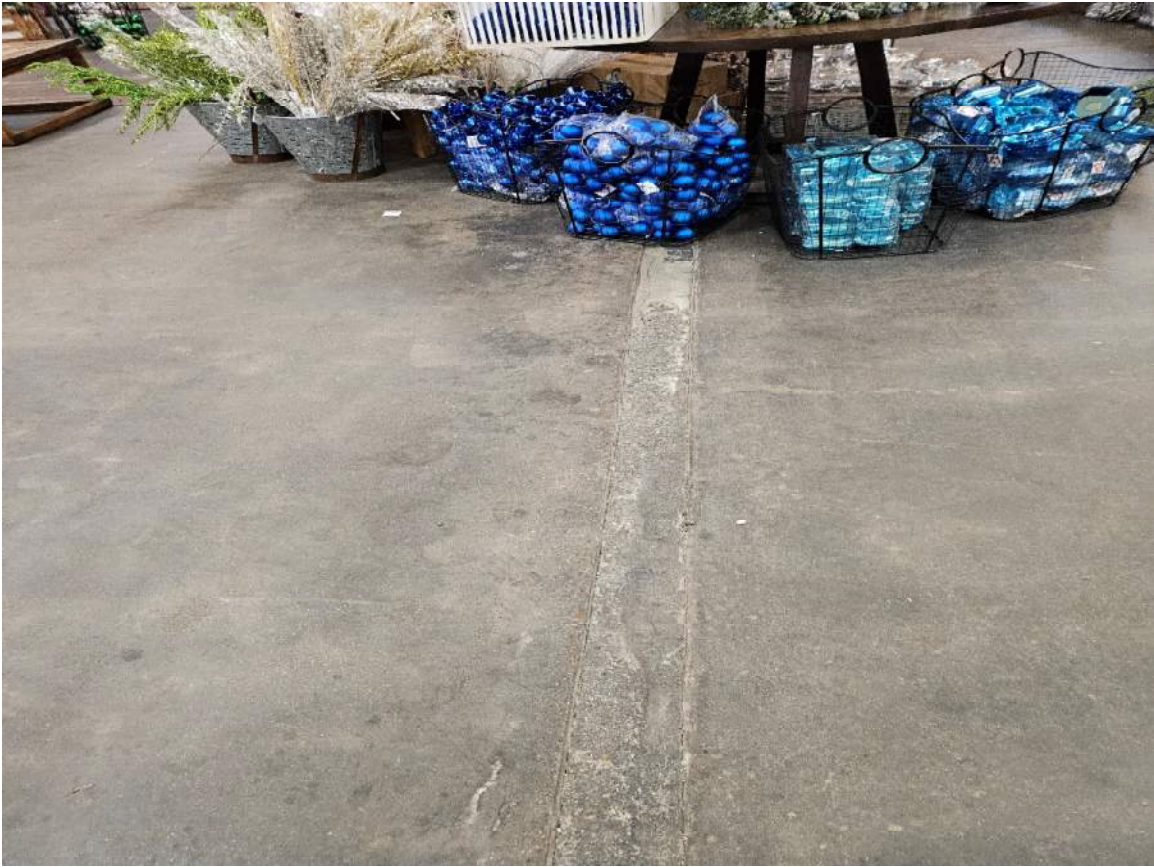
**Photo #25 (Indication of add-on or separate build – Building 2)**

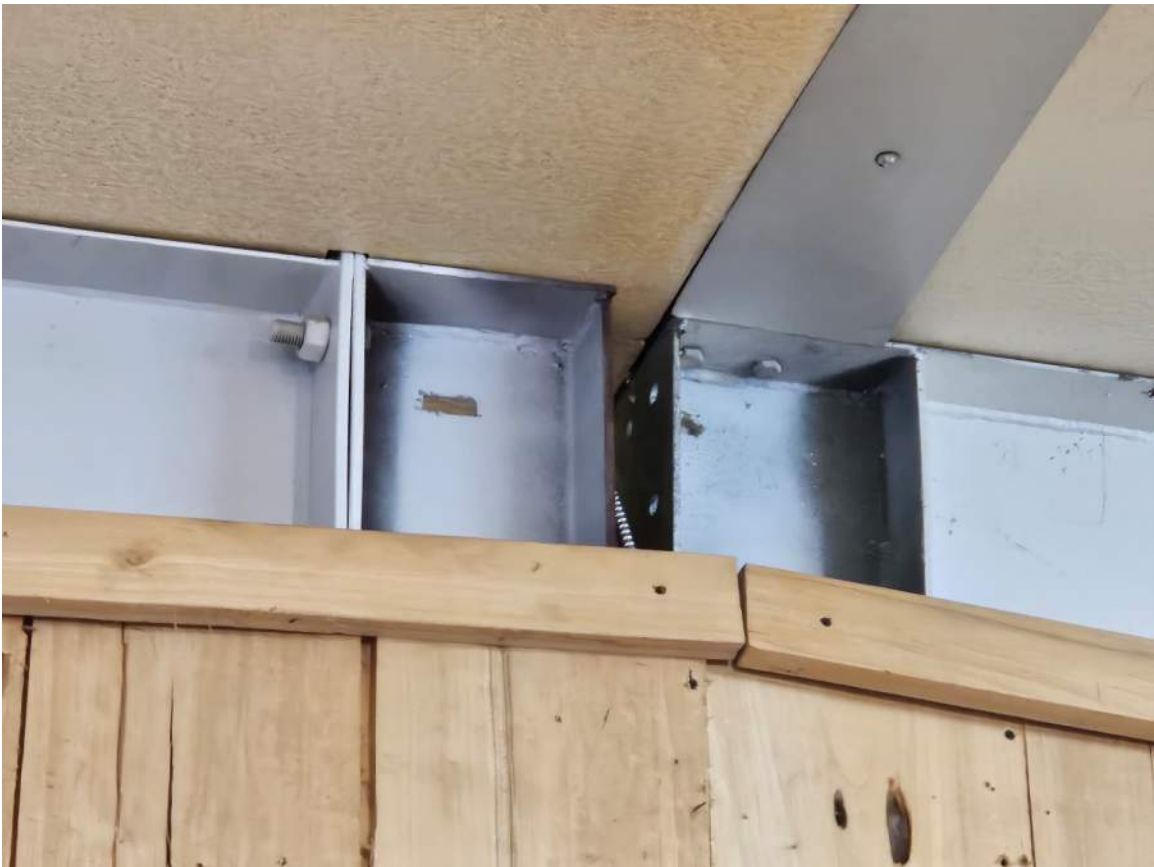
**Photo #26 (Indication of add-on or separate build – Building 2)**
