KOMATSU
ARCHITECTURE

Meeting Minutes No:
01

Project Title: Courthouse-Site Evaluation
of Material Damages

Project Location: Lampasas County
Courthouse Building

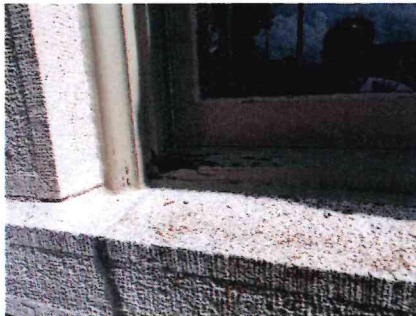
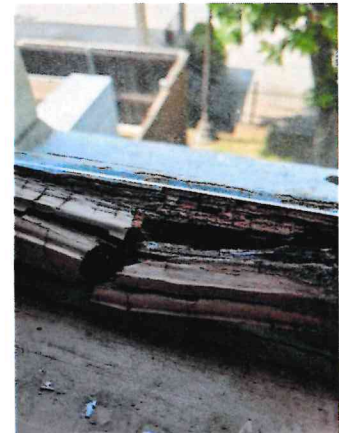
Several of the windows (as shown on the attached photos) had severe water damage at primarily the sill locations. Some of the lower portions of each jamb was also noted. This was observed at 50% of lower level

windows and approx. the same at the upper level window at various degrees of damage. A review of the wood species will need to be analyzed to ensure the proper wood was installed during the 2001 construction phase. According to the project documentation, Poderosa Pine was scheduled for installation.

Upon continued review of the window deterioration, it was noted that most damages were on the north side of the building. This area is highly shaded from sunlight which would evaporate most, if not all, residual water remaining on the wood members. This shading is speculated to be due to the large overhanging trees and HVAC system enclosure. Also noted by visible observation, is each window reviewed did not seem to have a water protective coating applied prior to finished application of paint which would allow for damages sooner. This will need to be confirmed.

Determinations for excessive water on the windows and door was presumed as:

1. Overuse of in-ground water sprinklers against the building
2. Possible malfunctioning of sprinkler head directional devices
3. North side of building was noted to have a large degree of mossy growth, indications of excessive moisture and lack of evaporation.
4. Use of movable sprinkler too close to the building allowing continuous use against windows and doors.

4. All wood windows have been compromised in some form. Most damage is to the exterior sides with concentration to all sills and approx. 18" high at each jamb condition where the wood has rotted, and sealants have been damaged or missing. The

following windows will require a "dutchman" repair, consolidant injections or full replacement if the damages are too great:

- a) North Façade has a total of 18 windows with 13 showing need for extensive repairs. One window will require a sash replacement. (See photos on sheet 1, interior side).
- b) East Façade has a total of 14 windows with repairs to all the sills and re-caulking of the jambs.
- c) South Façade has a total of 18 windows with extensive repairs needed to at least two (2) window sills. The rest require sill repairs and re-caulking of the jambs.
- d) West Façade has a total of 14 windows with damage to all the exterior sills. Two (2) showed the need for extensive repairs or replacement. All will require re-caulking. One (1) window has extensive damages to the interior lower sash.
- e) All windows will need to be repainted and resealed to eliminate all areas of air and water infiltration. The noted areas of damage to all the windows will require closer examination.

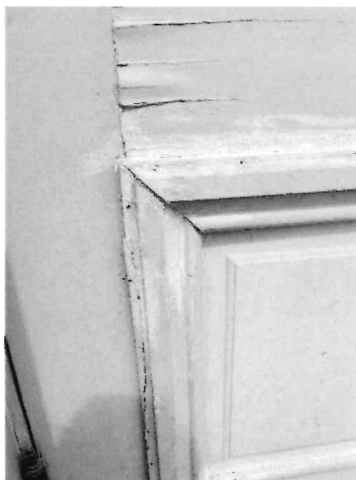
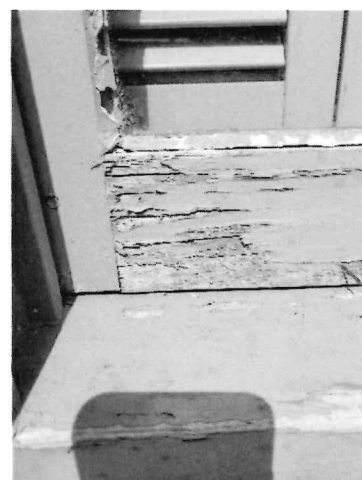
Photos above show the exterior damage to lower sections of the door panels.

The openings shown at door and window deterioration samples are a few points of sure water and air infiltration into the building space. Recommendations are to remove all rotted wood pieces and replace with solid materials. Some areas of the window sashes and frames may just require a consolidate injection to stabilize the wood, while other locations could just have a "dutchman" installation. This would be a decision point by a restoration window and door contractor.

3. Repairs and or partial material replacement of lower panels of entry doors at the South, East and West entries. Portions of the lower area of these doors are damaged due to water and have rotted panels and bases (see photos on sheet 2 for examples). Recommend adjacent side panels be repaired. Remove and replace all damaged and/or missing sealant at door frames and re-paint doors and frames.

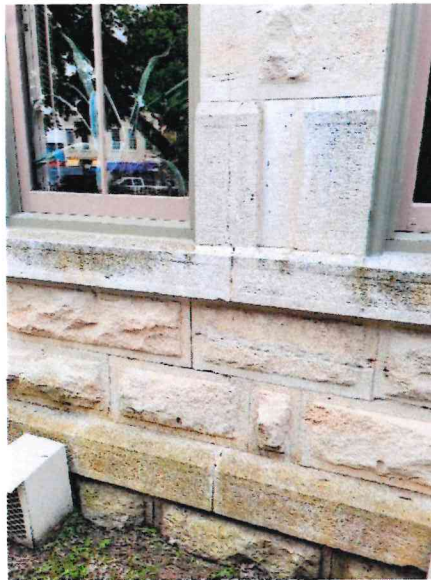
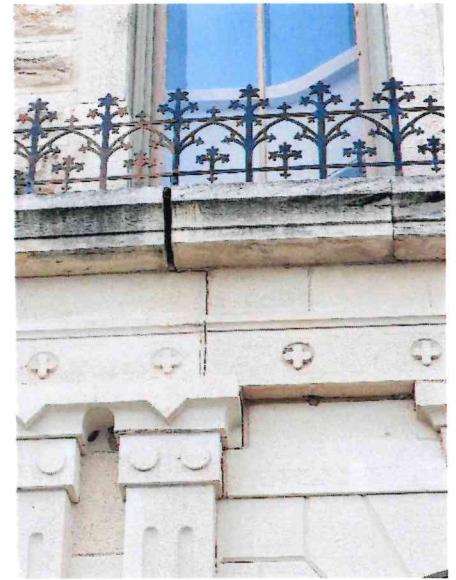
Another exterior water infiltration point noted by the building walk around, were the numerous missing mortar joints. The photos shown below are just a couple of existing conditions found primarily at the exterior masonry facades from the five (5) foot level down to the ground level. Water migrating through the missing mortar joints would most likely go through a freeze-thaw action over a few years thus expelling more and more of the mortar materials until large gaps are left. This would also account to large pieces of spalled limestone located around the building.

(Missing mortar joints throughout allowing water infiltration)

Recommendations are for a more thorough examination of all areas of missing mortar and then a cutting out of all effected joints of all loose and unsound materials, then replacing mortar. All existing mortar should be tested for materials and strength prior to a re-pointing exercise.

1. Eliminate water infiltration into the building through the gaps in the stone mortar joints. The concentrated areas for re-pointing are from the grade level upward to approx. 60". Above the 60" level showed little to no compromises to the mortar joints but will need further review from a contractor. Estimated linear feet of mortar repairs and replacement are:

- a) North Façade – 40% coverage
 - b) East Façade – 40% coverage
 - c) South Façade – 35% coverage
 - d) West Façade – 75% coverage
2. Repairs of spalled stone located on the South and West facades with special attention to damaged stone on NW corner.

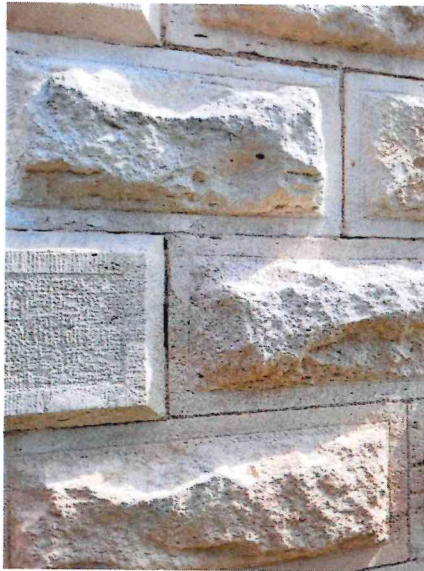
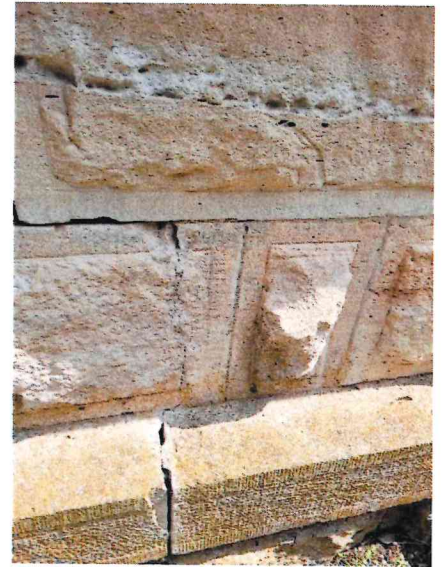
(Additional locations of missing mortar in joints)

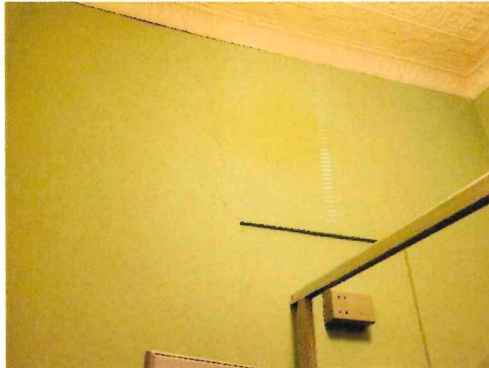
Men's Restroom cracking on east wall

Recommend a more thorough investigation of interior cracking locations and causes. At this time there is no indication there is a structural problem, however a structural analysis may be required for a more detailed assessment.

1. Plaster cracks repaired. These cracks are approx. .125" wide to hairline in width.
 - a) First Floor- approx. 14 locations at 5 l.f. each
 - b) Second Floor-approx. 4 locations at 5 l.f. each. A large crack was noted in the storage room north of the elevator lobby. This crack is between the exterior wall and backside of the elevator shaft and will be difficult to reach.

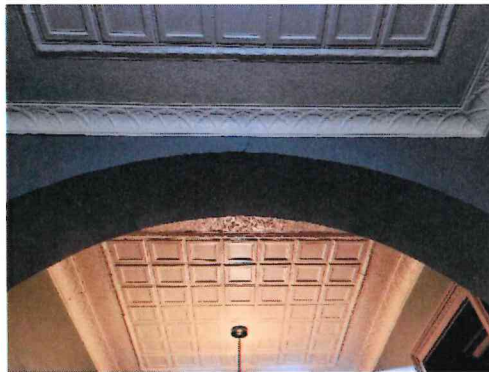
One very noticeable location was the east concrete beam that crossed the corridor. This was only noticed on the First Level.

Arch across corridor-First Level

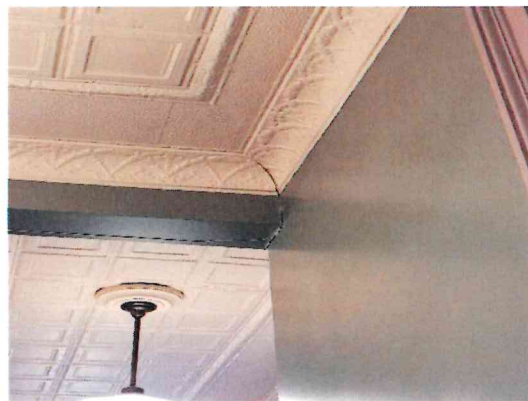
Cracking at Corner connections
