Fannin County Courthouse Punchlist Update 6/30/2025

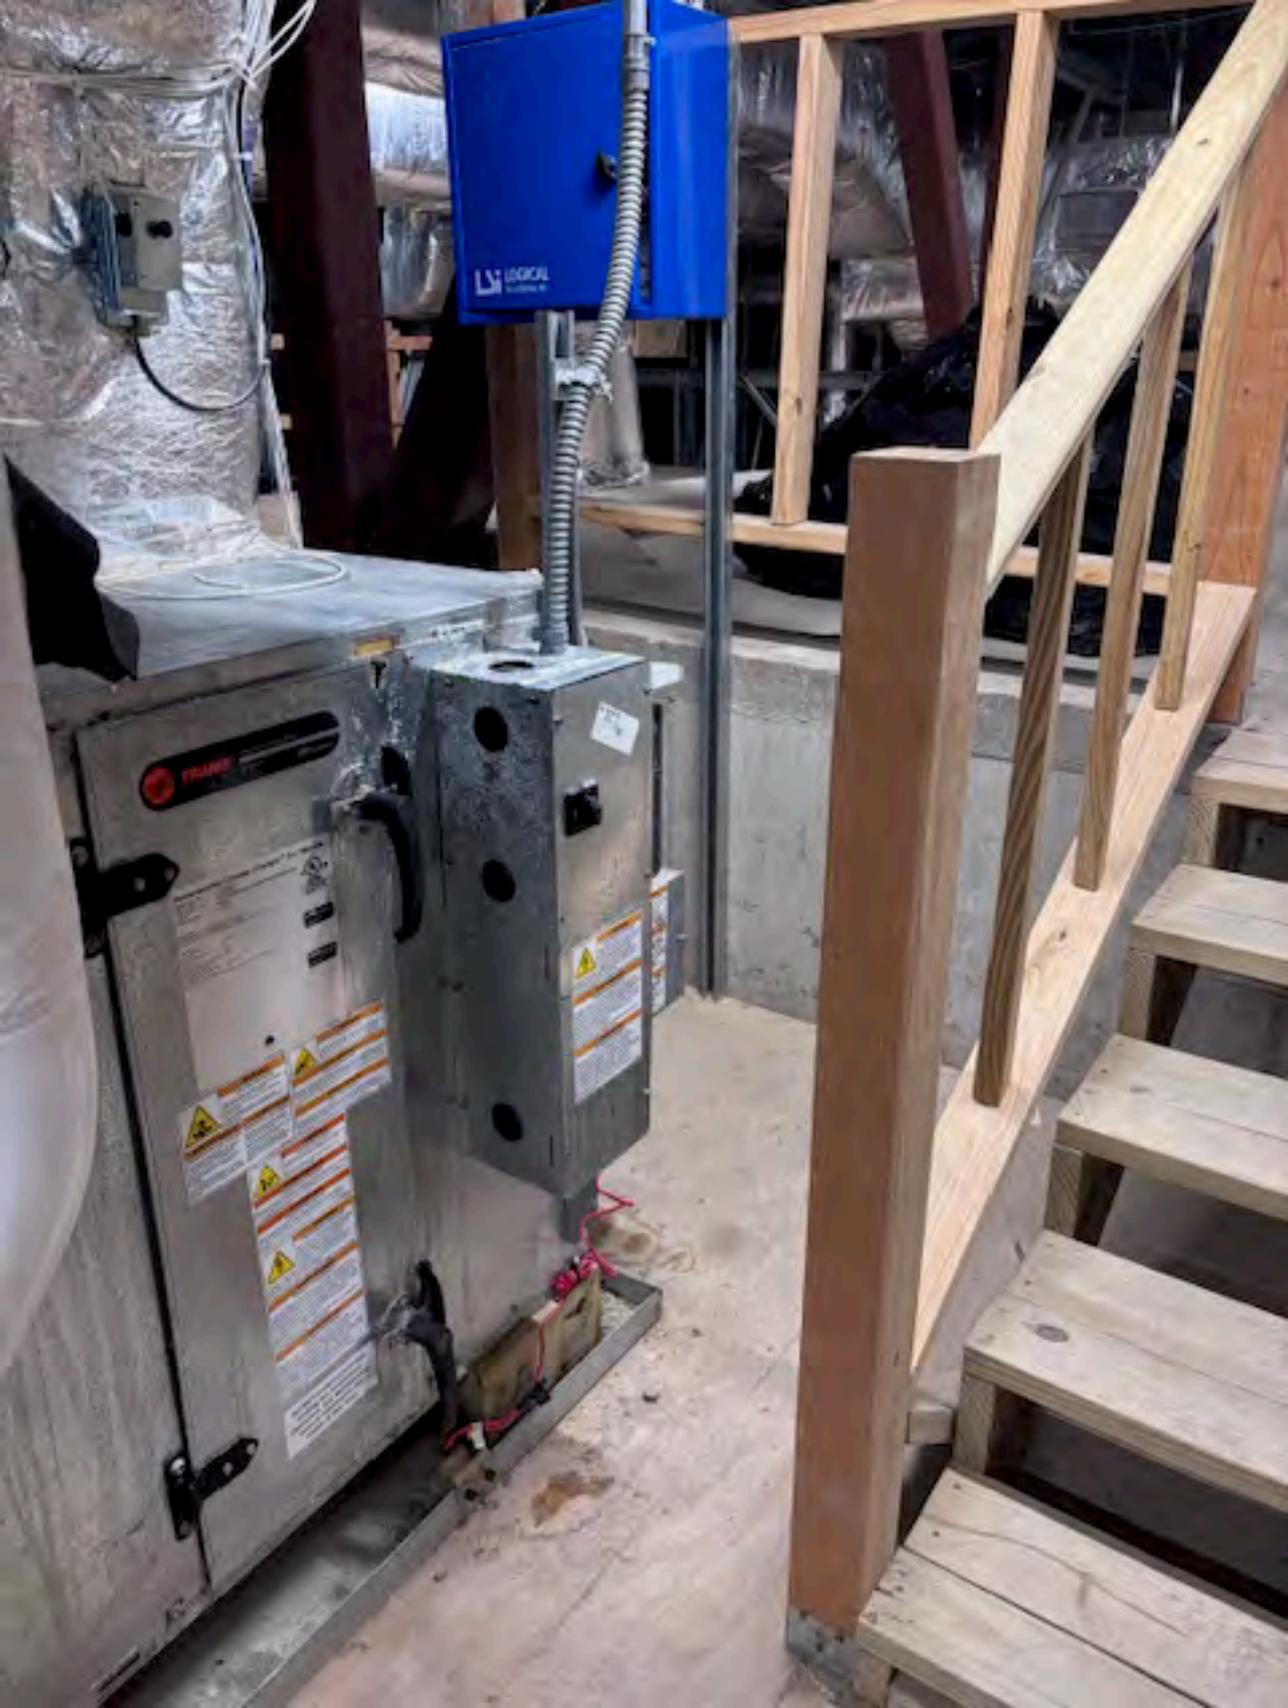
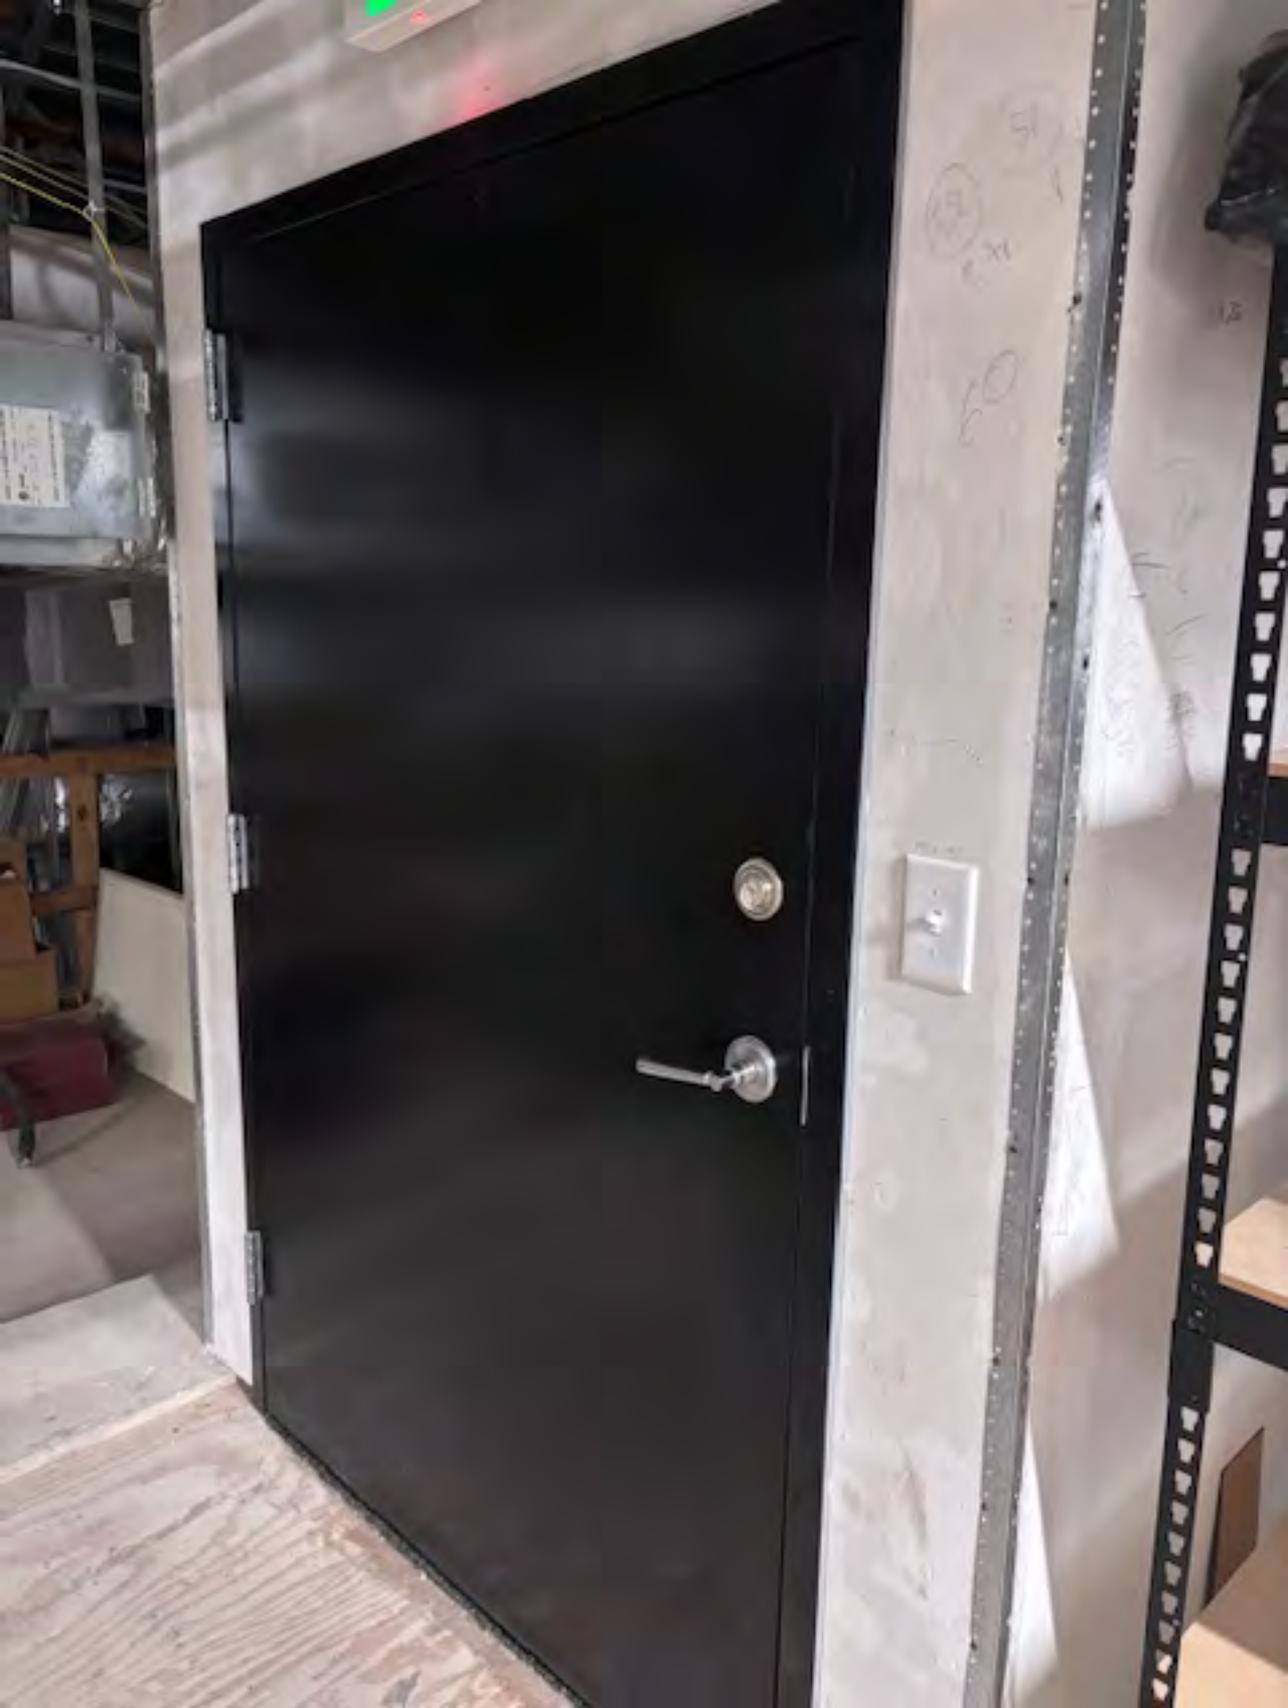
ATTIC
PHOTOS

1. Clearance issues for air handler safety switches
2. No pull station for fire alarm

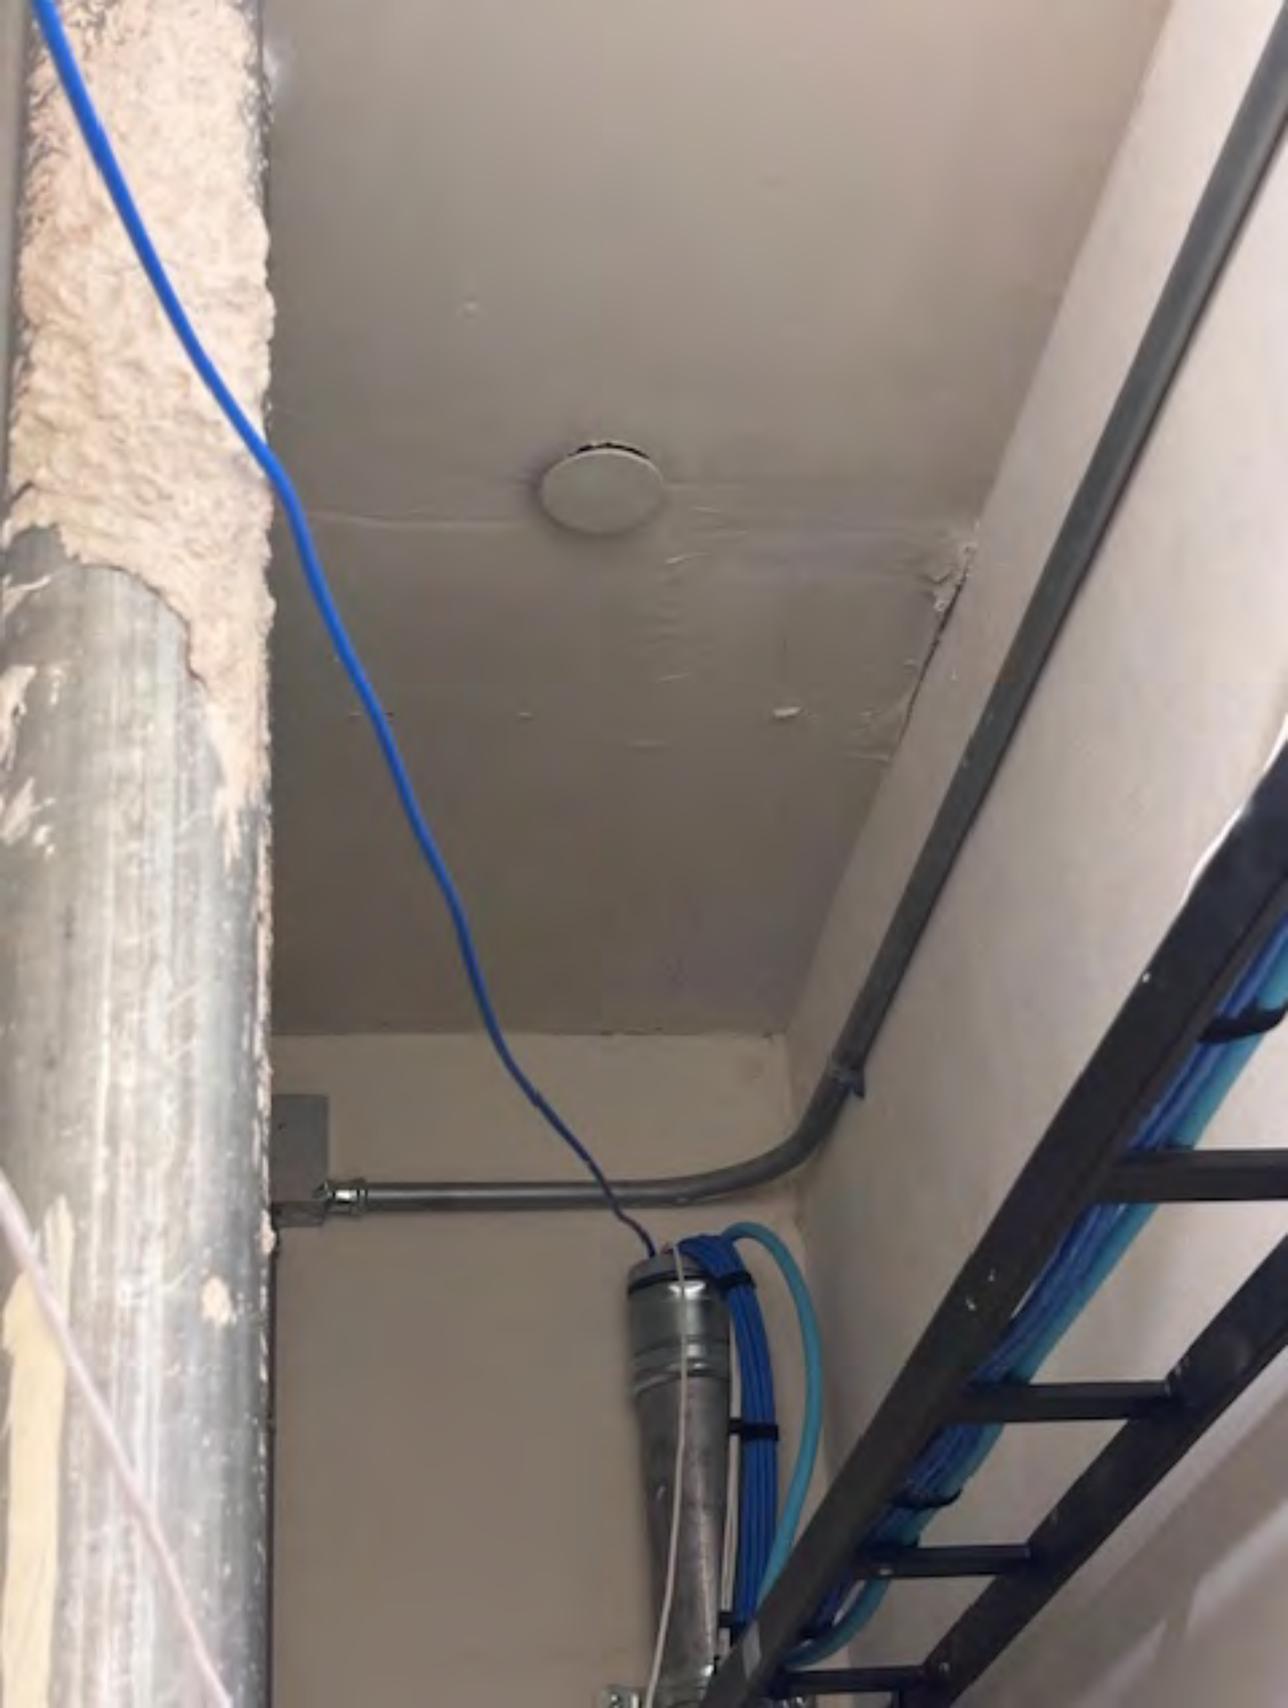
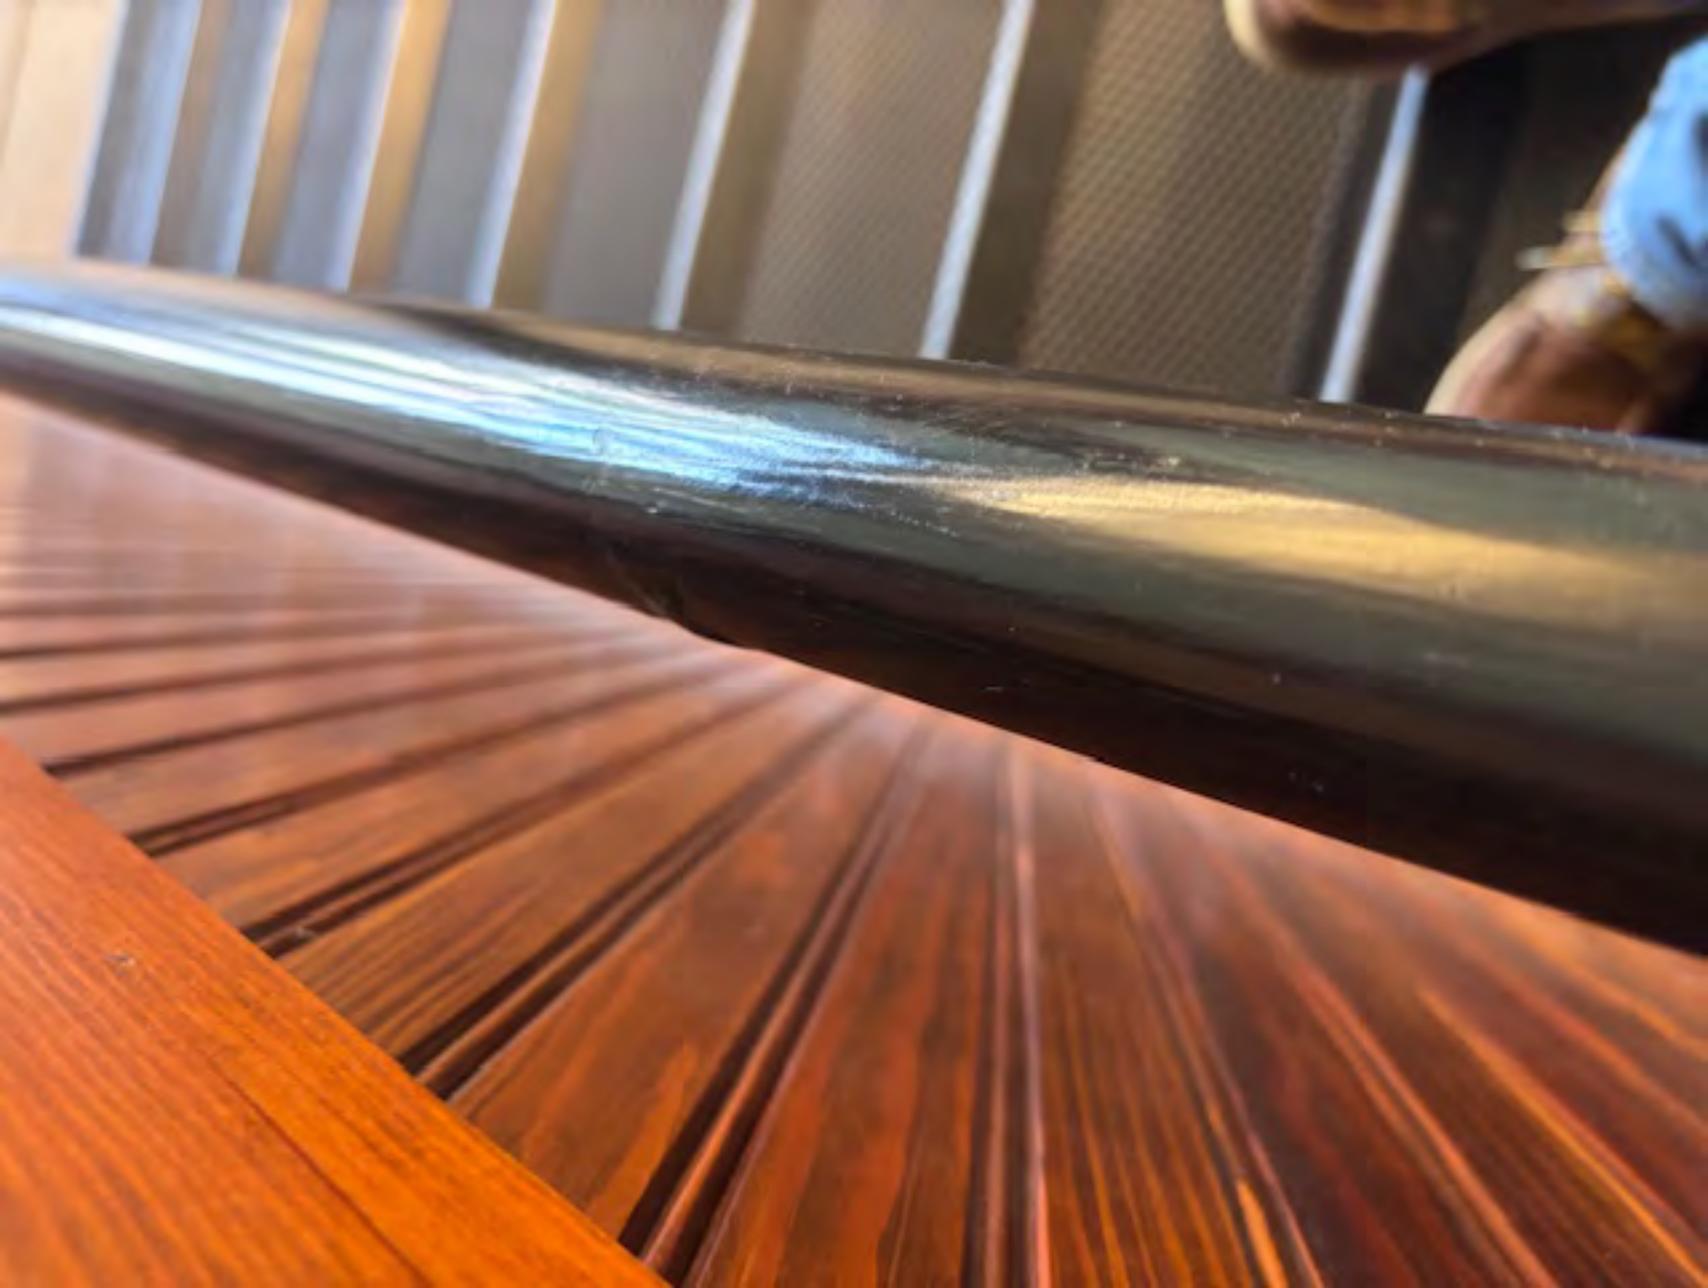
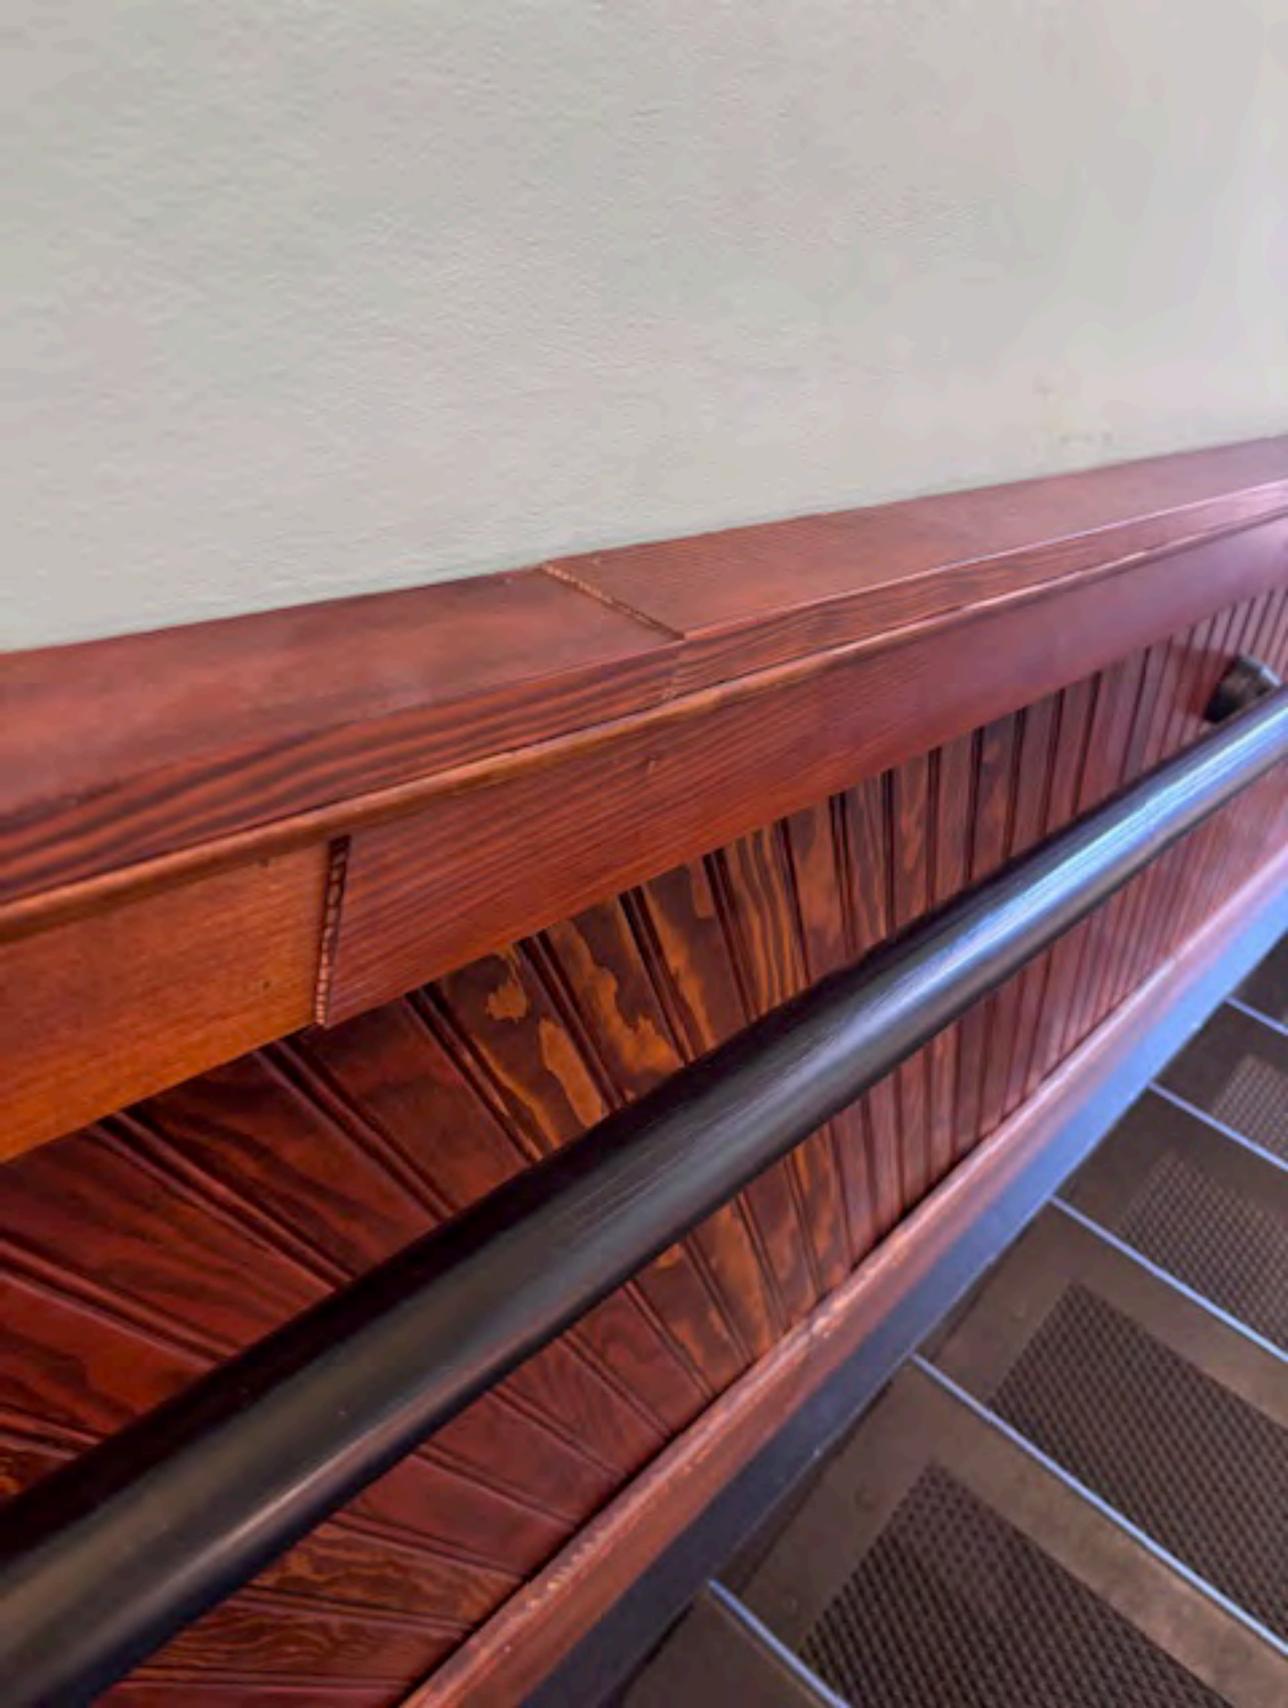
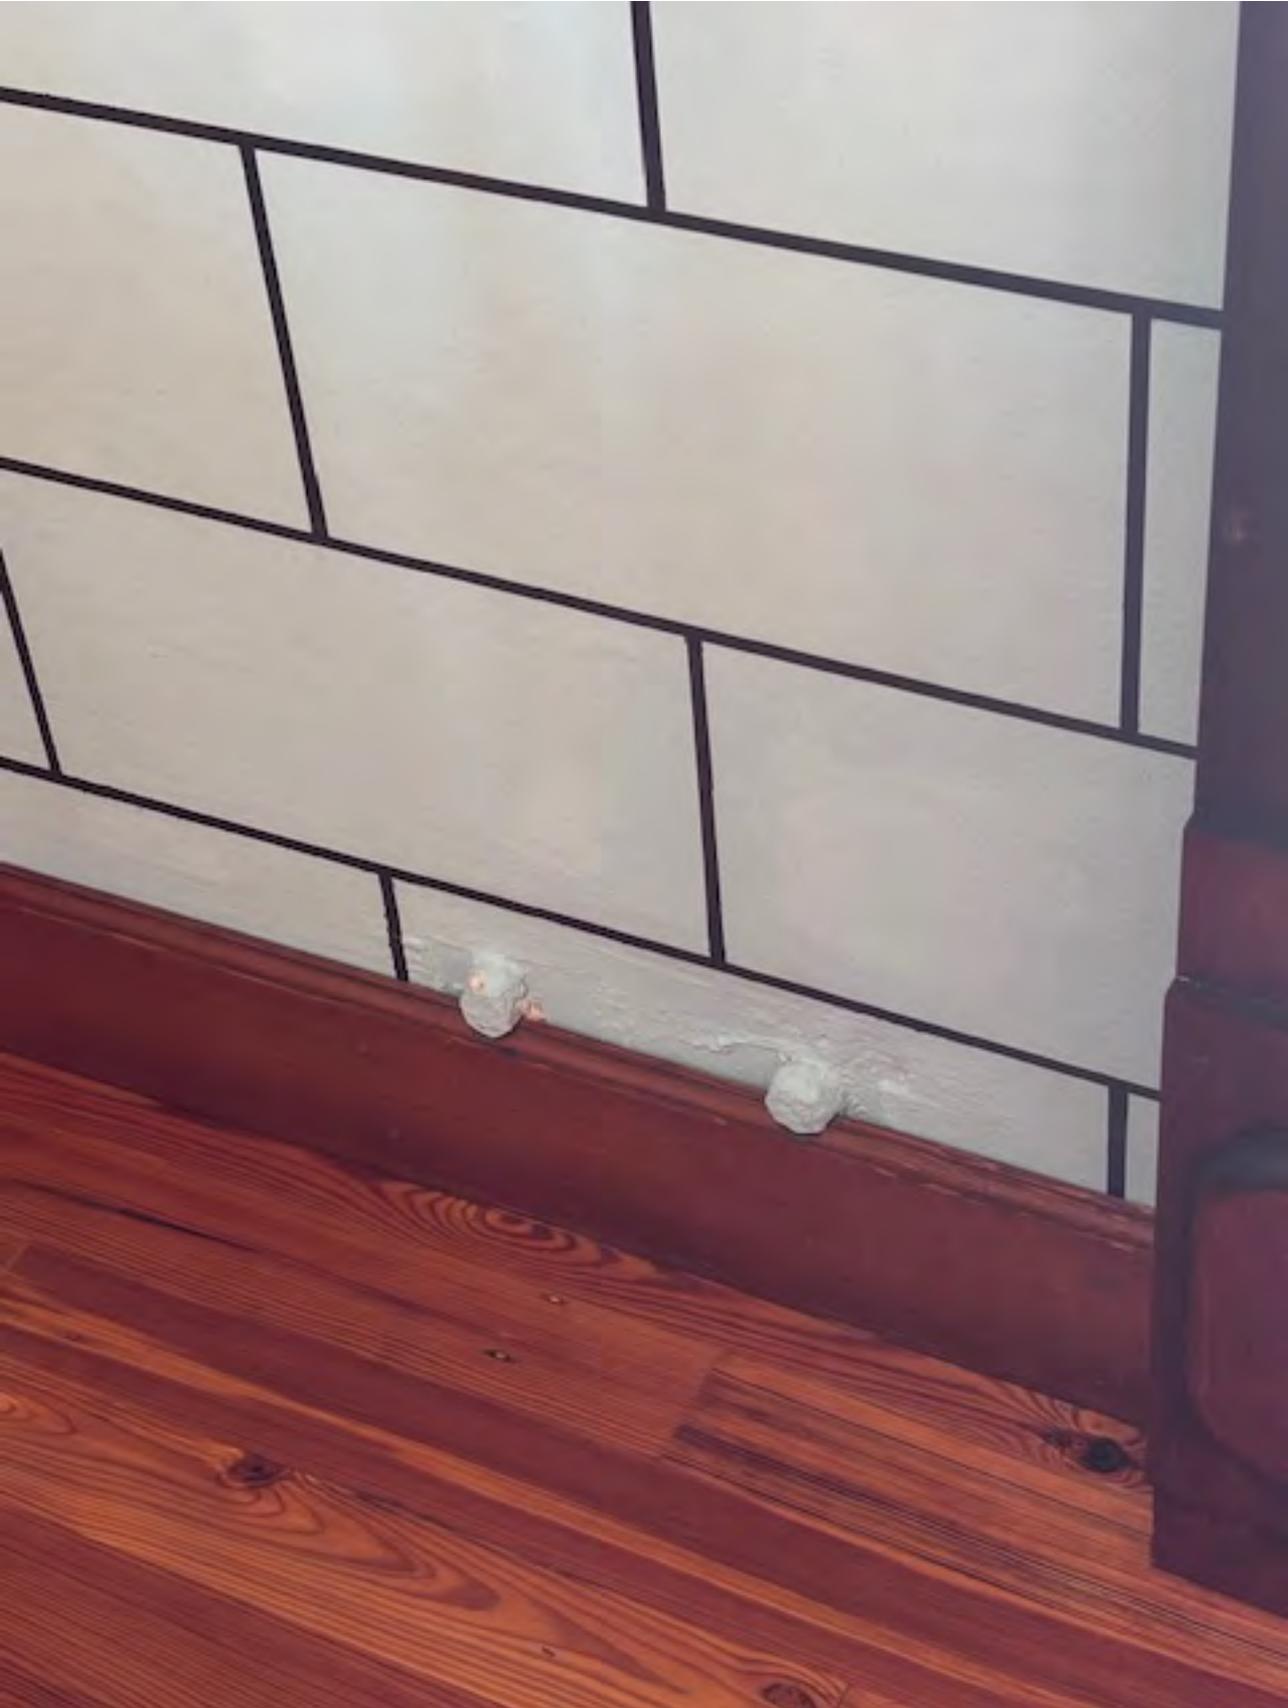
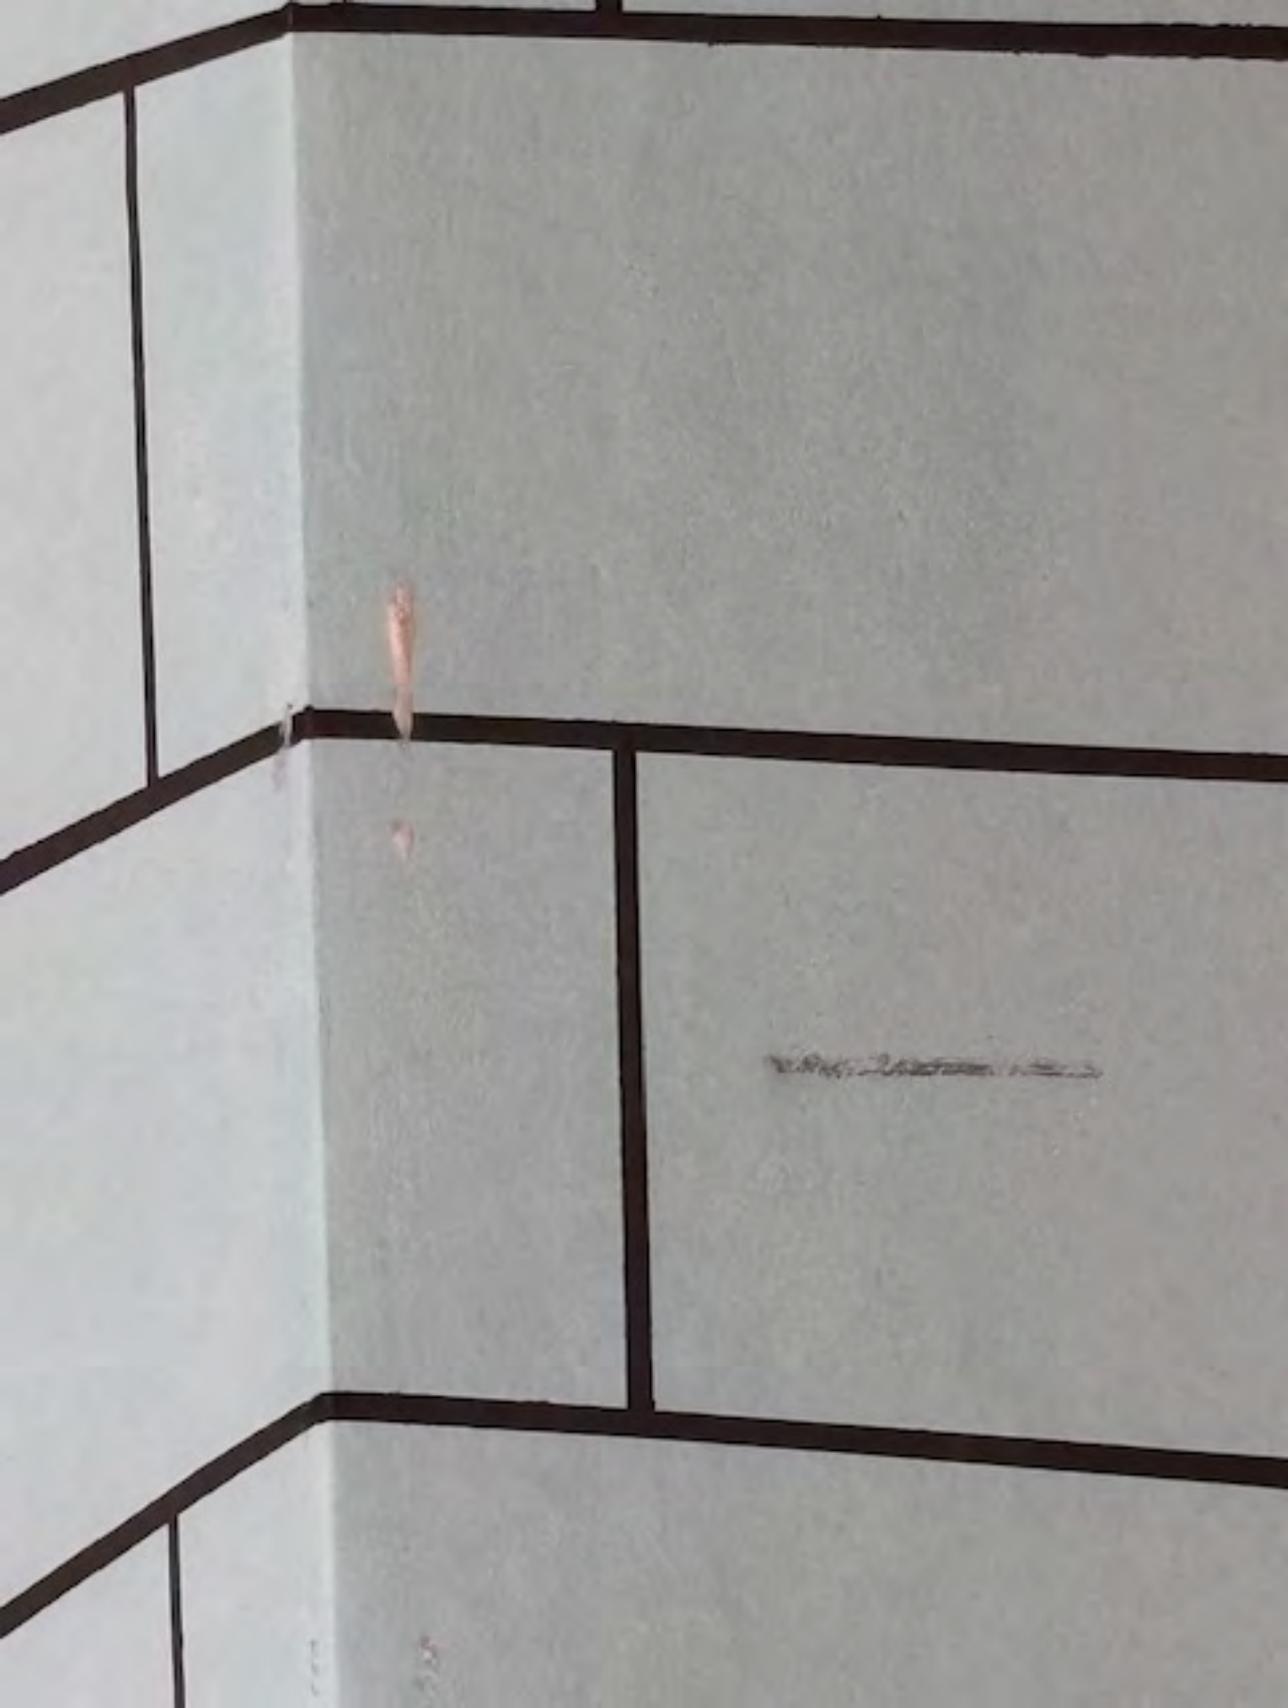
3RD FLOOR
PHOTOS

1. Crack in wall under attic stairwell
2. Plaster not troweled out smooth to match wall texture under stairwell
3. IT closet fire sprinkler cap not flush with ceiling
4. Hand rail to attic has pinch point halfway up
5. Wood trim on stairwell to attic is loose
6. Wall damage NE & NW corner of the courtroom
