Fannin County Courthouse Punchlist Update 6/30/2025

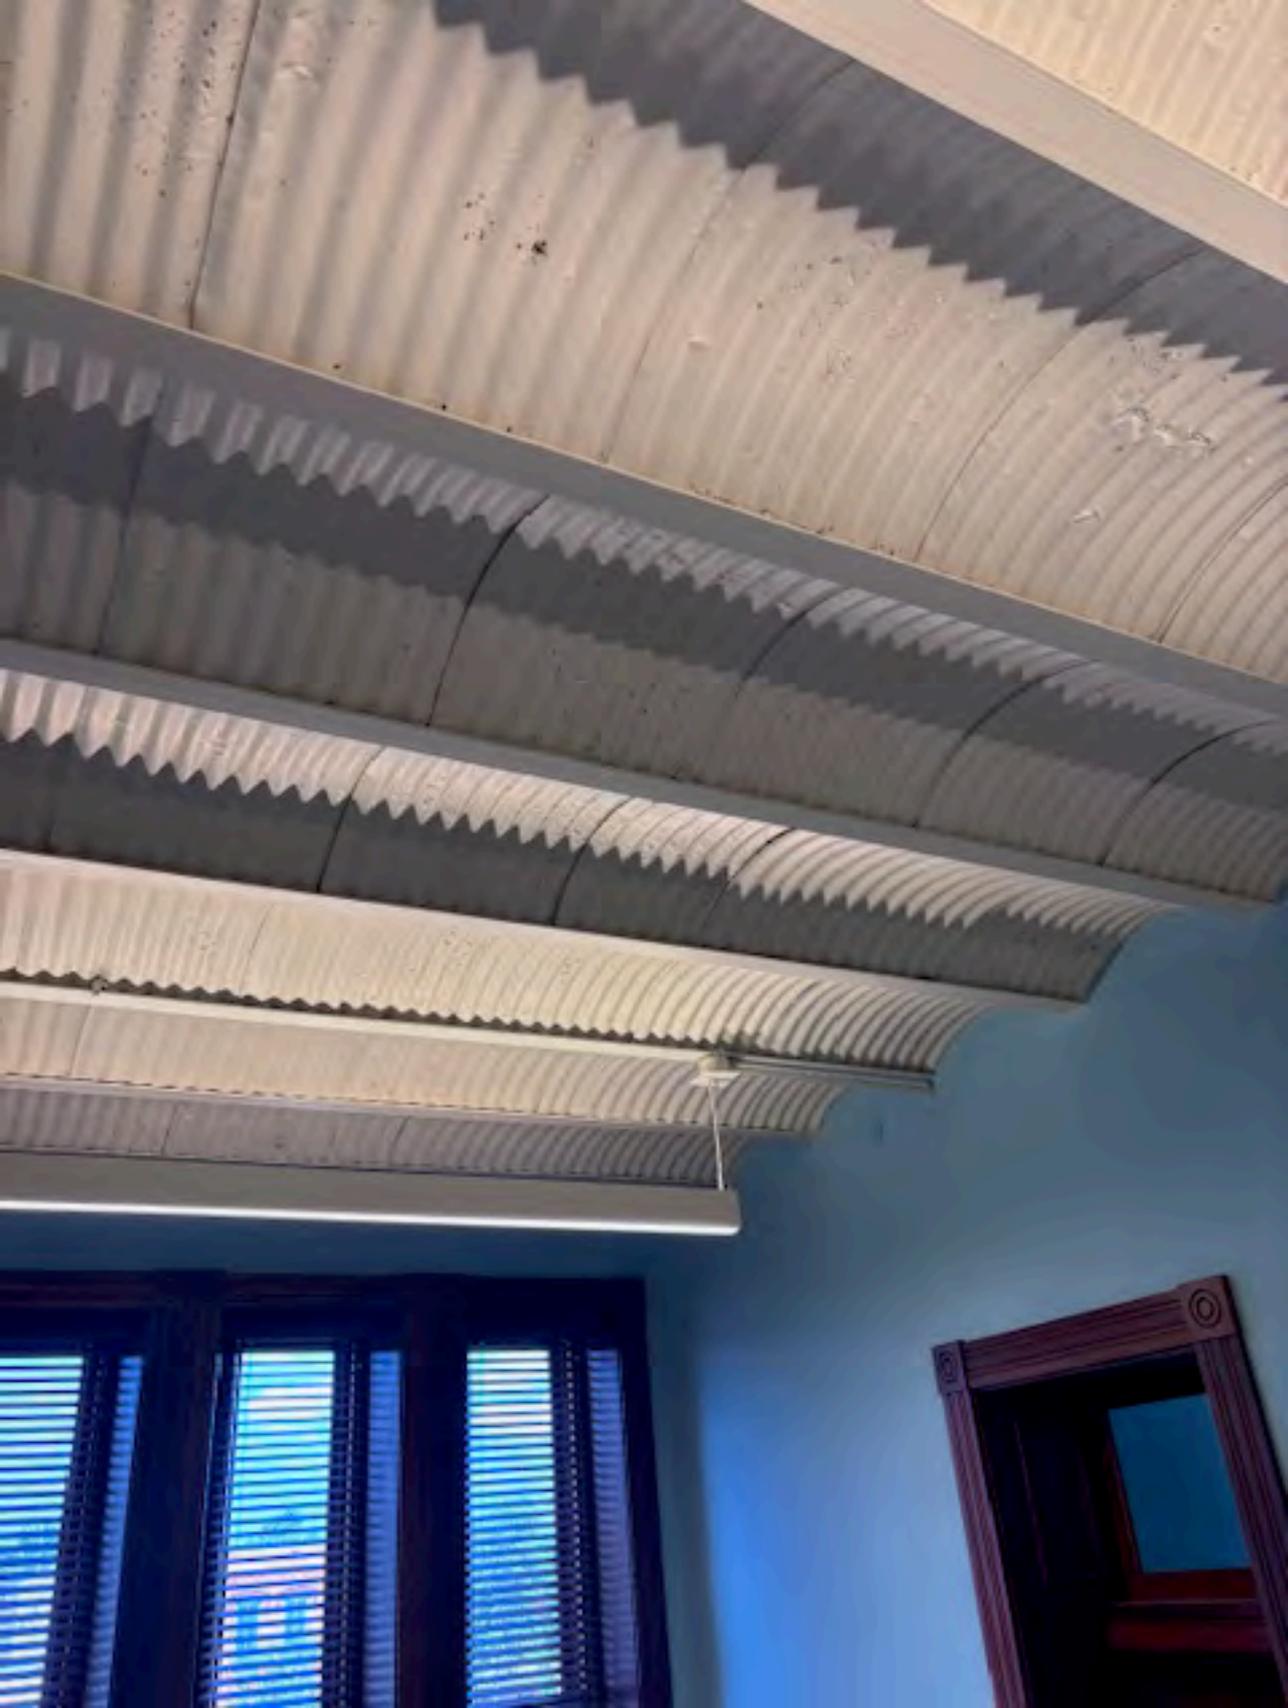
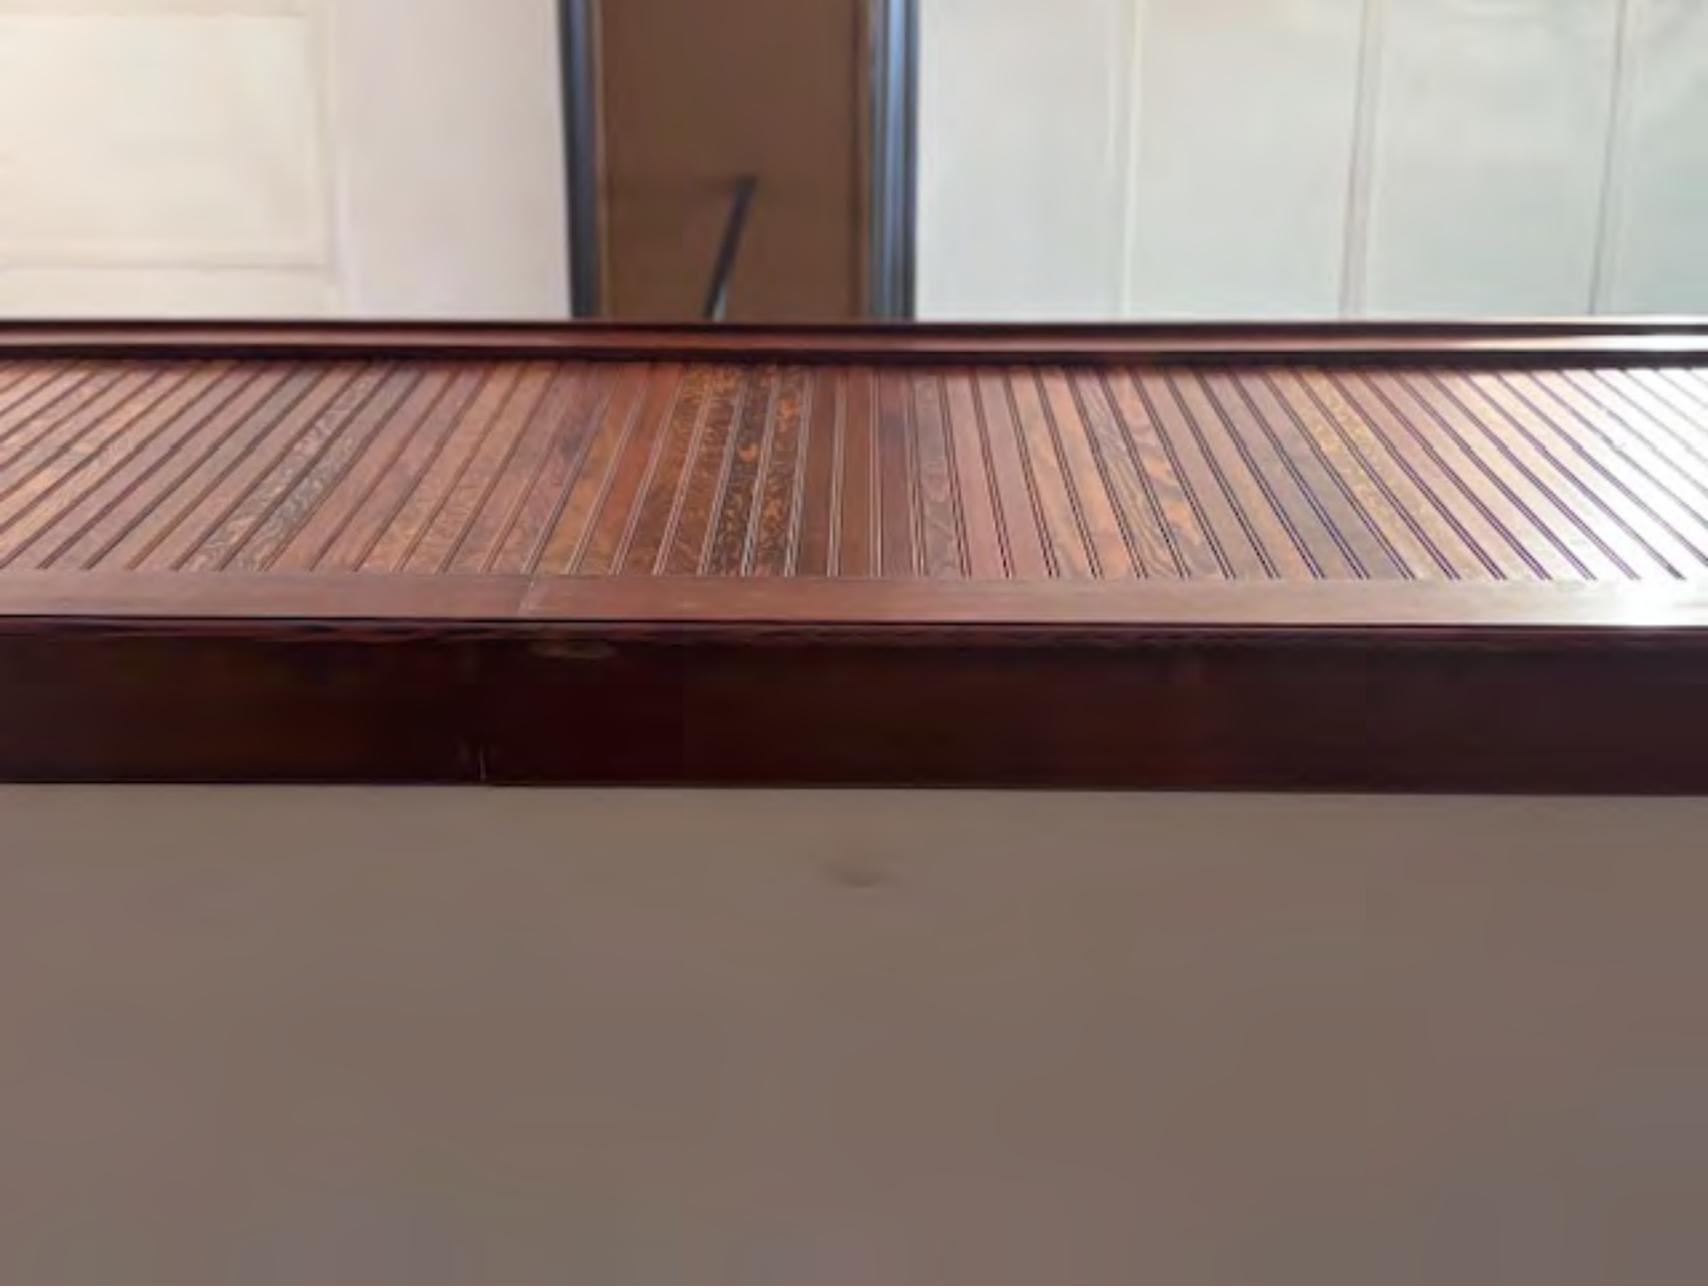
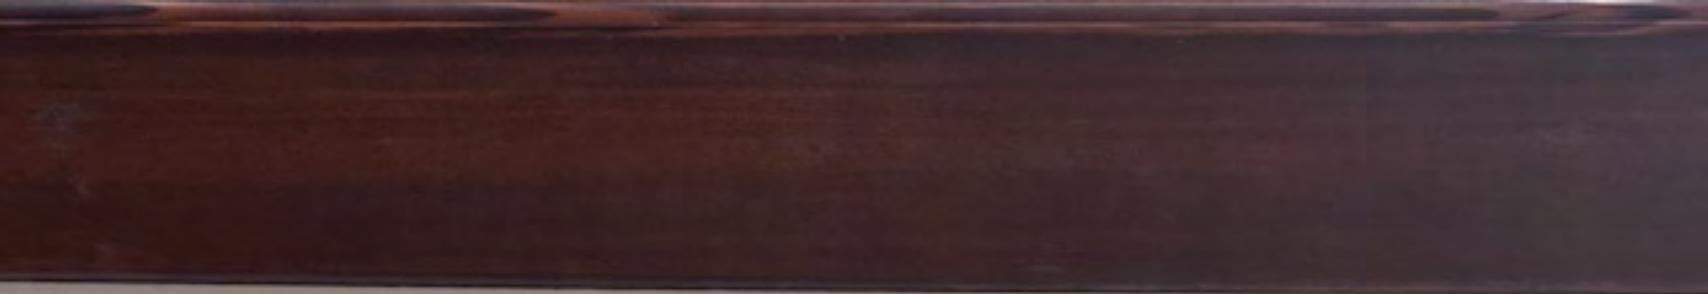
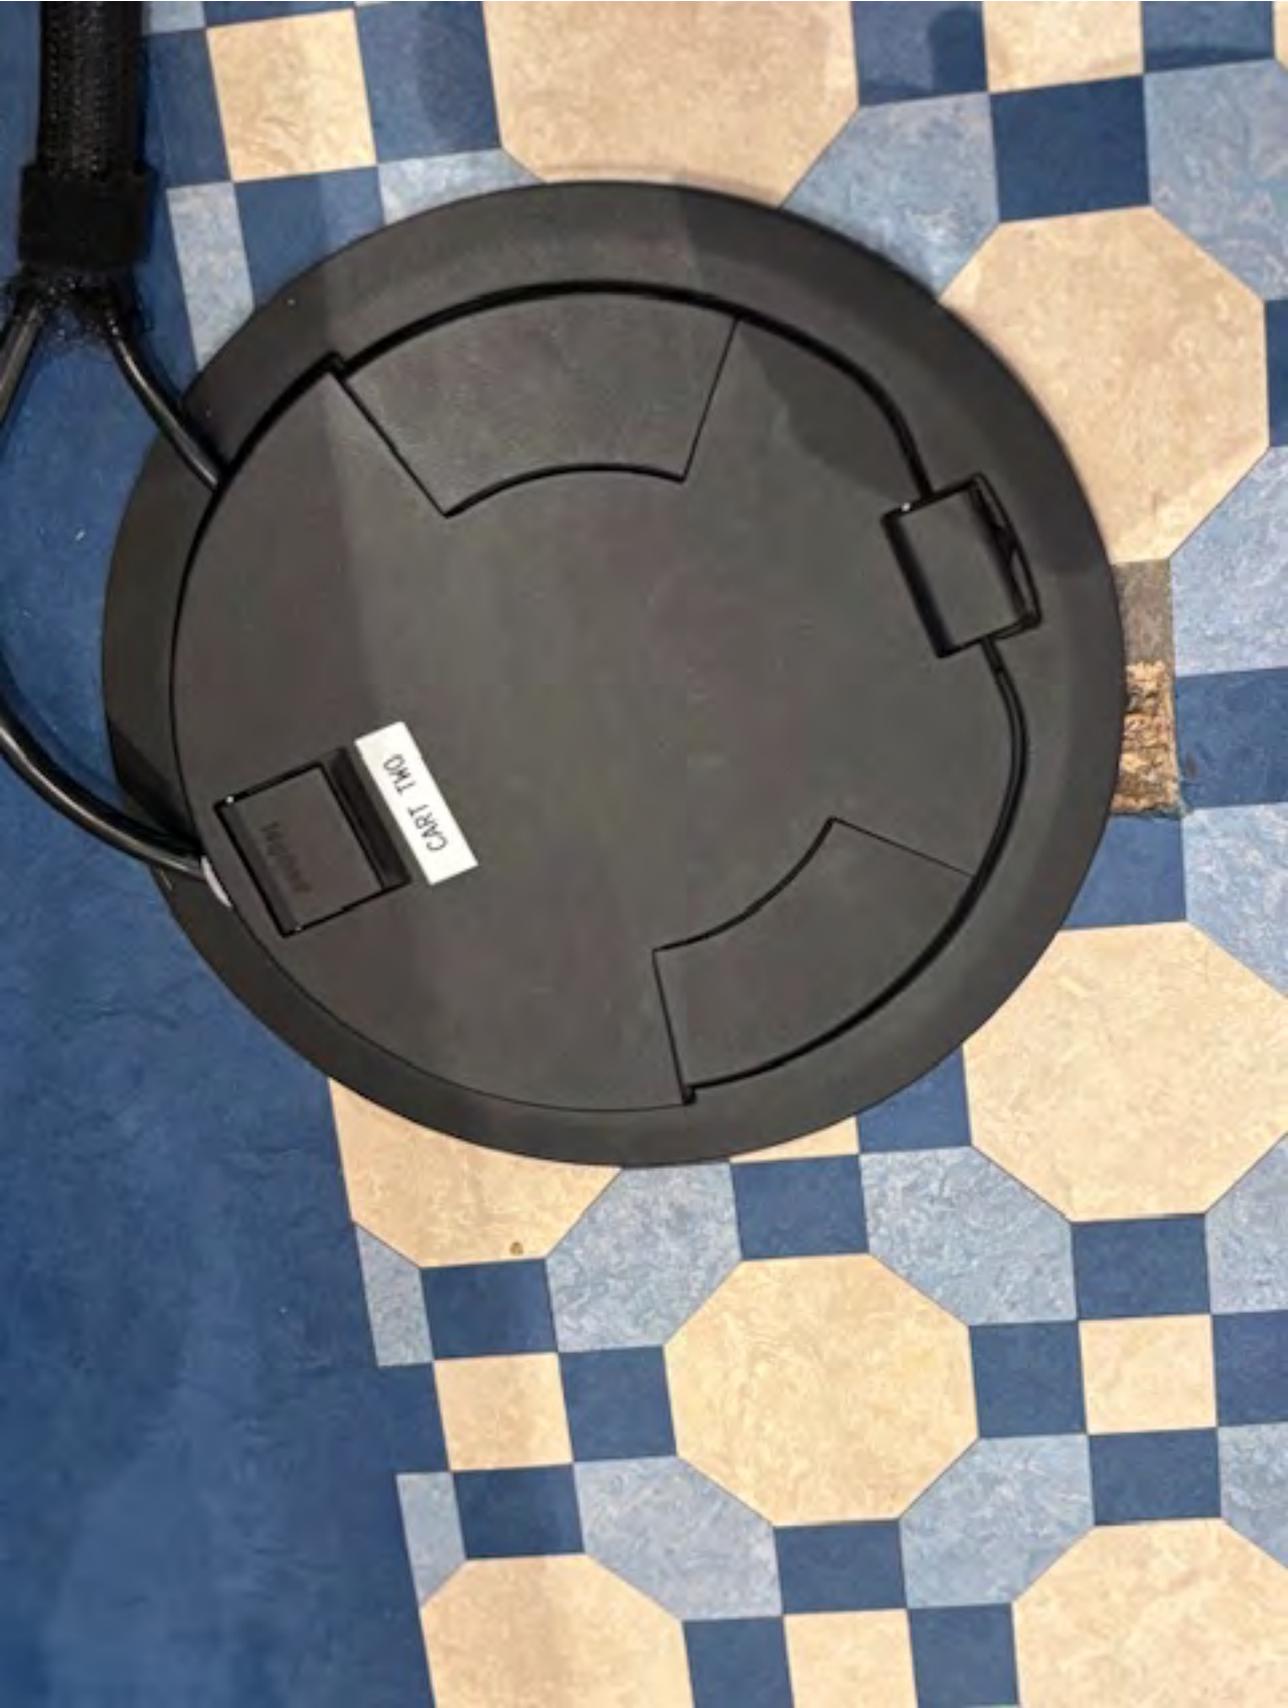
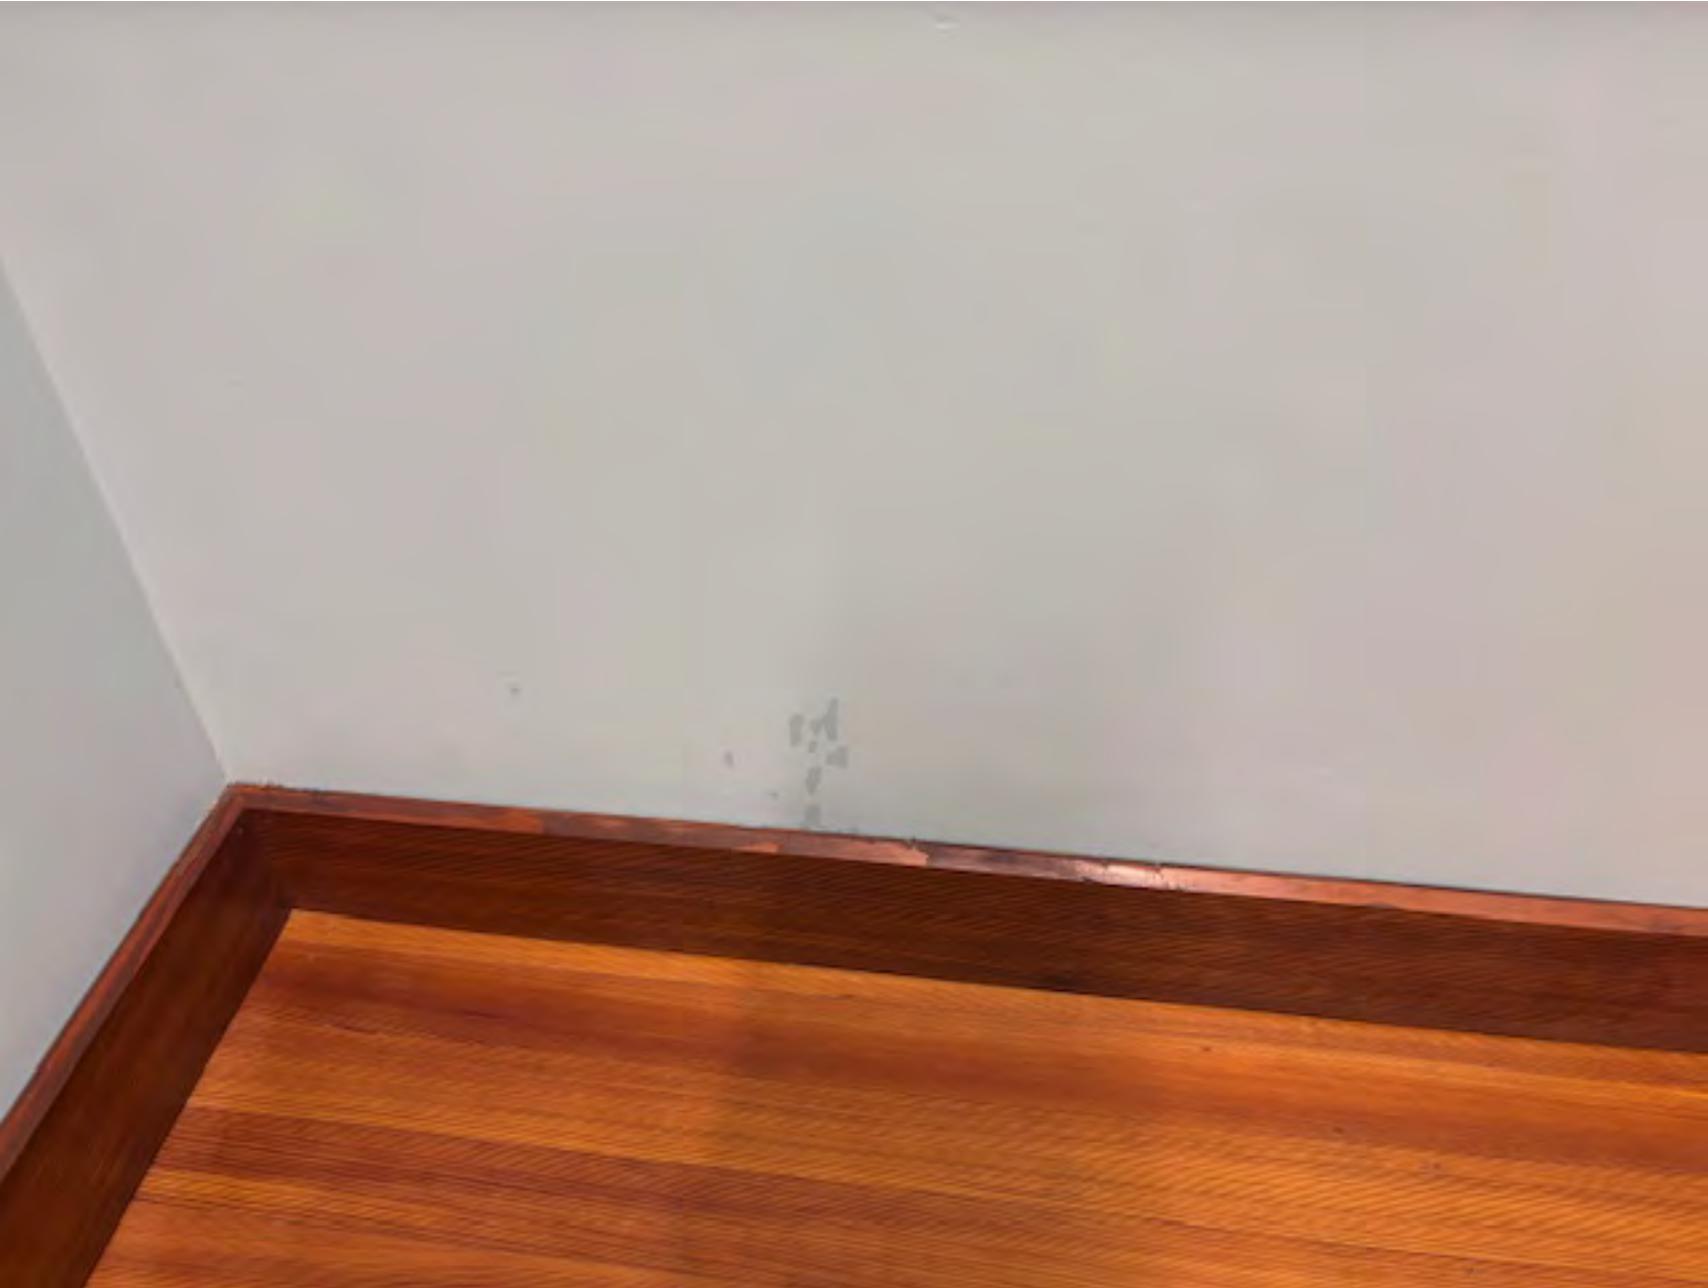
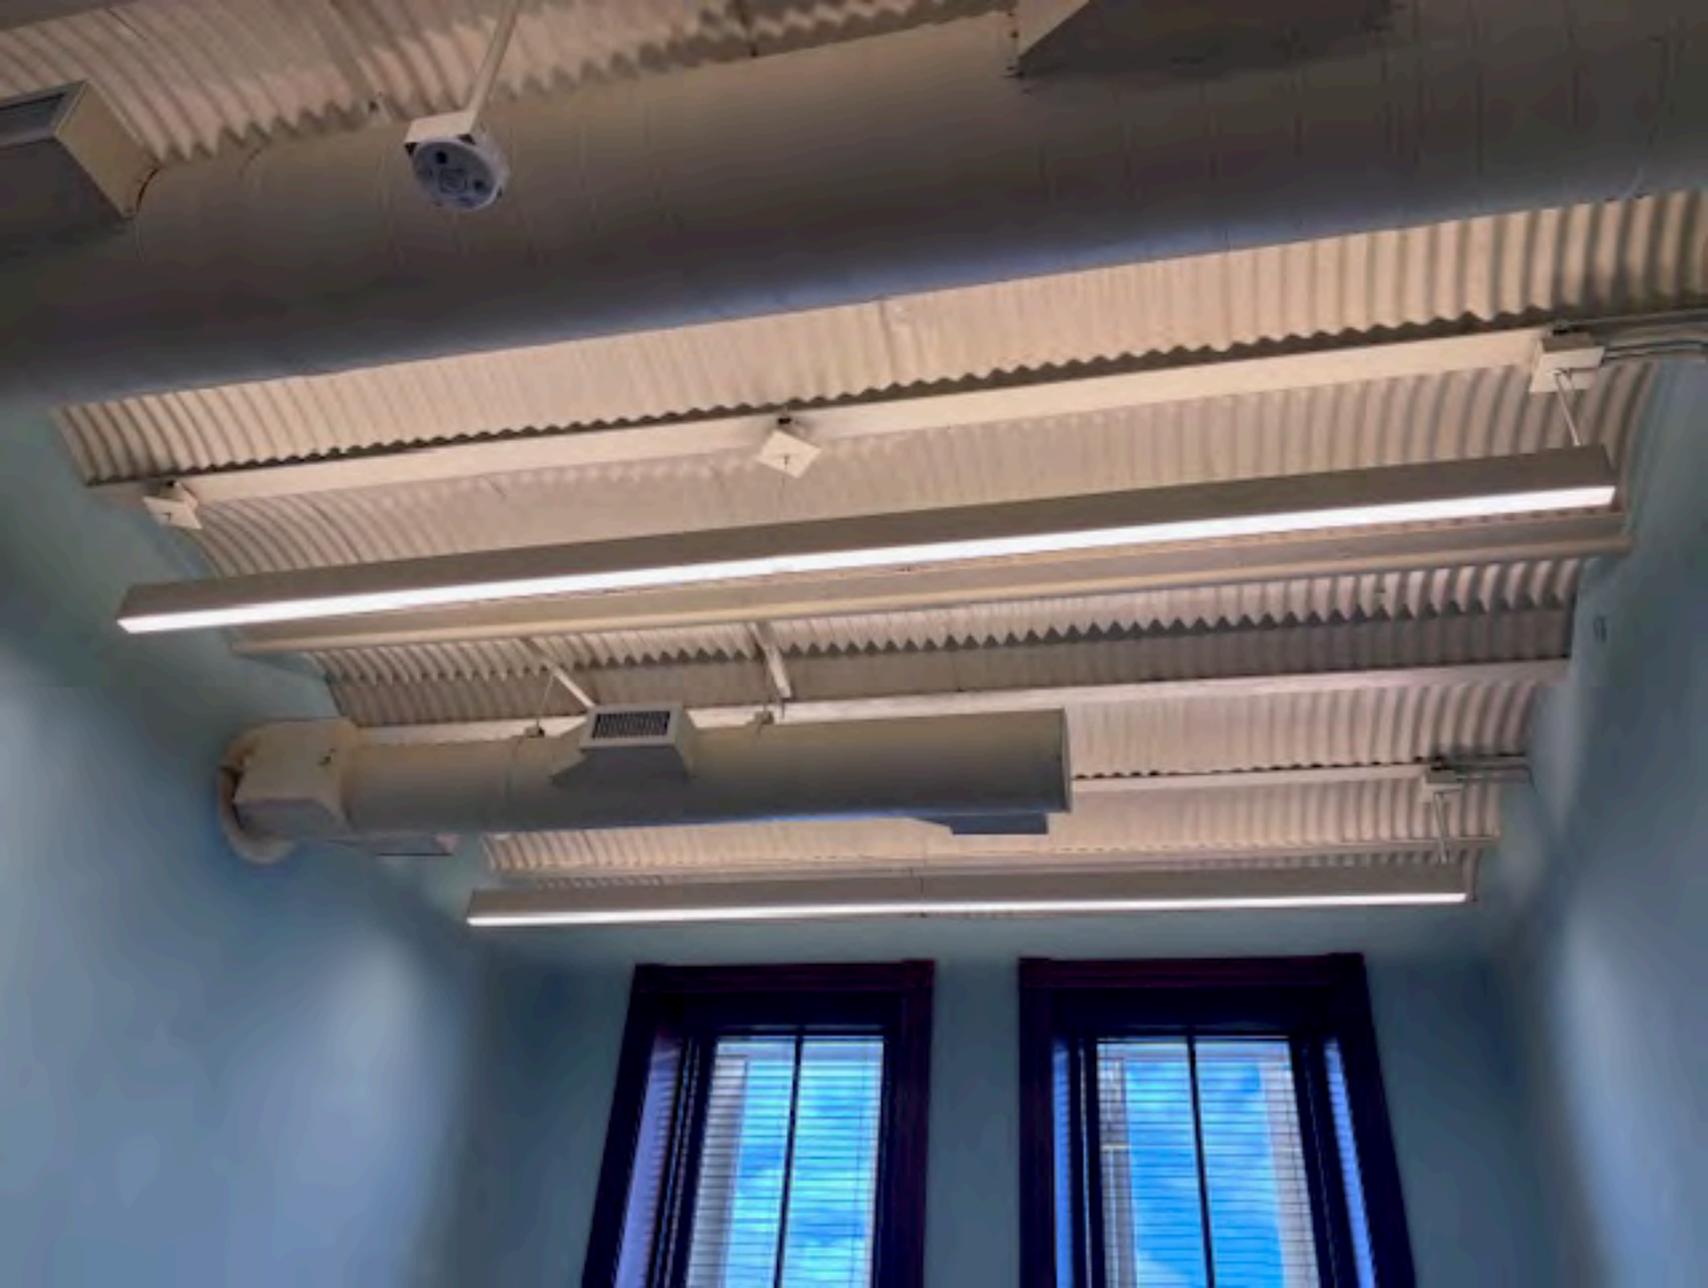
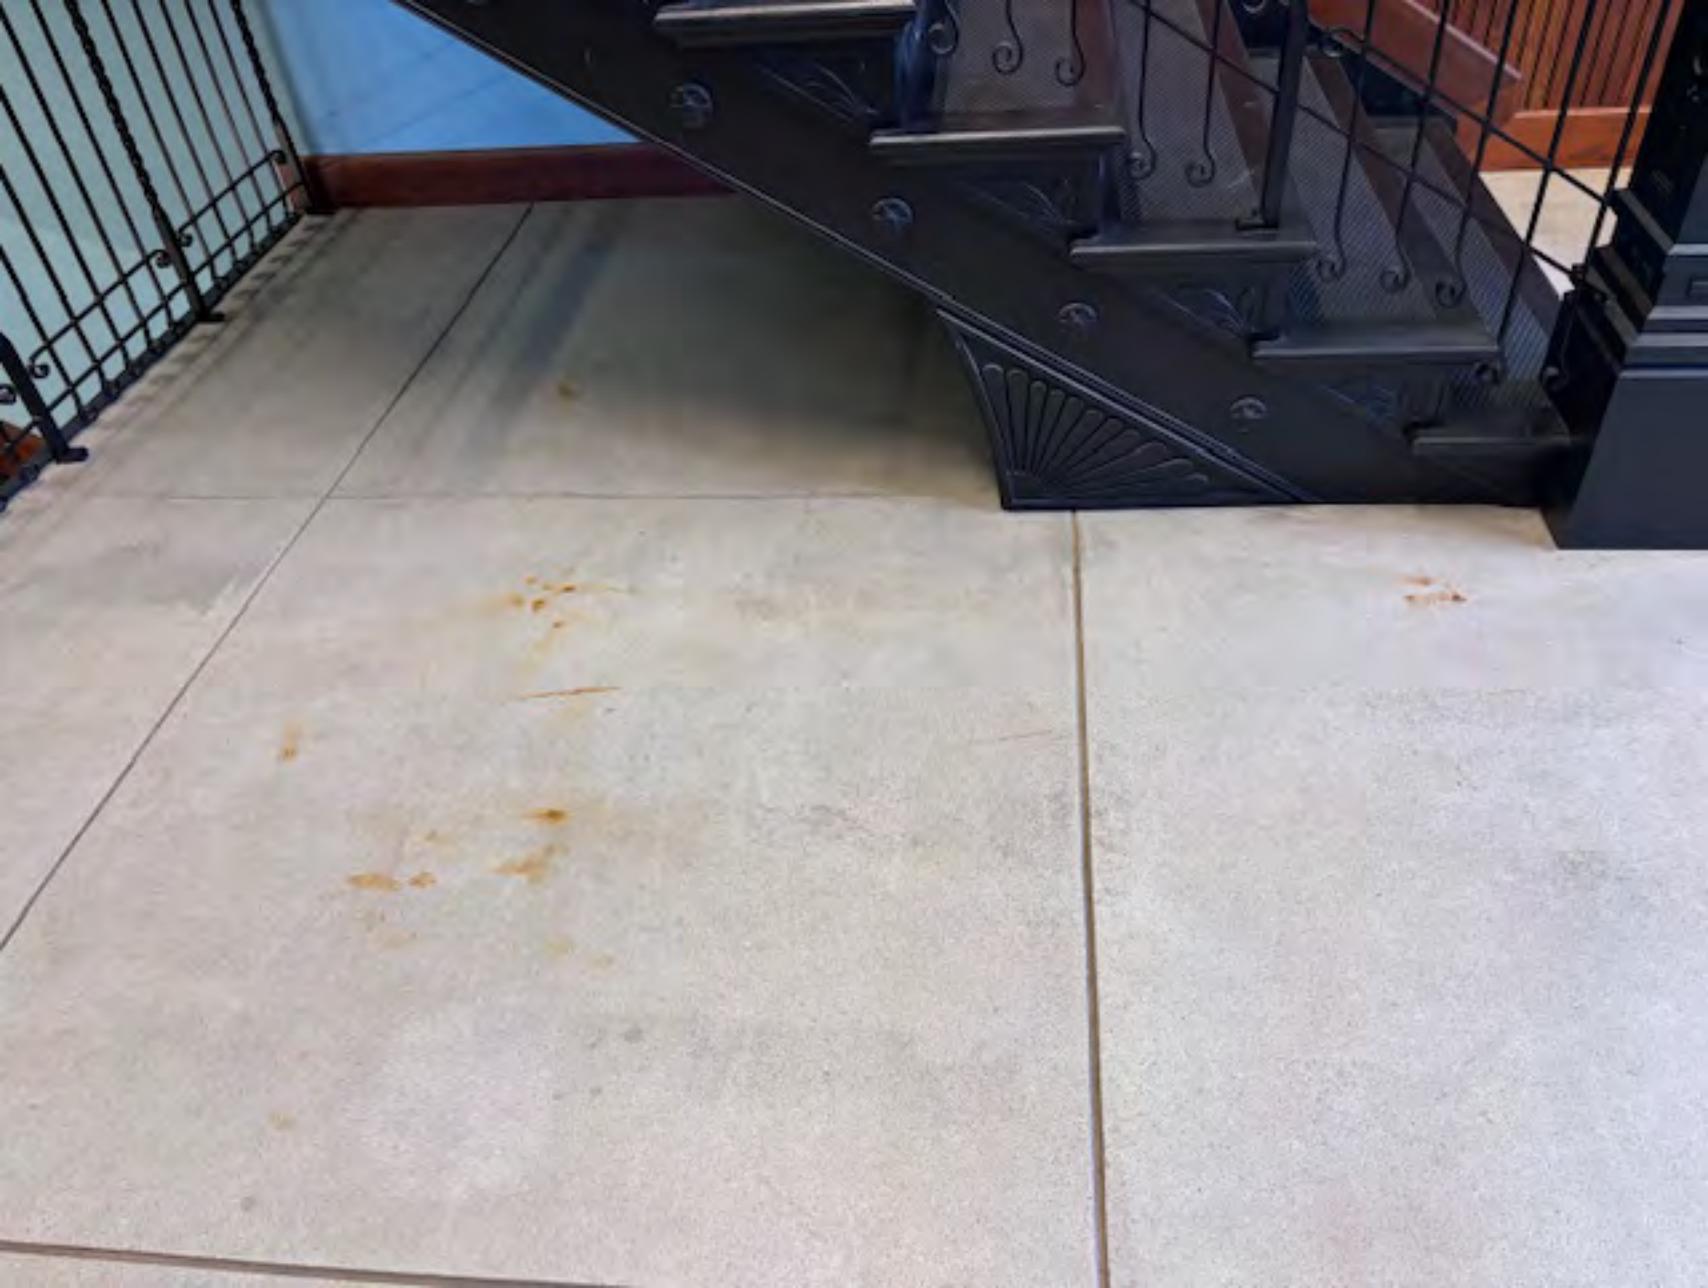
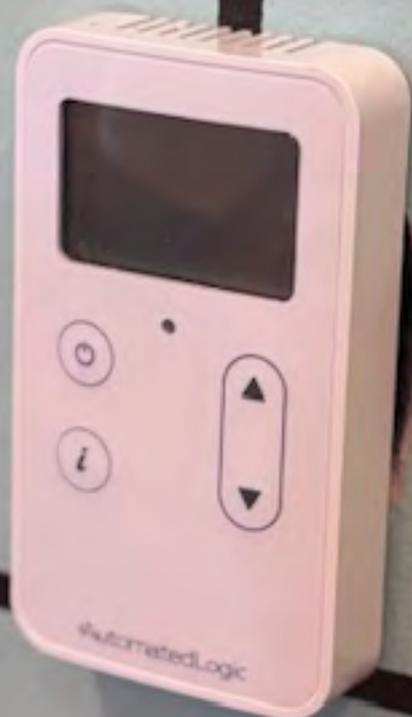
2ND FLOOR
PHOTOS

1. Rust bleeding through ceiling paint
2. Courtroom West wall wood stain up on ceiling
3. Courtroom floor data/plug hole bigger then plate
4. Elevator lobby wall is stain with clear substance
5. There is non-sufficient air vents in Judges office
6. Stain on concrete floors
7. Hole in wall under thermostat bigger then plate at SE wall
