Fannin County Courthouse Punchlist Update 6/30/2025

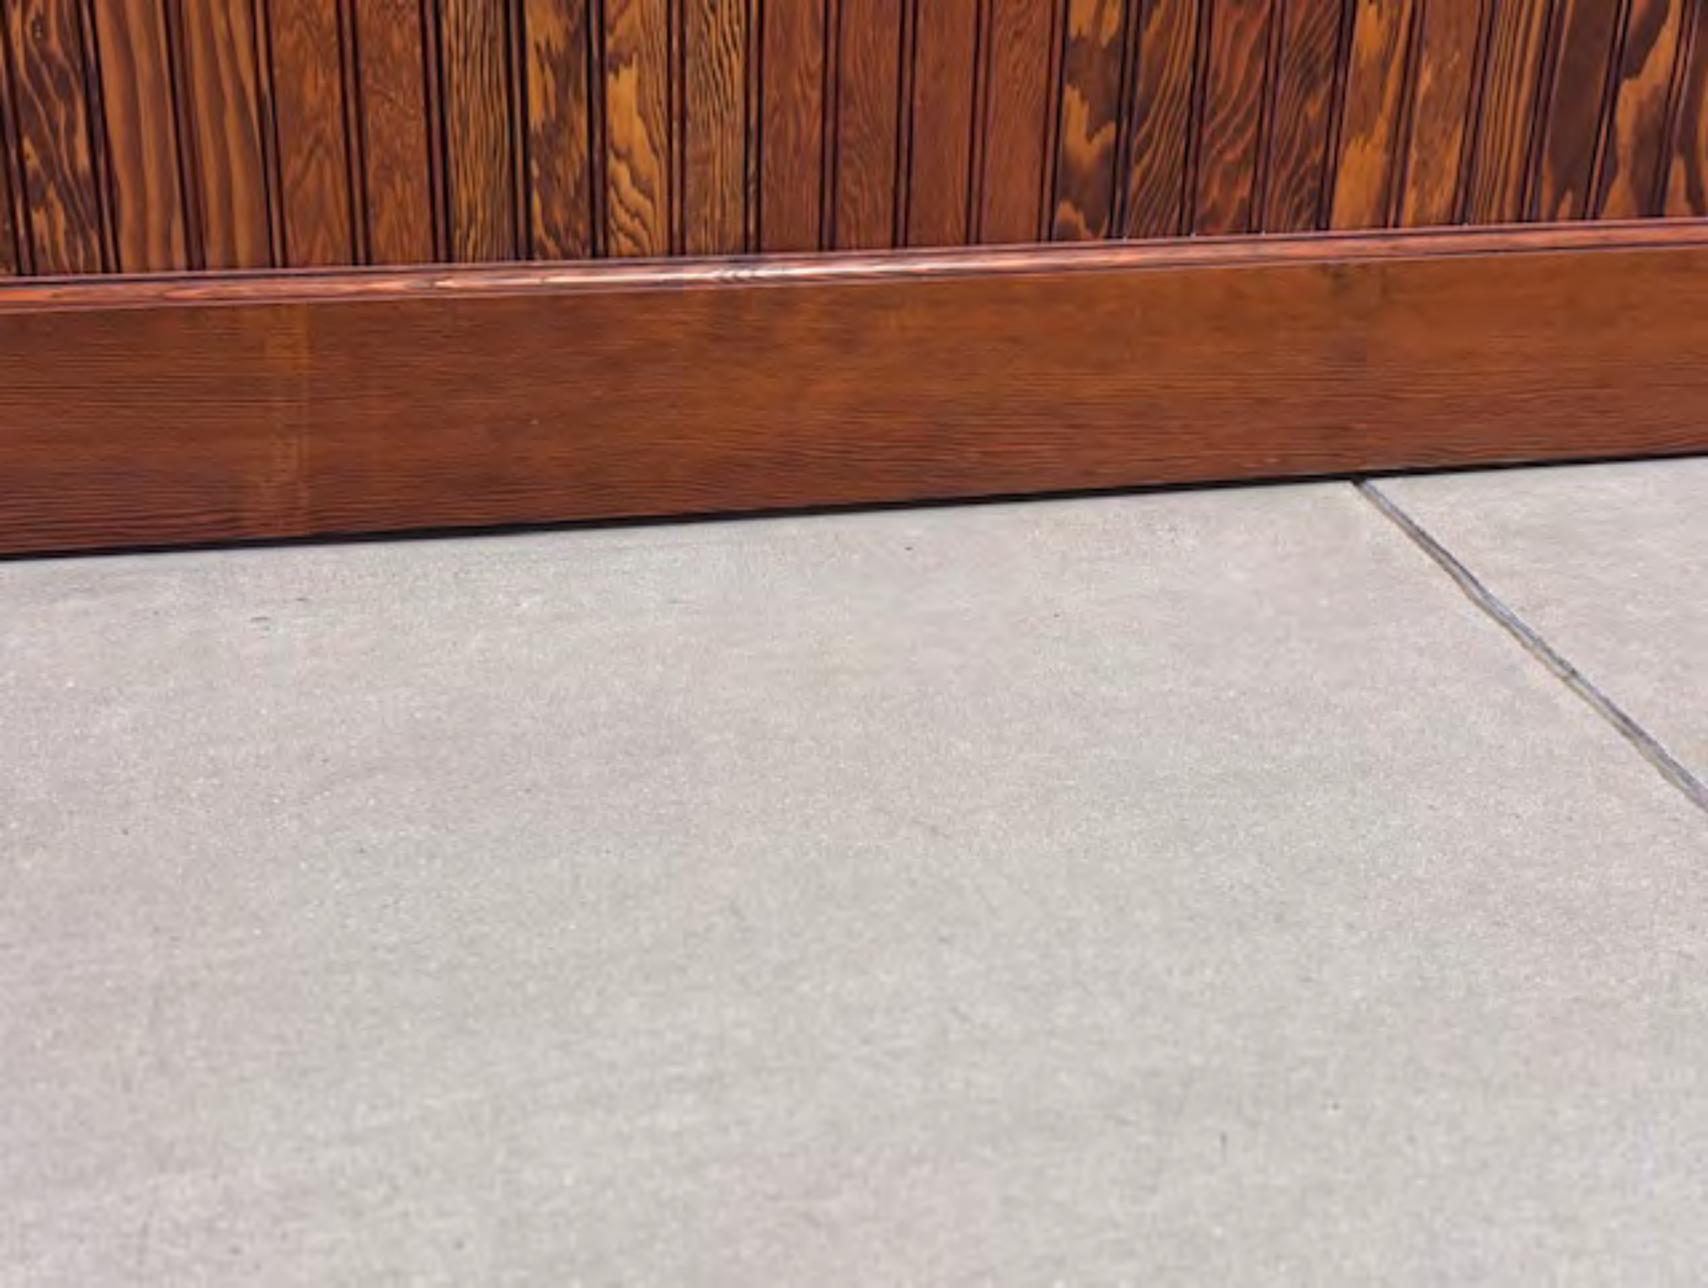
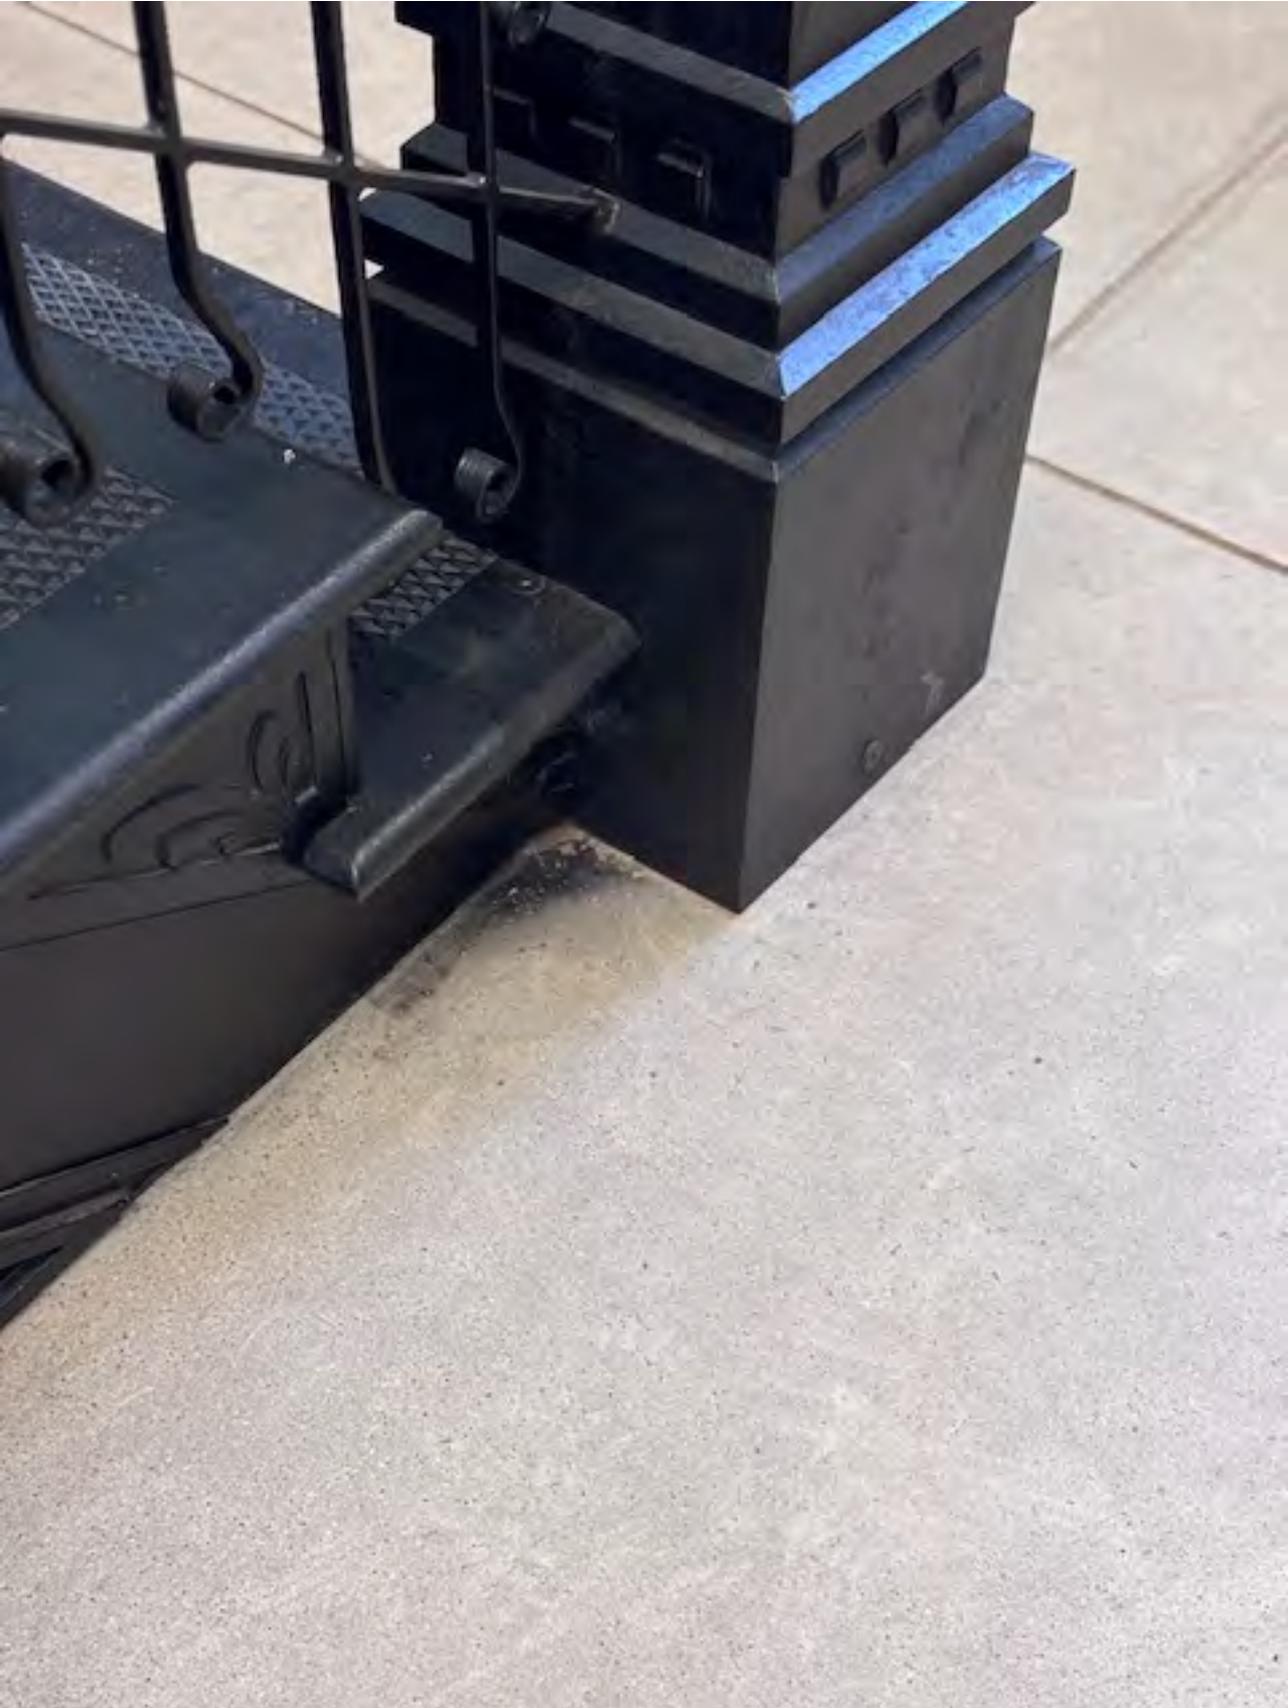
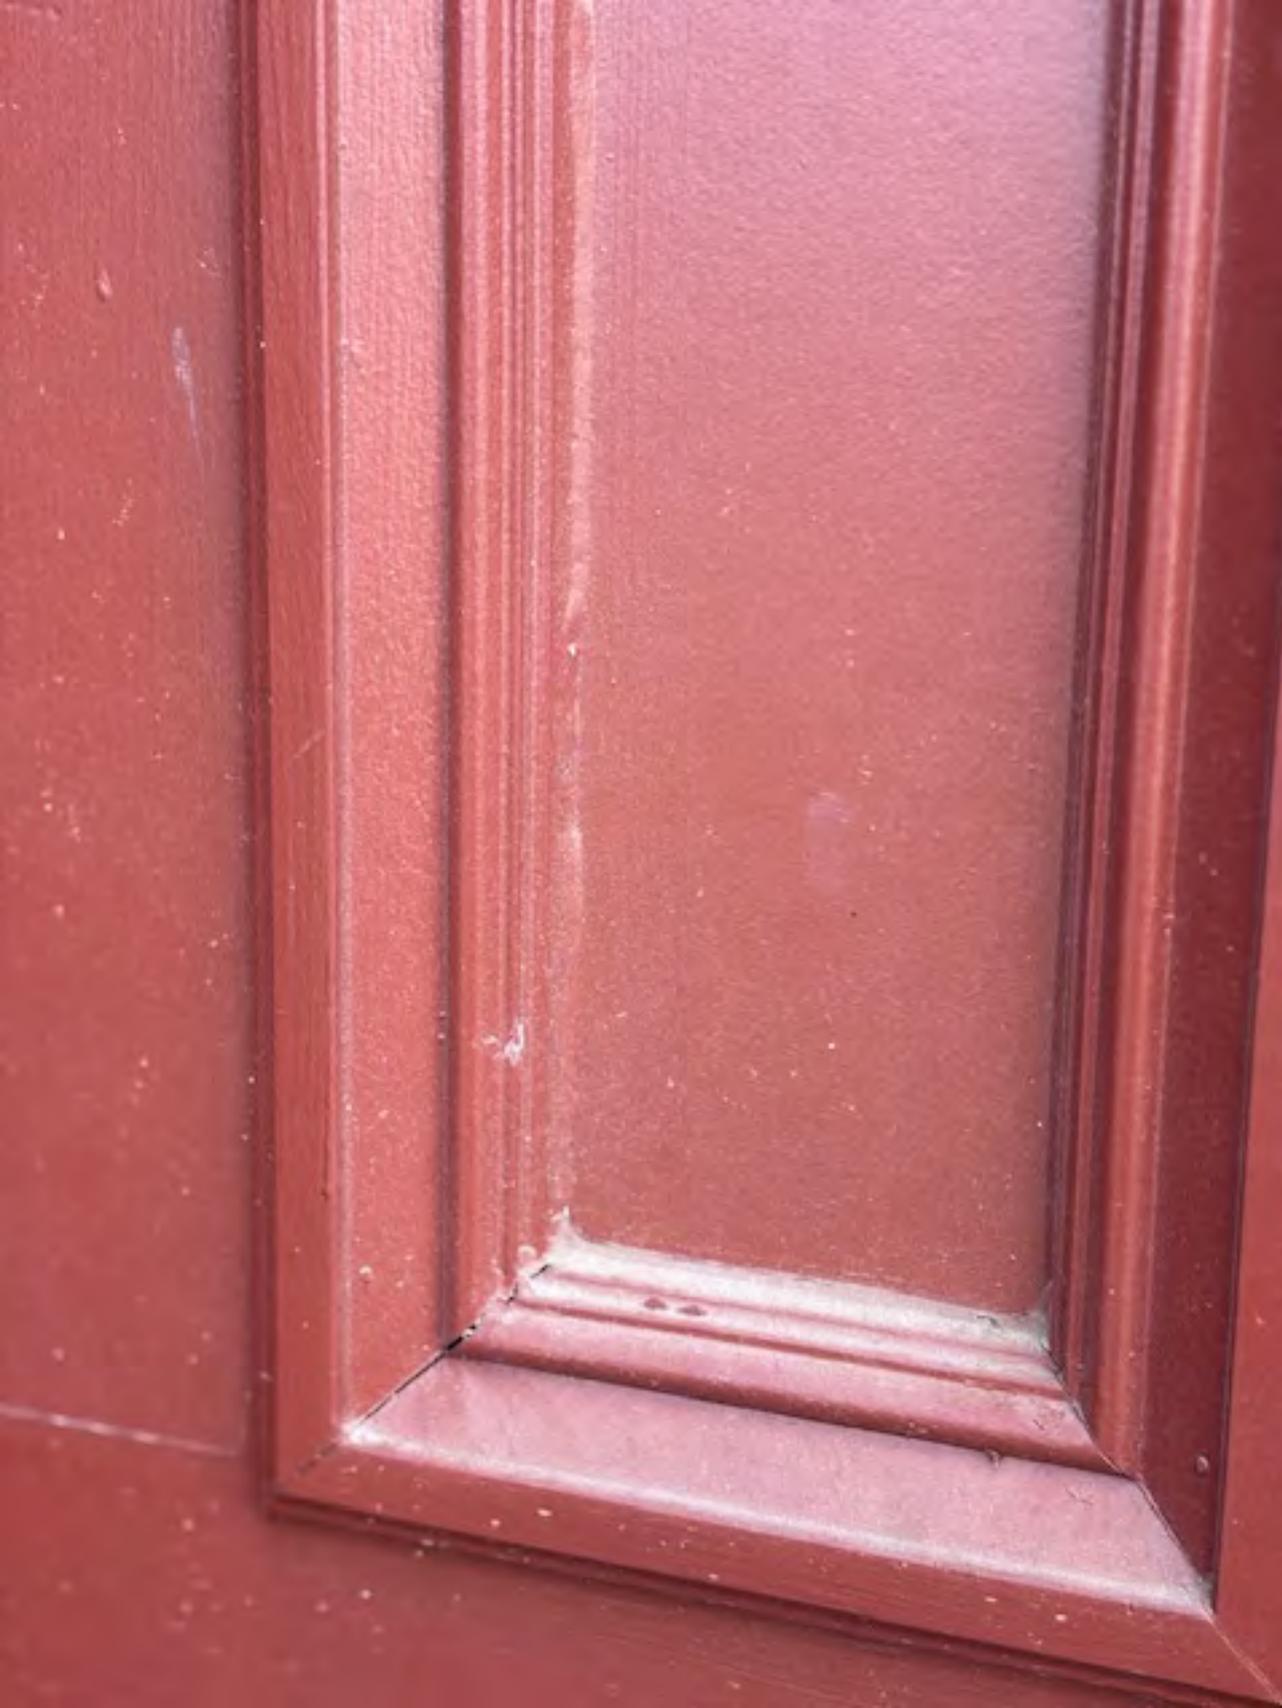
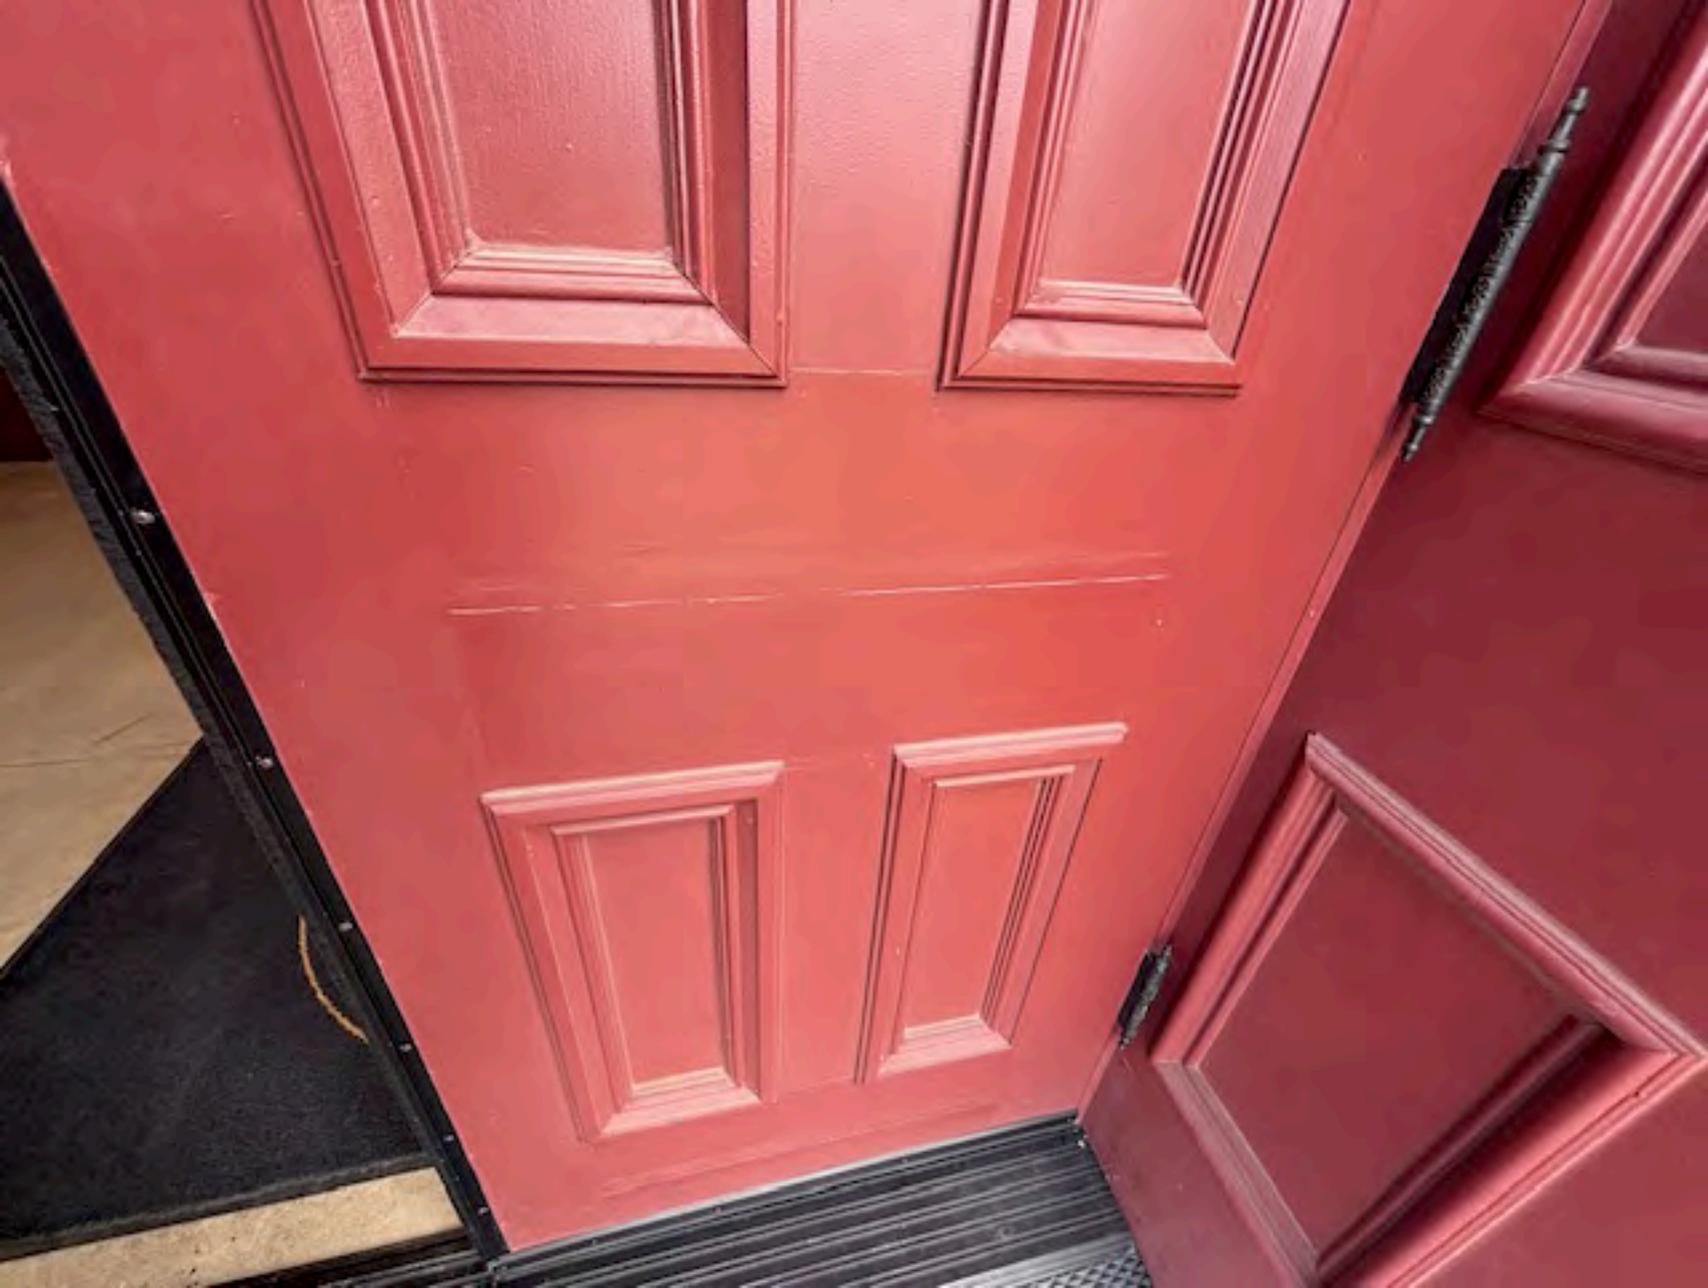
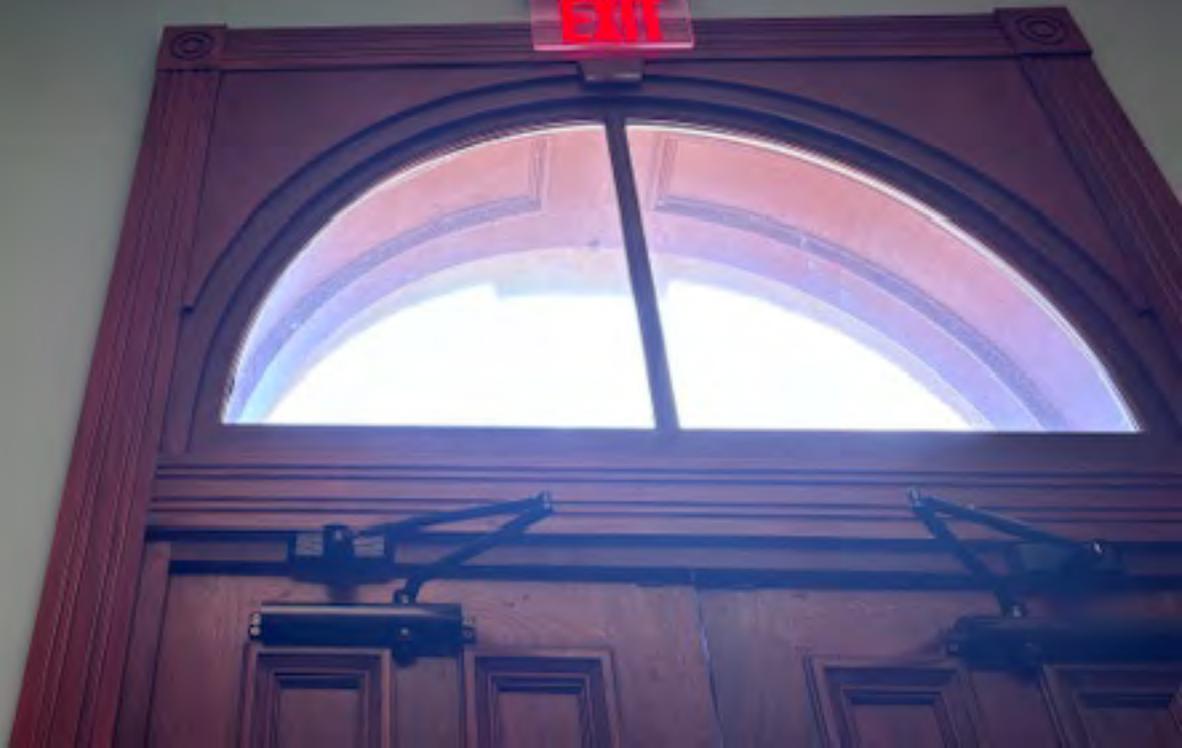
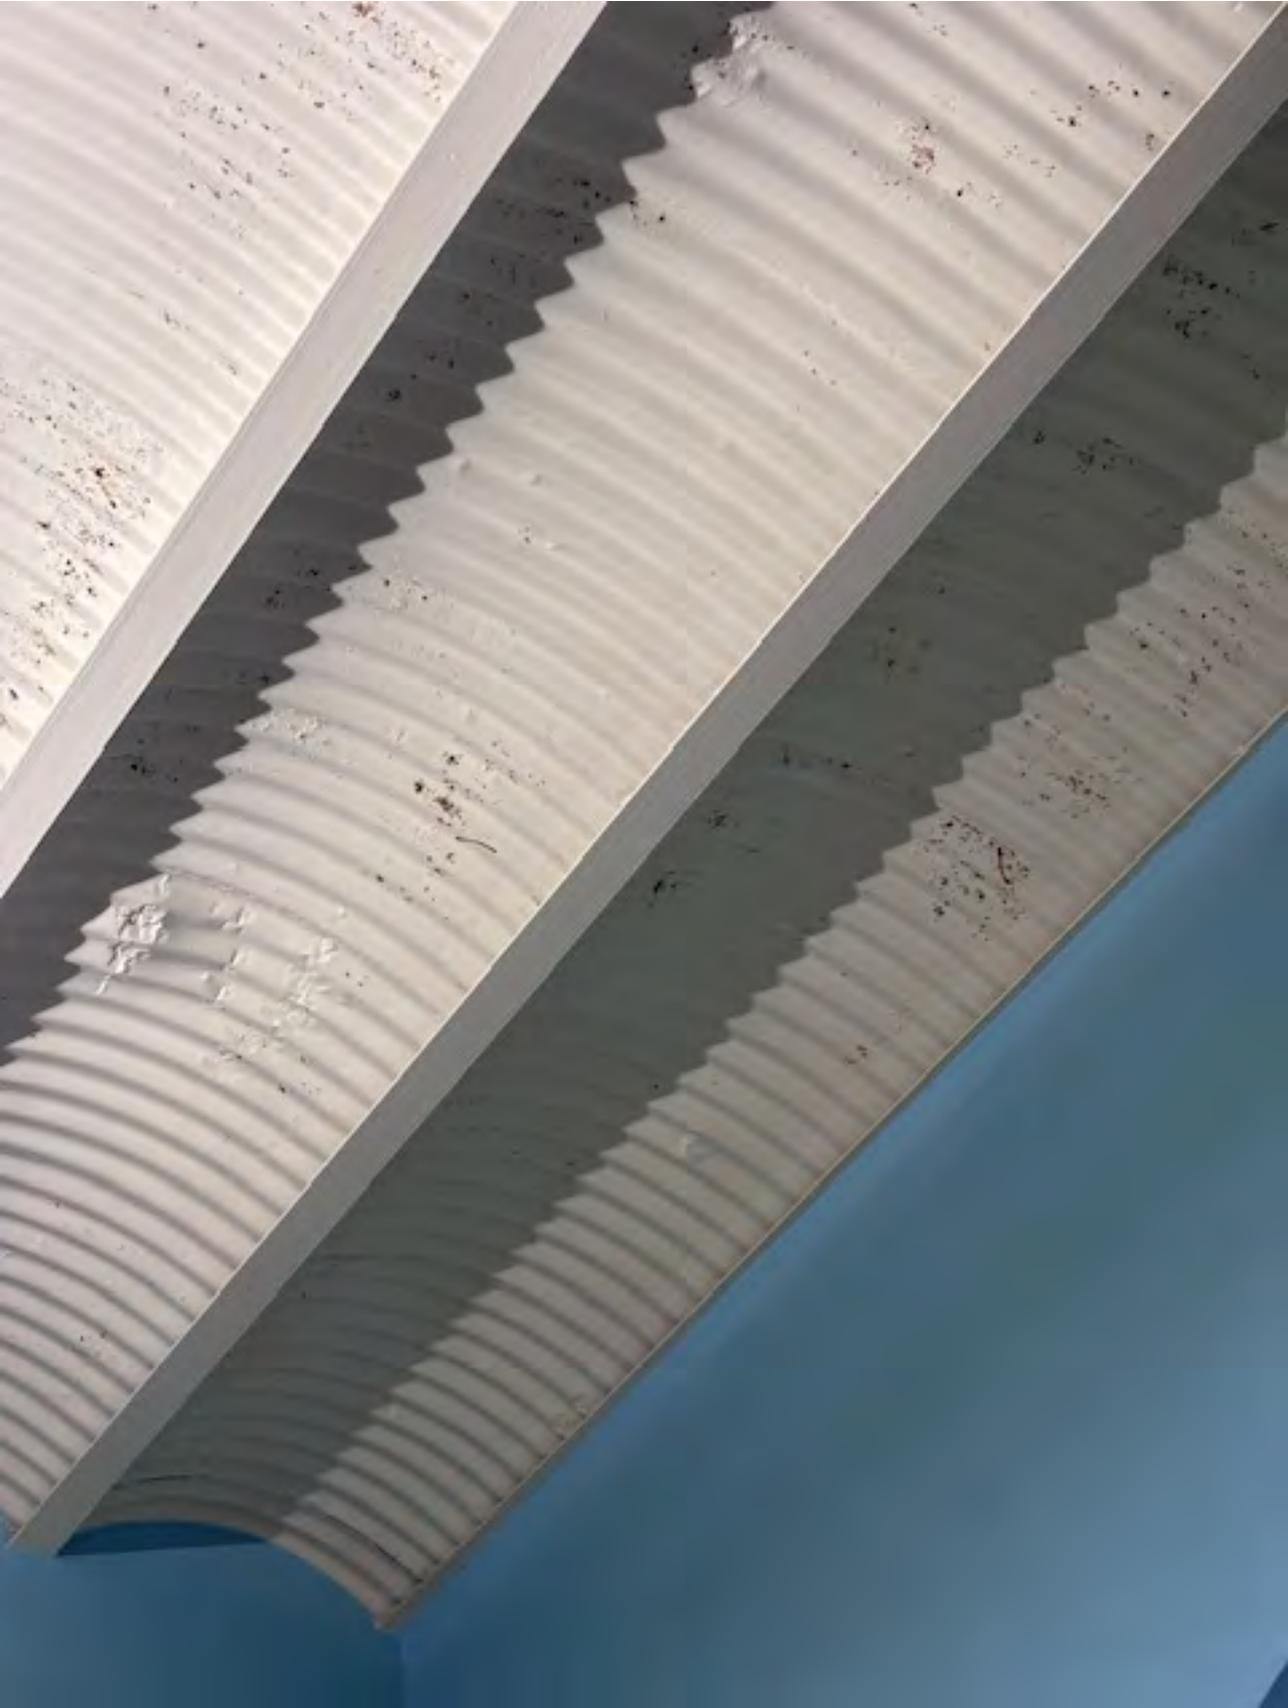
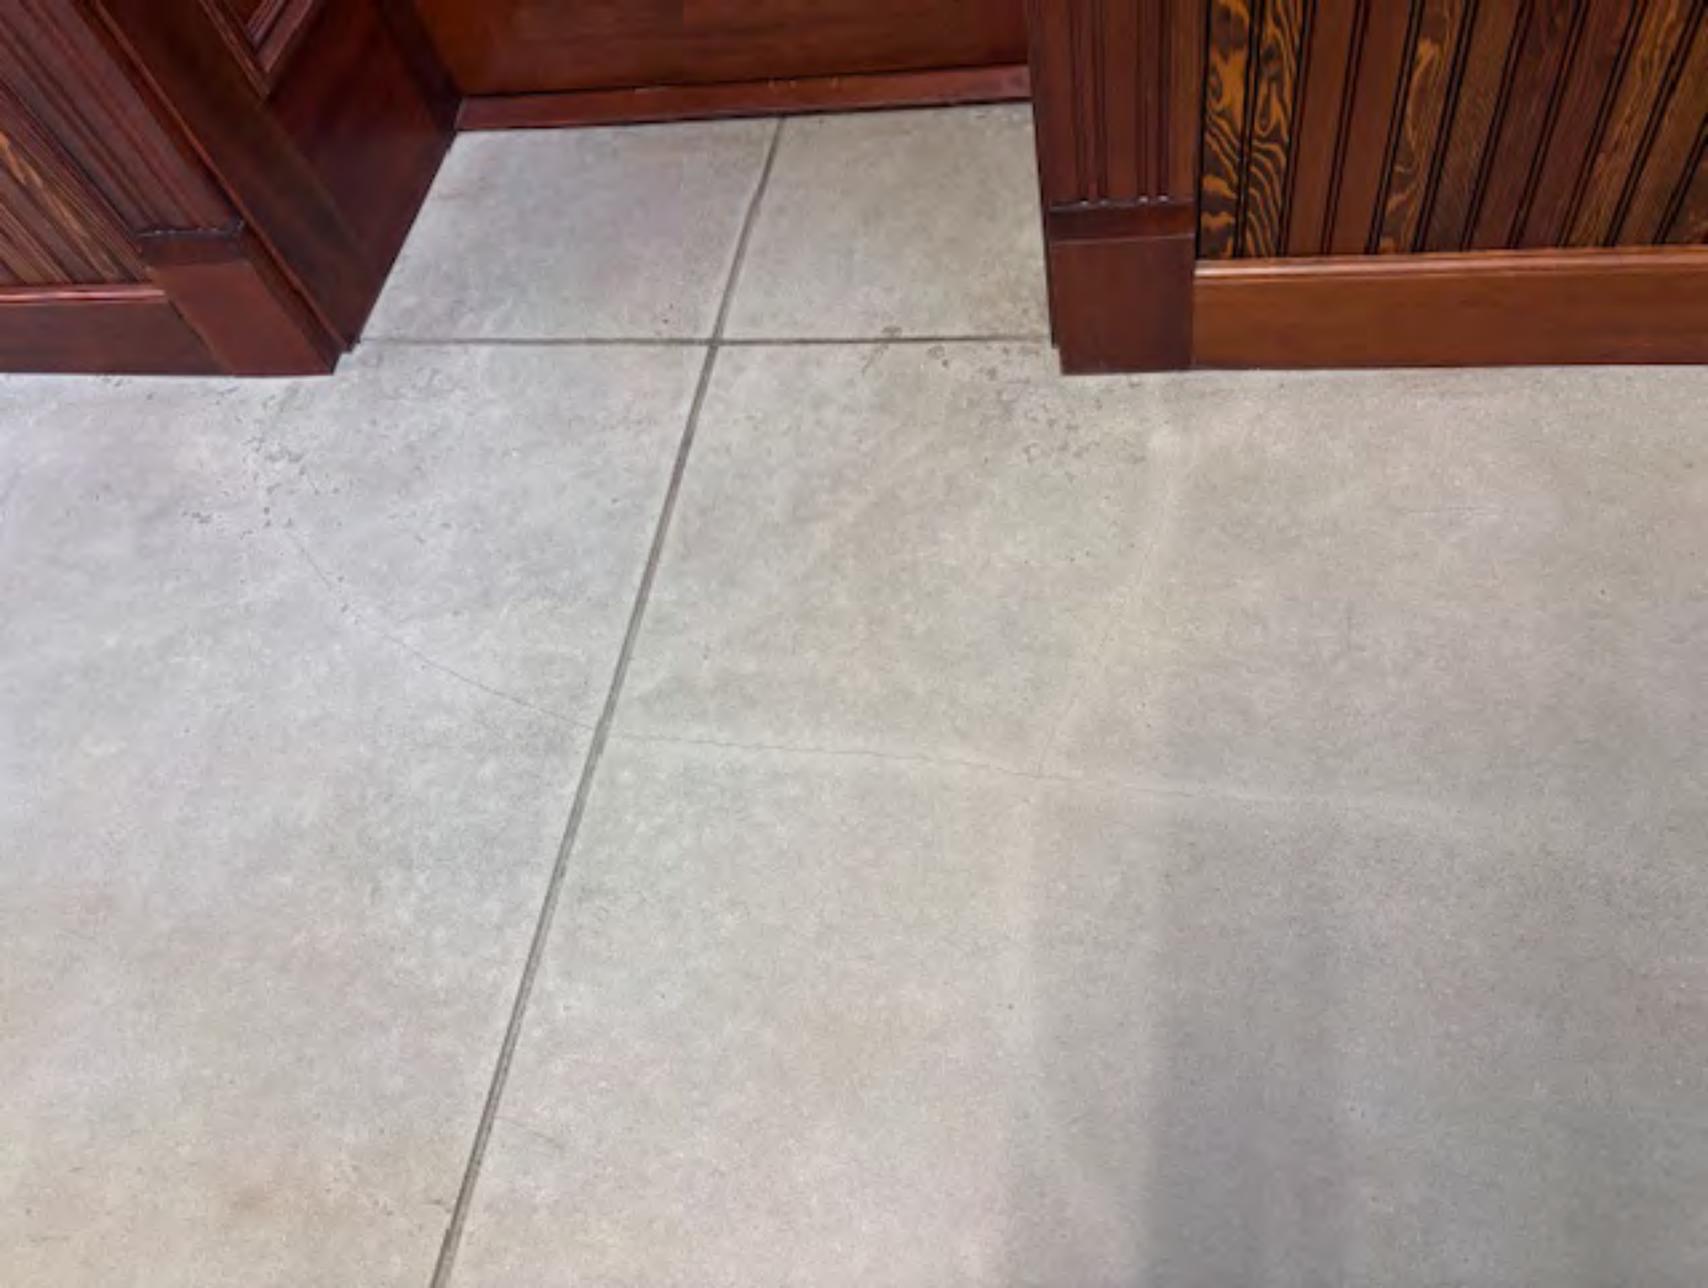
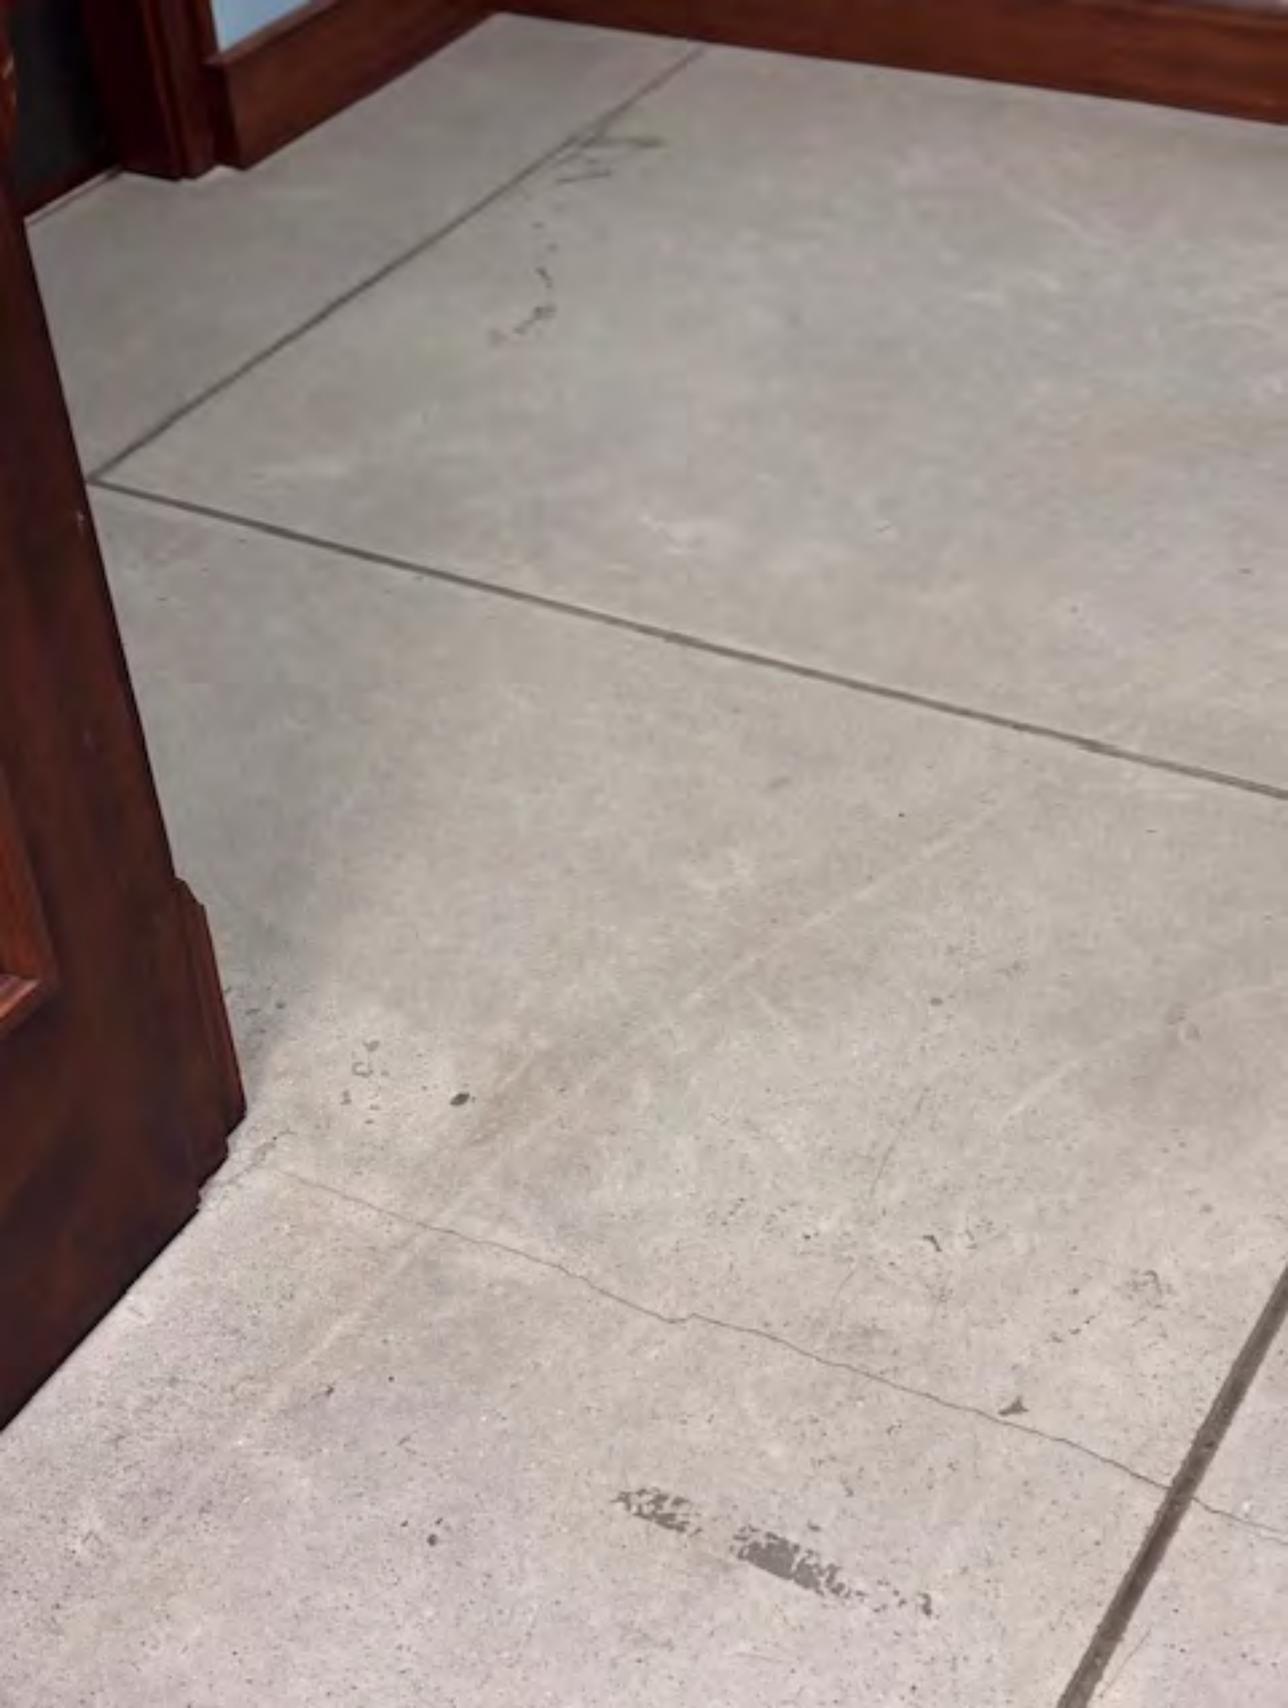
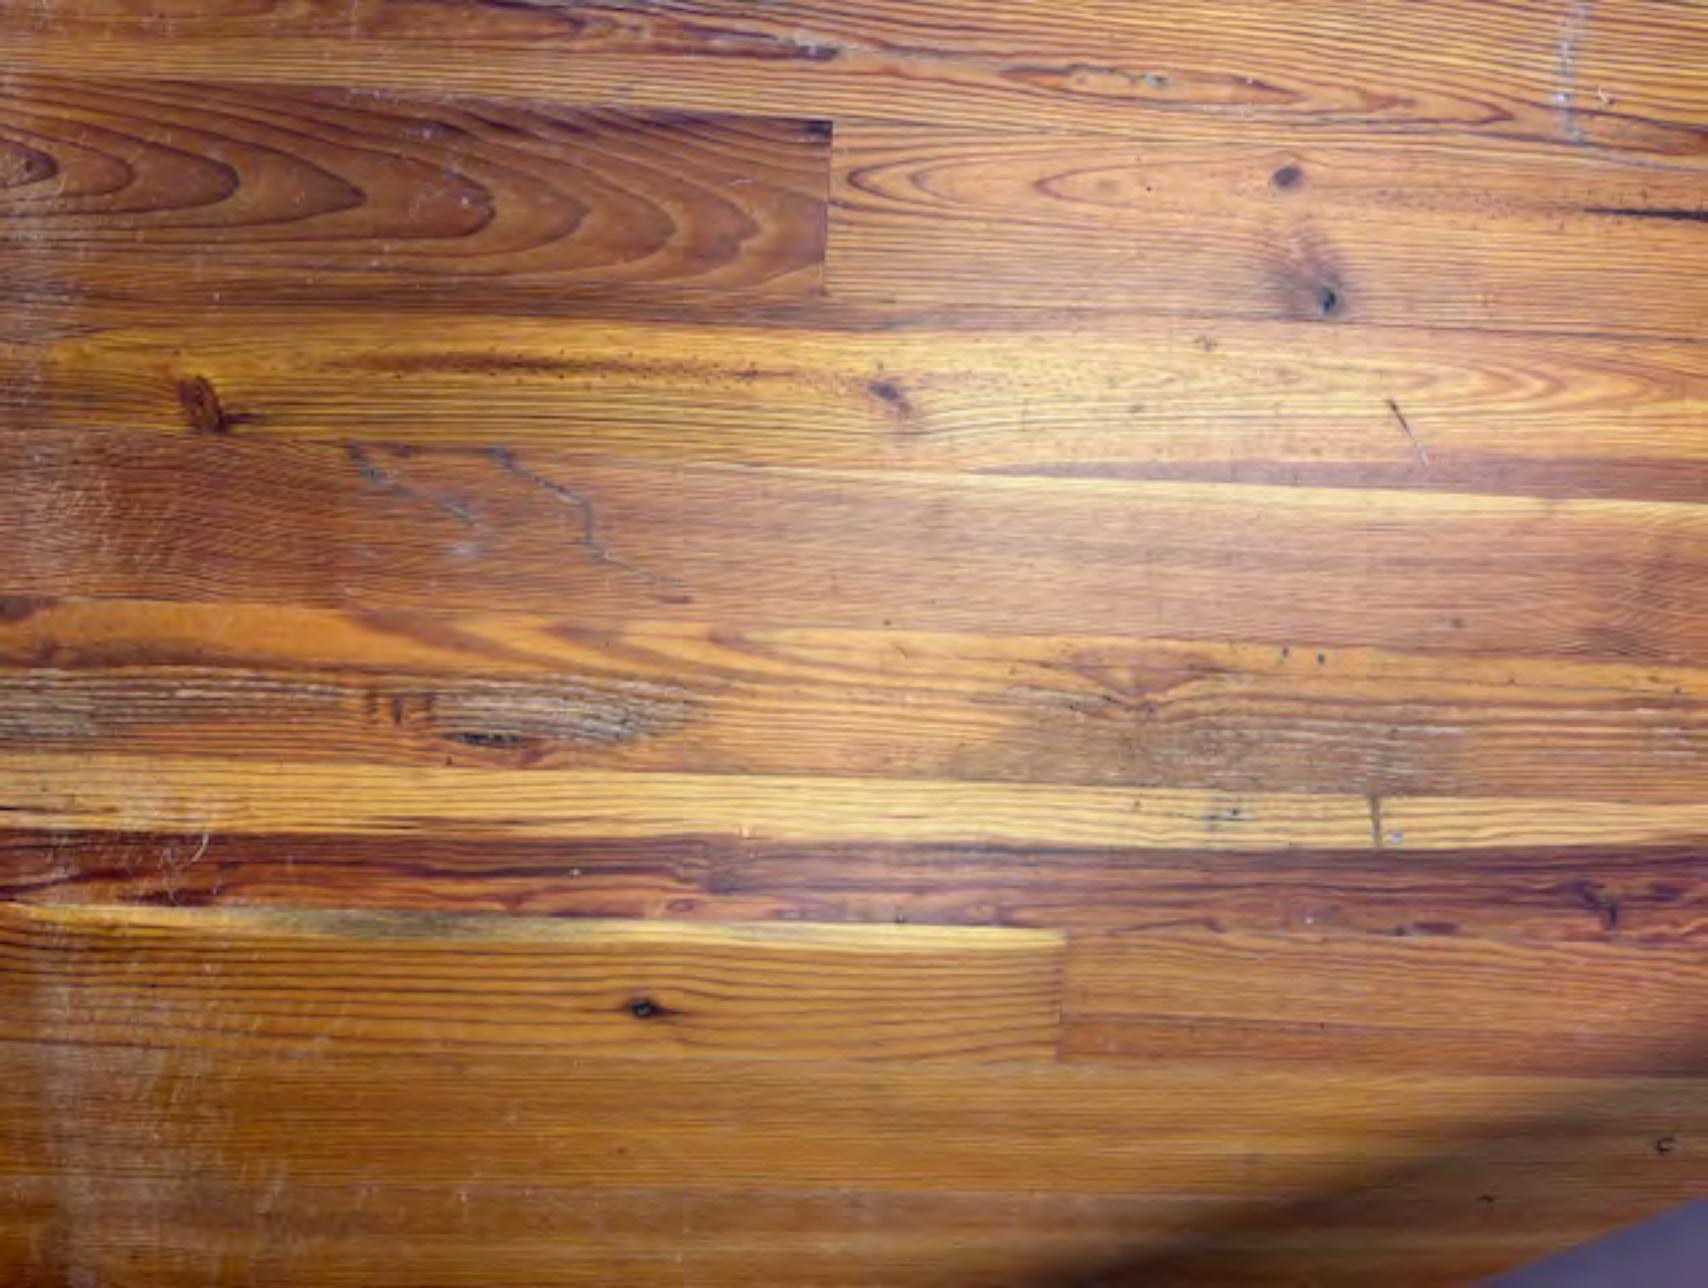
1ST FLOOR
PHOTOS

1. Trim on floor next to courtroom not installed correctly

2. Black over spray of painting stairwell
3. All entrance doors have trim and seams coming apart
4. East entrance ceiling has gap between ceiling and wall
5. Rust bleeding through ceiling paint
6. Crack on floor at East entrance
7. Stain on floors
8. Couple of wood planks in two offices need to be repaired
9. Courtroom tile floor coming apart
