Fannin County Courthouse Punchlist Update 6/30/2025

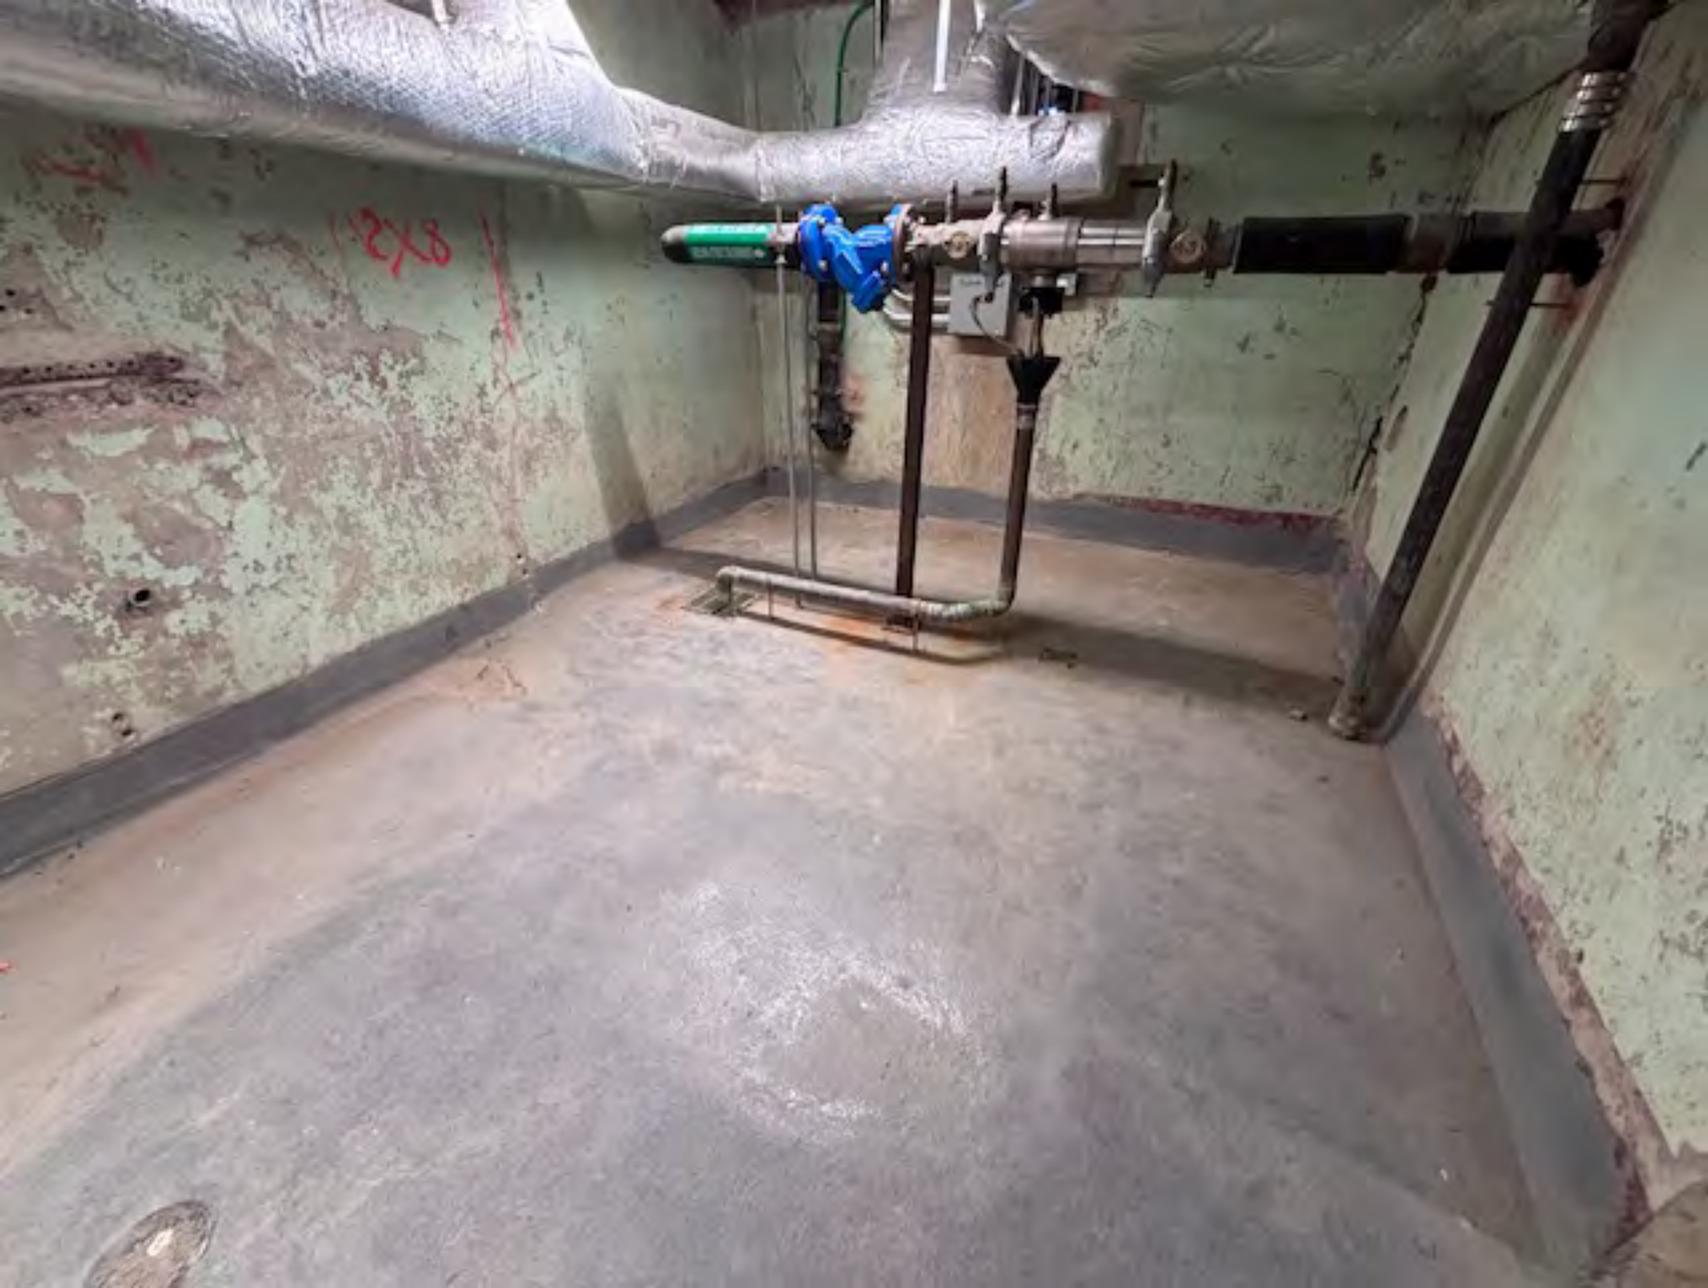
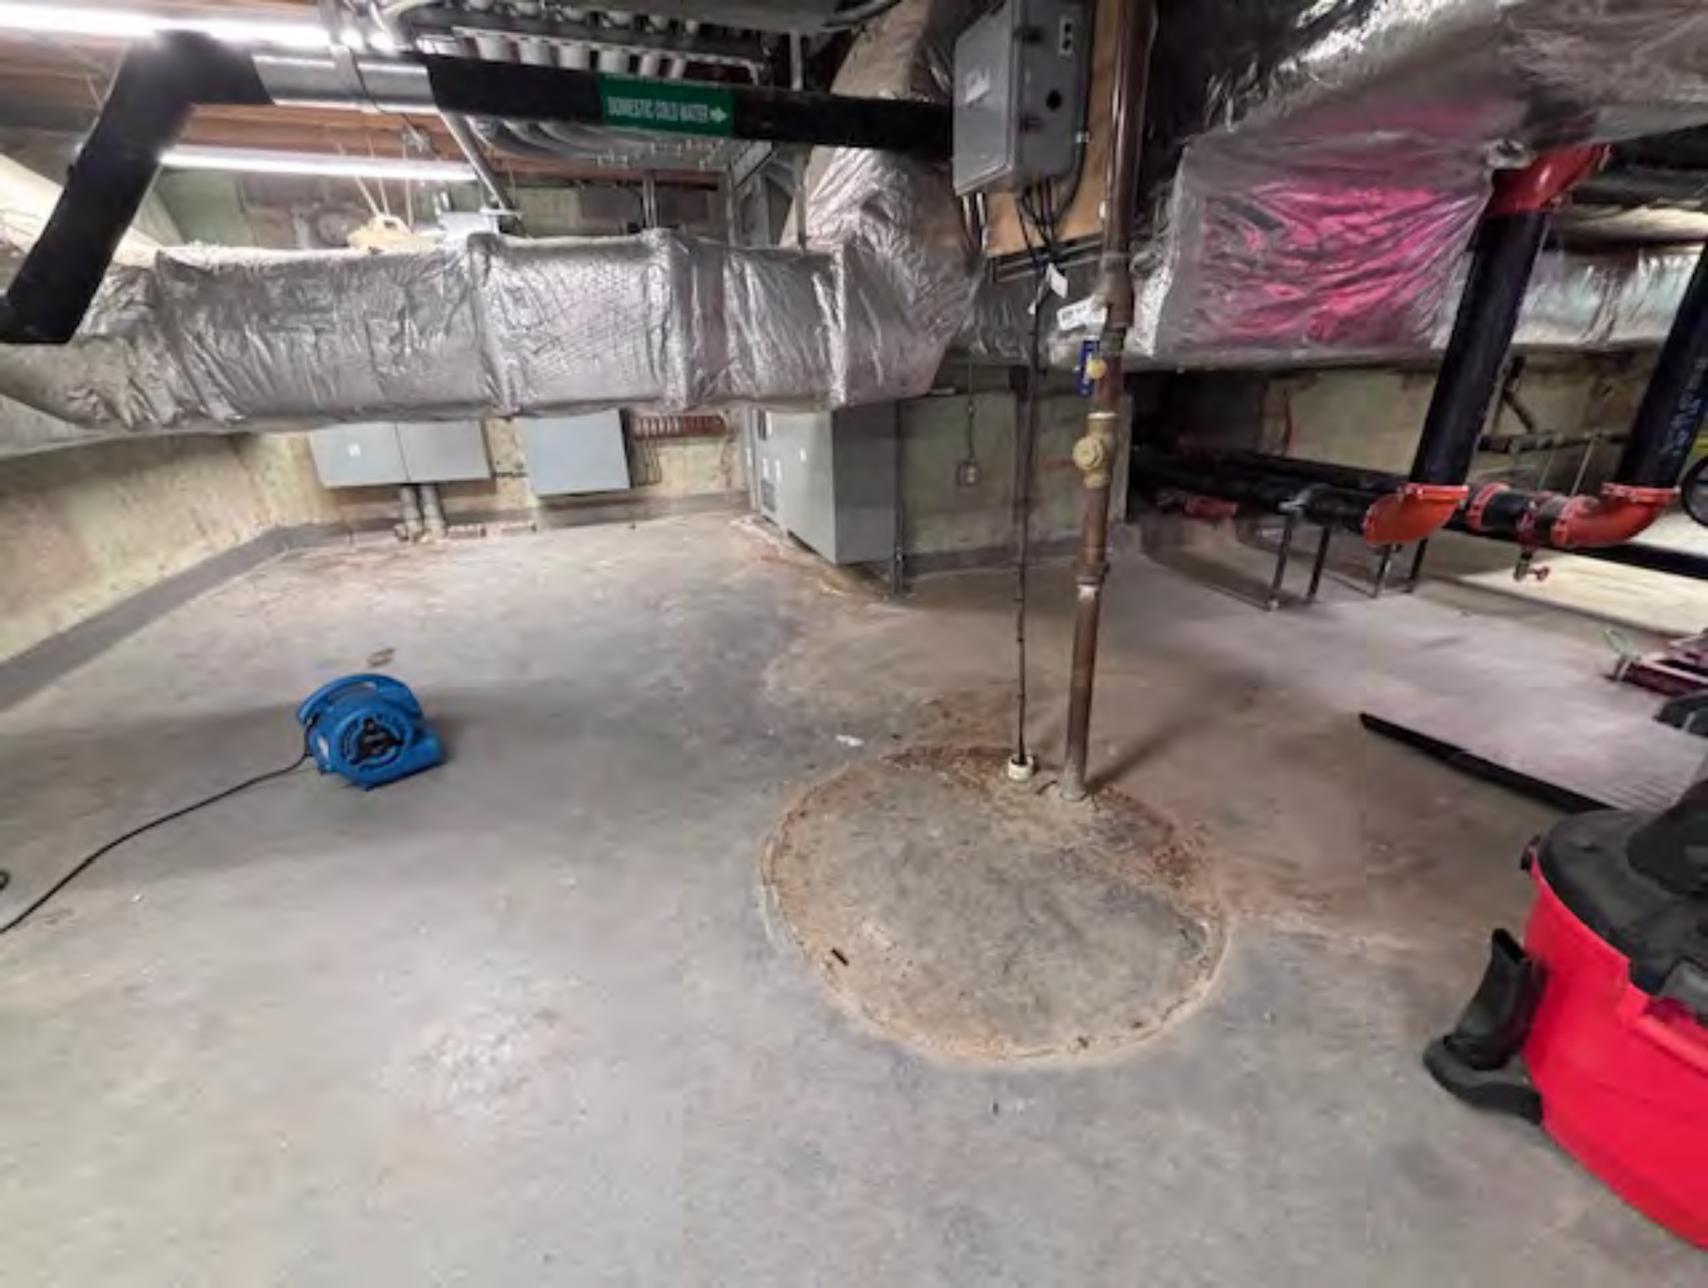
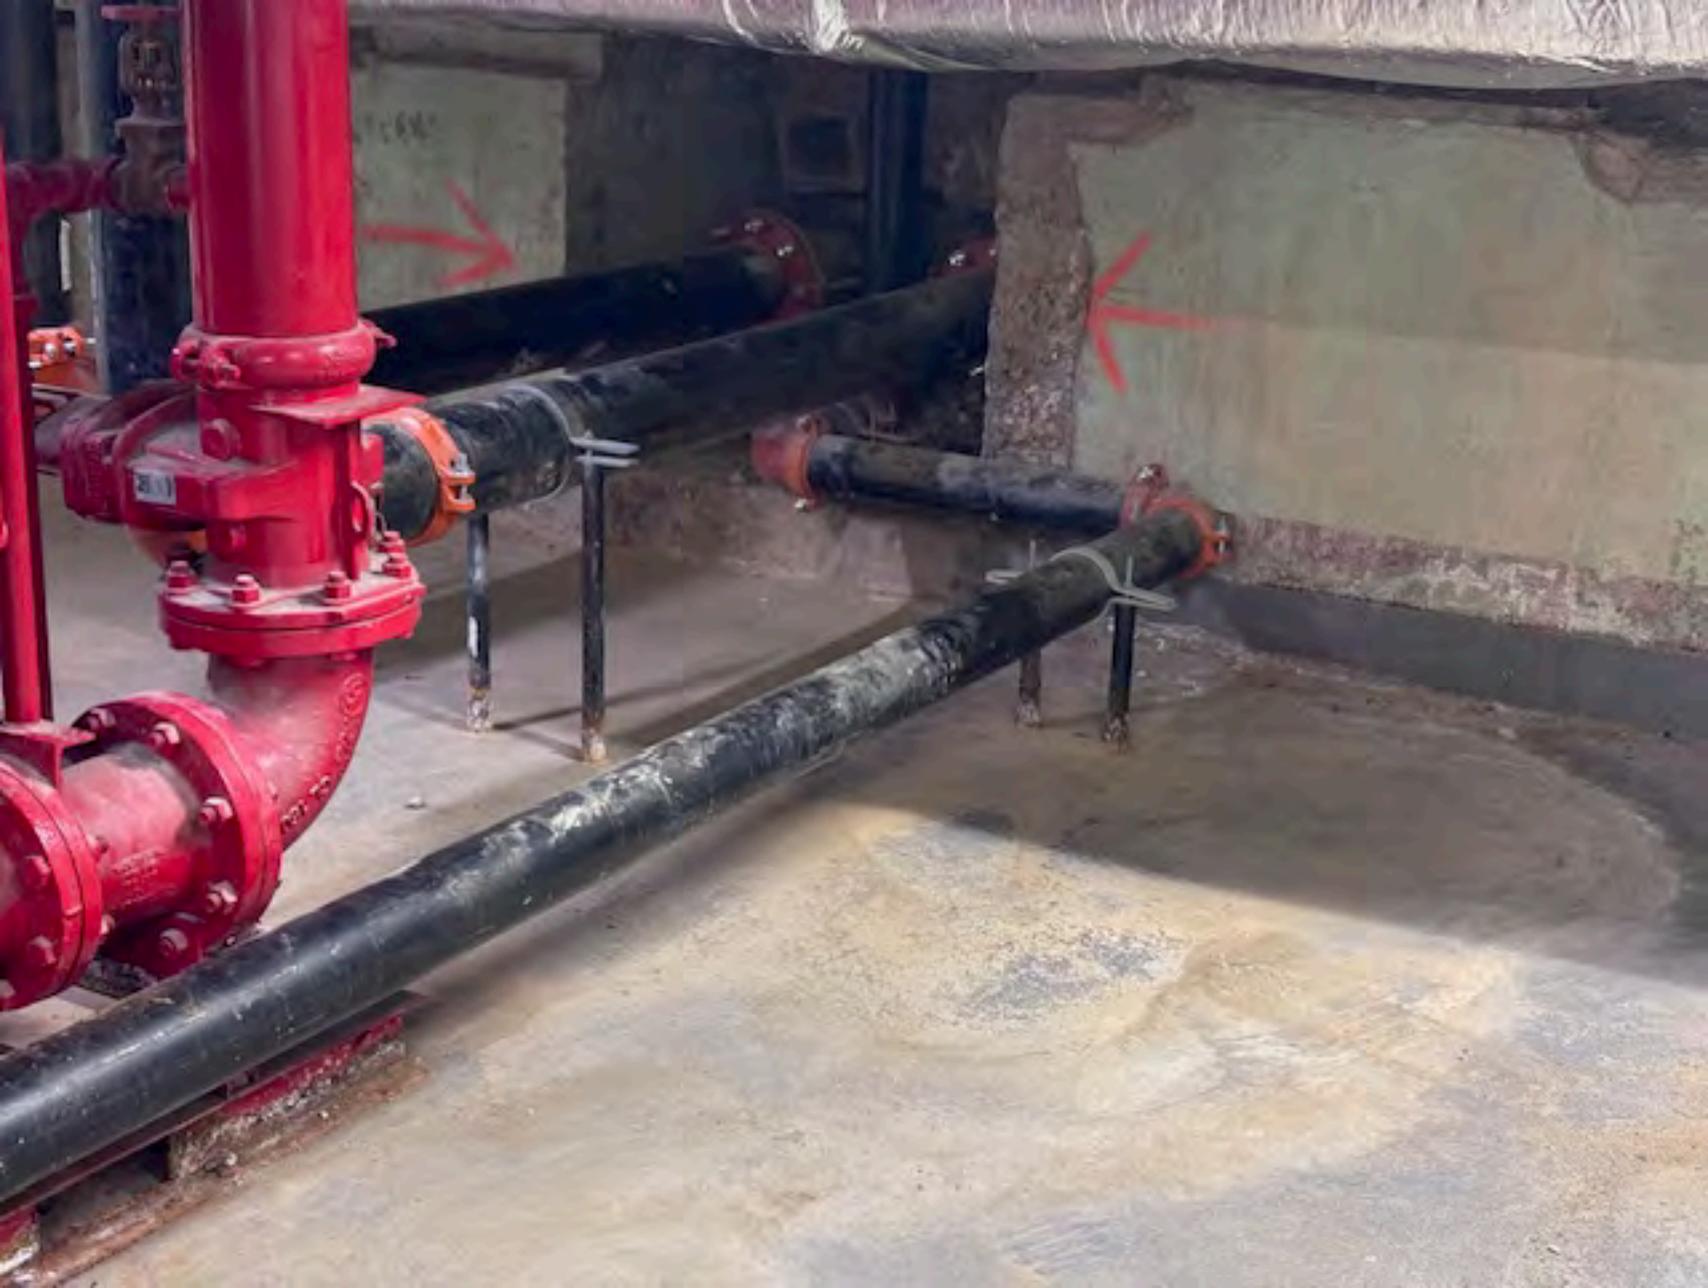
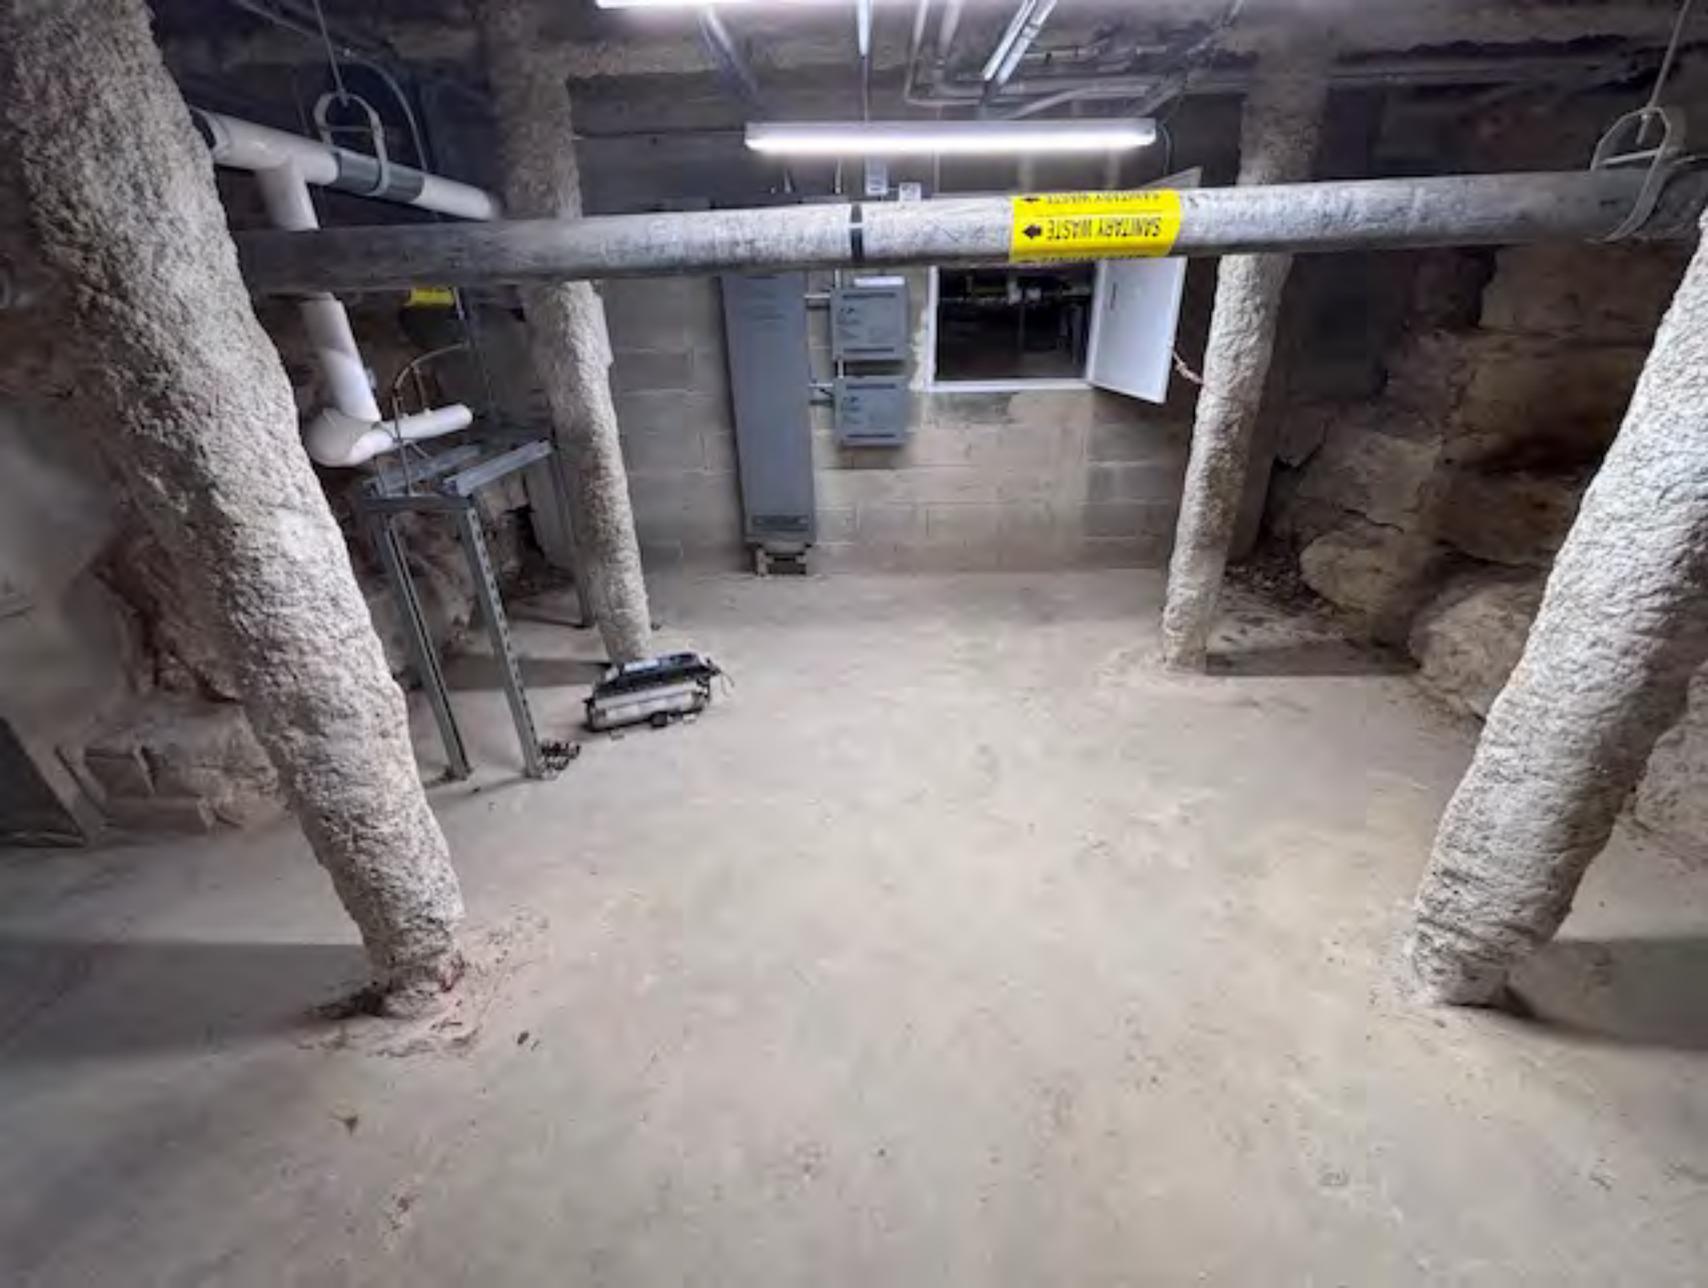
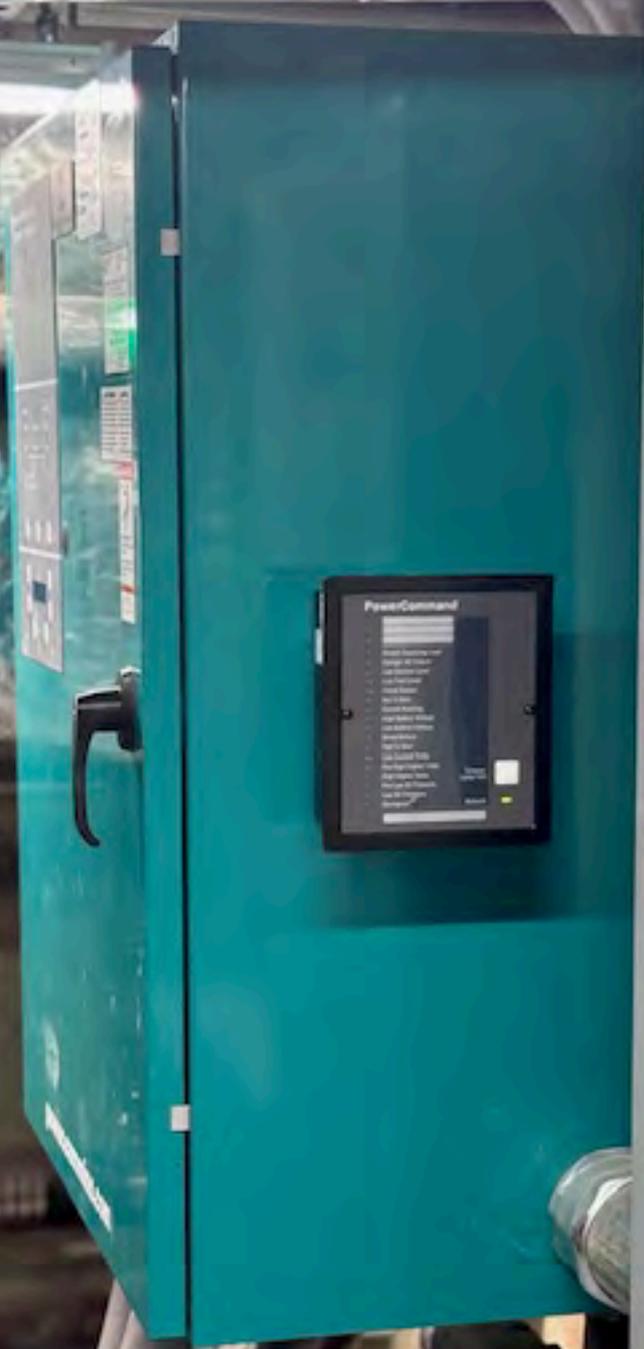
BASEMENT
PHOTOS

1. The main water leak is from fire pump pipes entry but on a heavy rainfall we have several other leaks.
2. ATS annunciator should be at floor level so that alarm is heard but city inspector ok'd it in the basement (no photo)
3. Fire Marshall wants the fire pump area room enclosed for a 2 hour rating
