Fannin County Courthouse Punchlist Update 6/30/2025

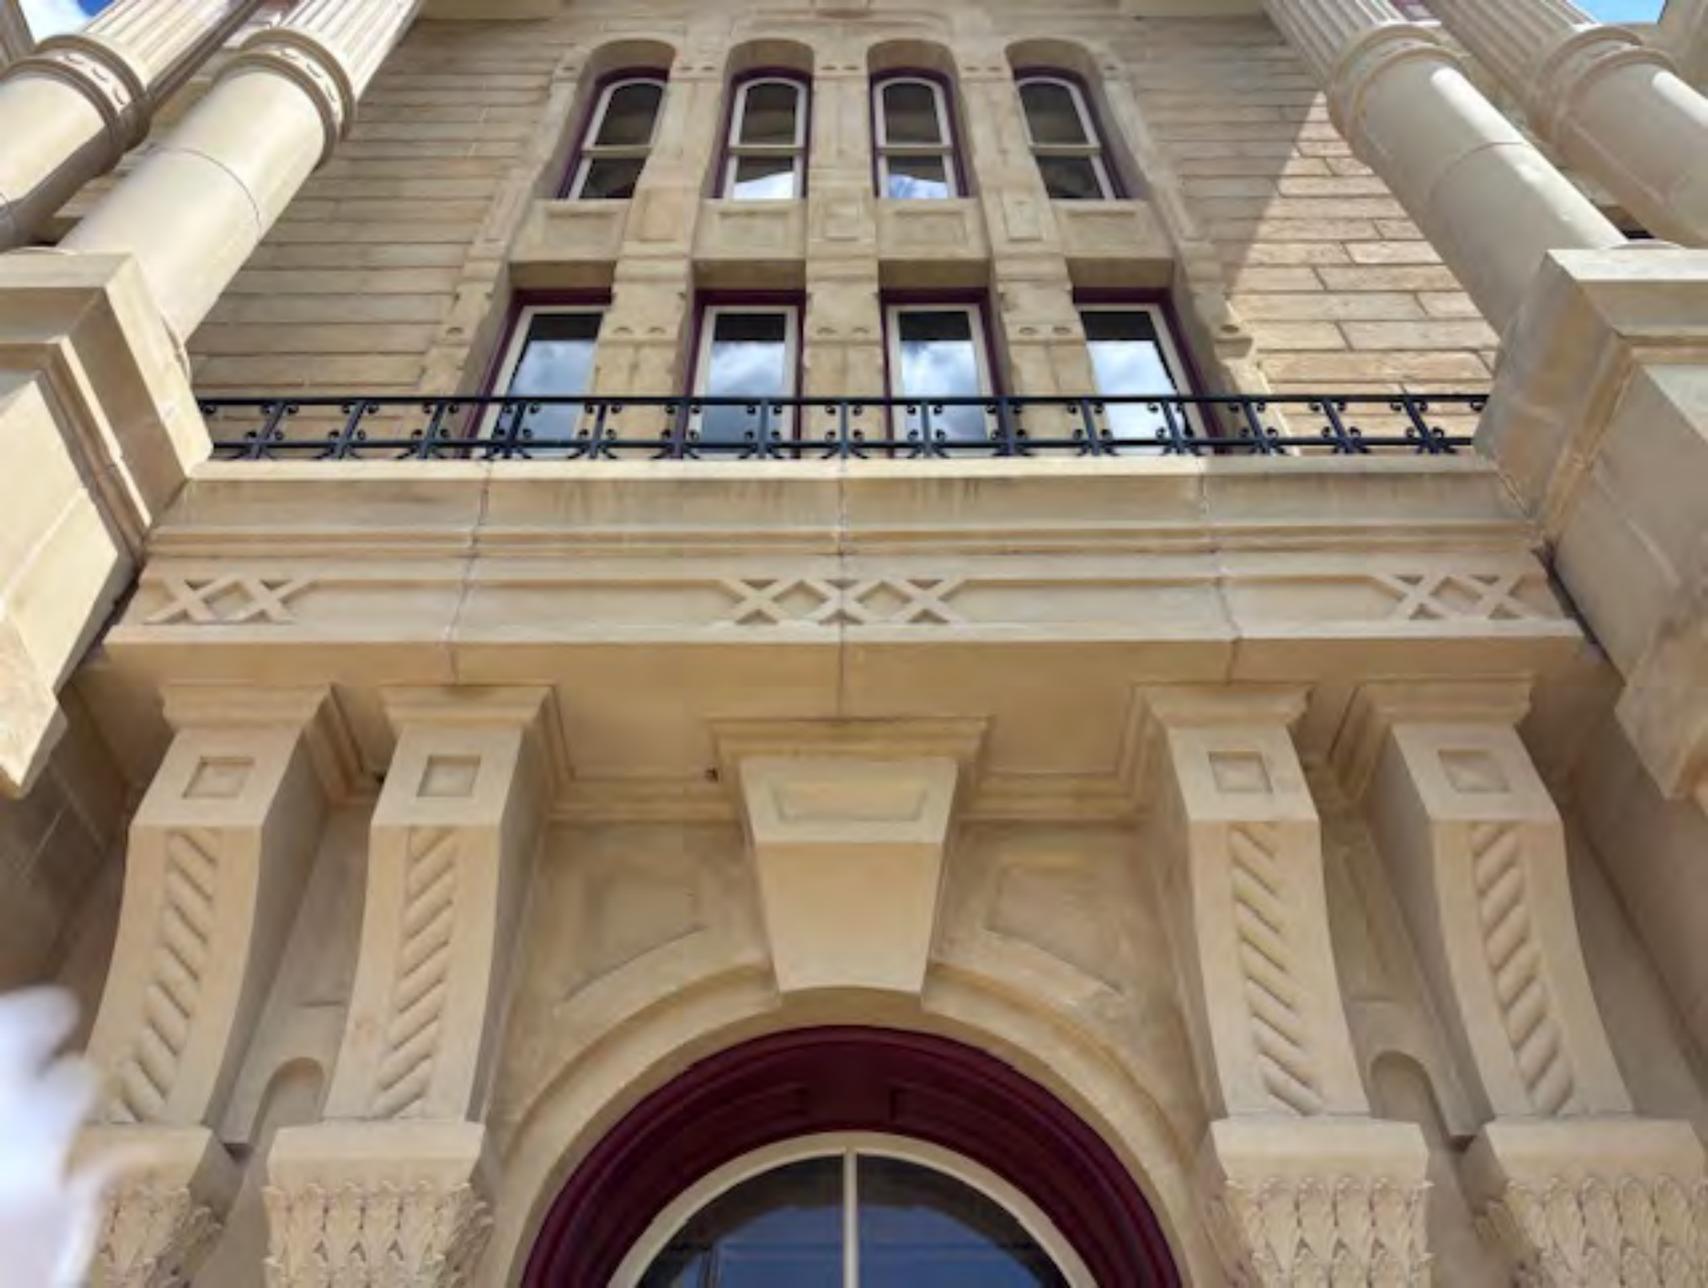
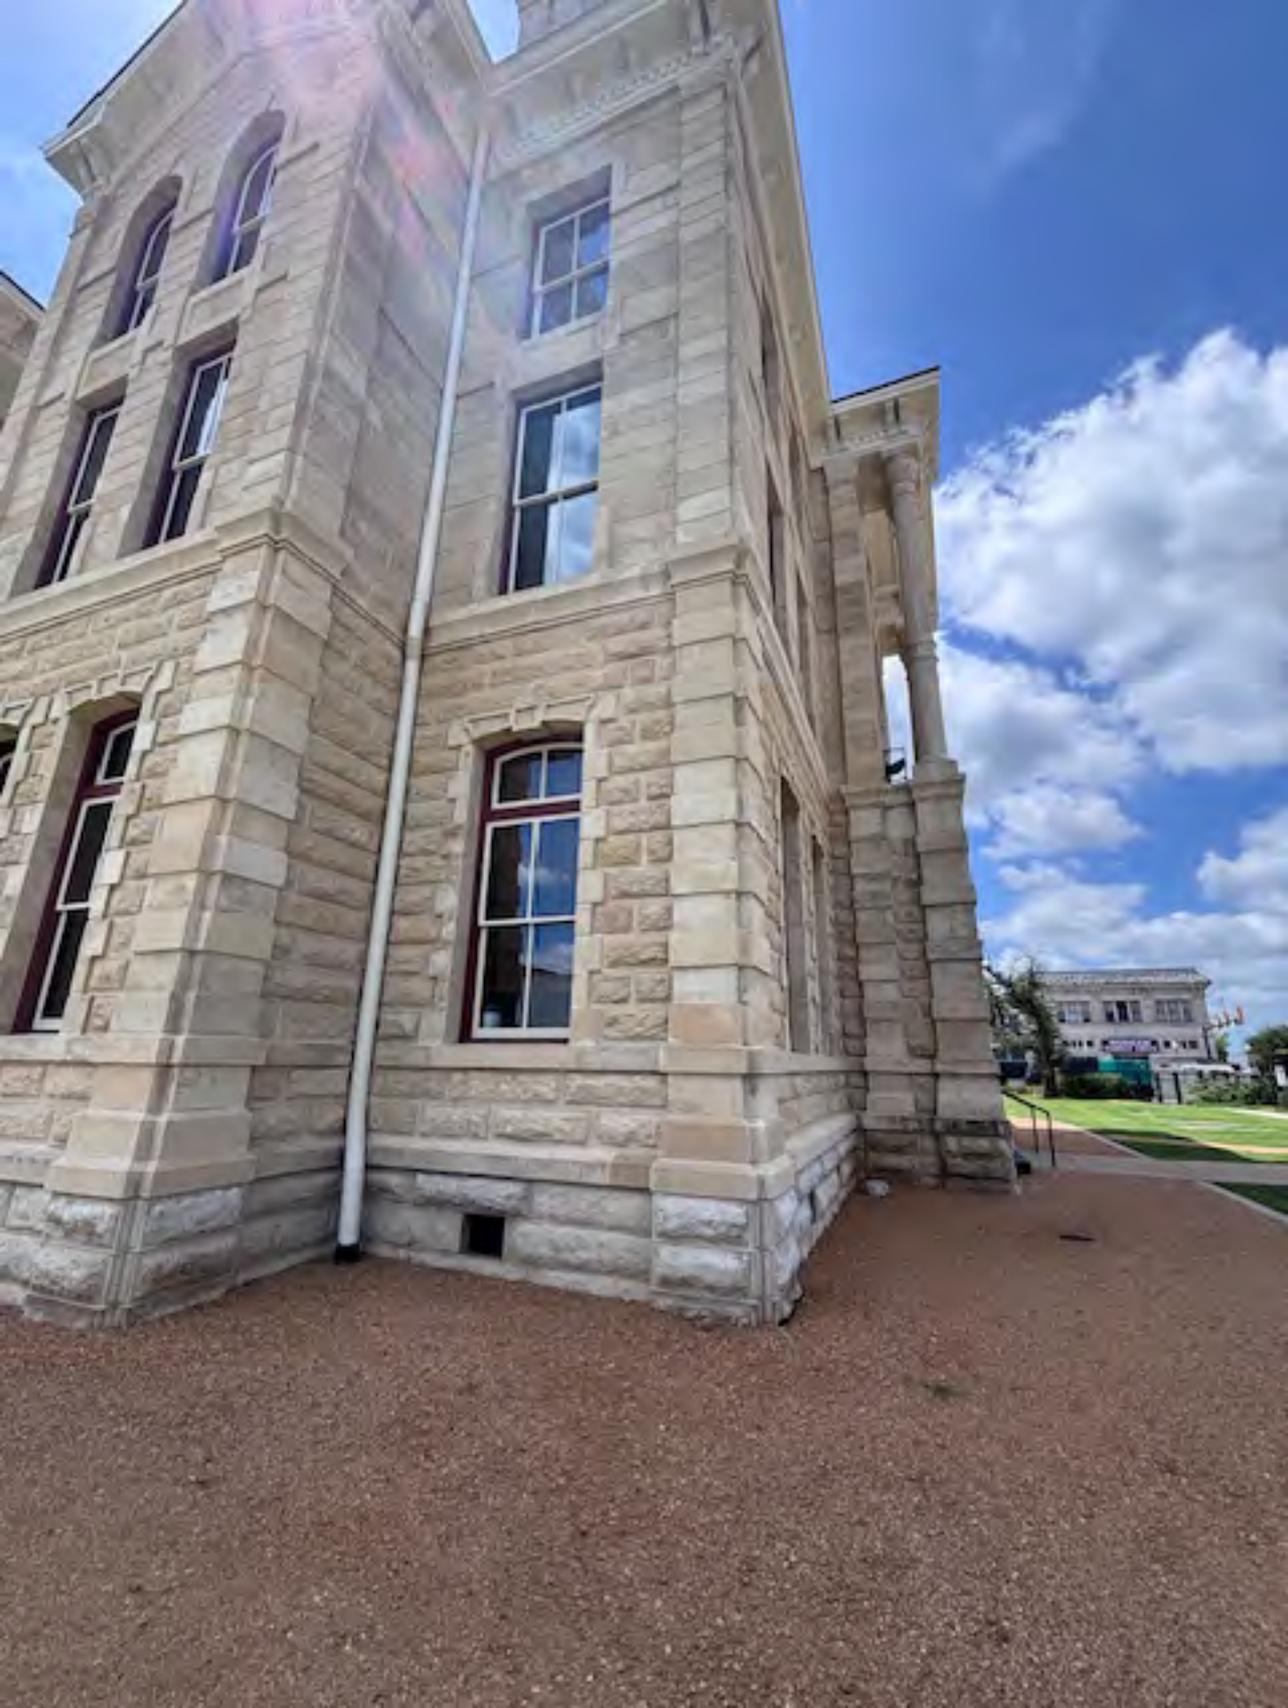
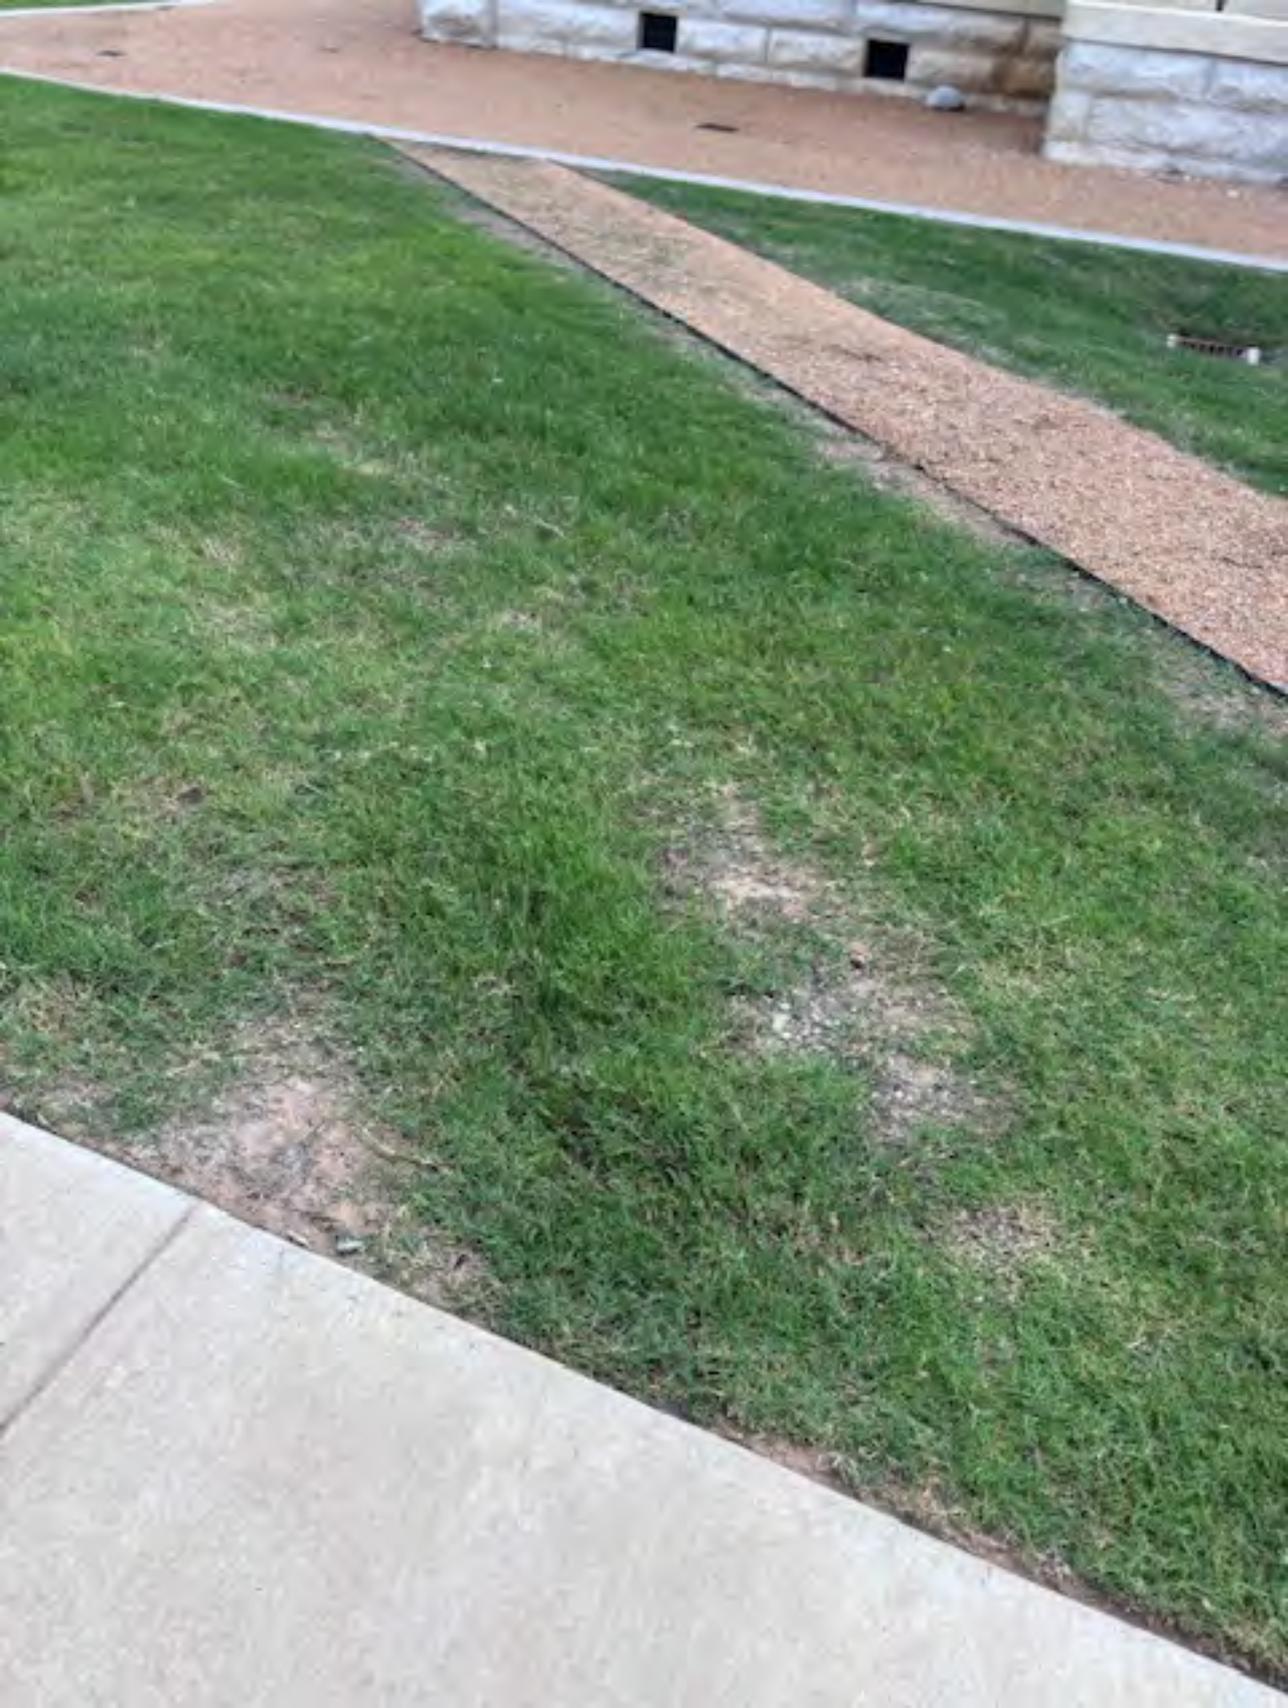
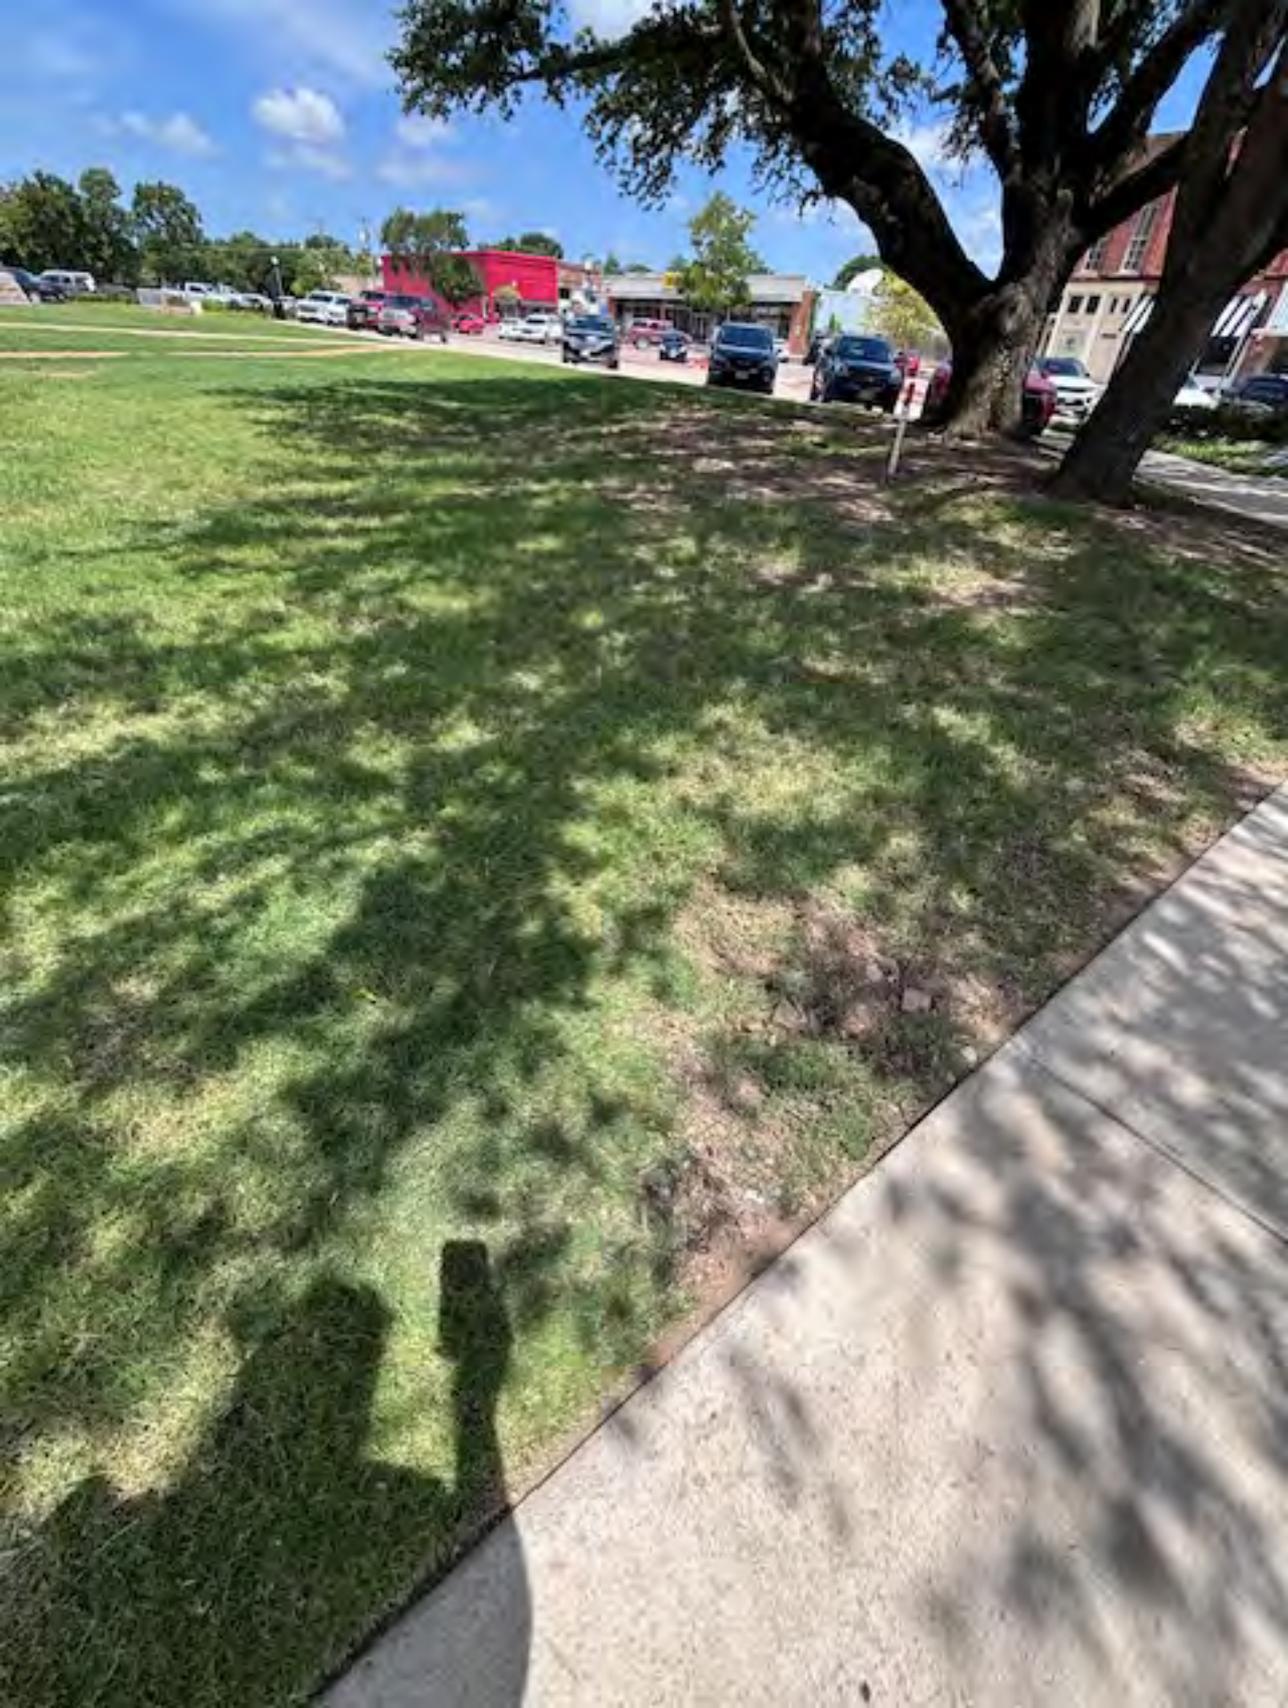
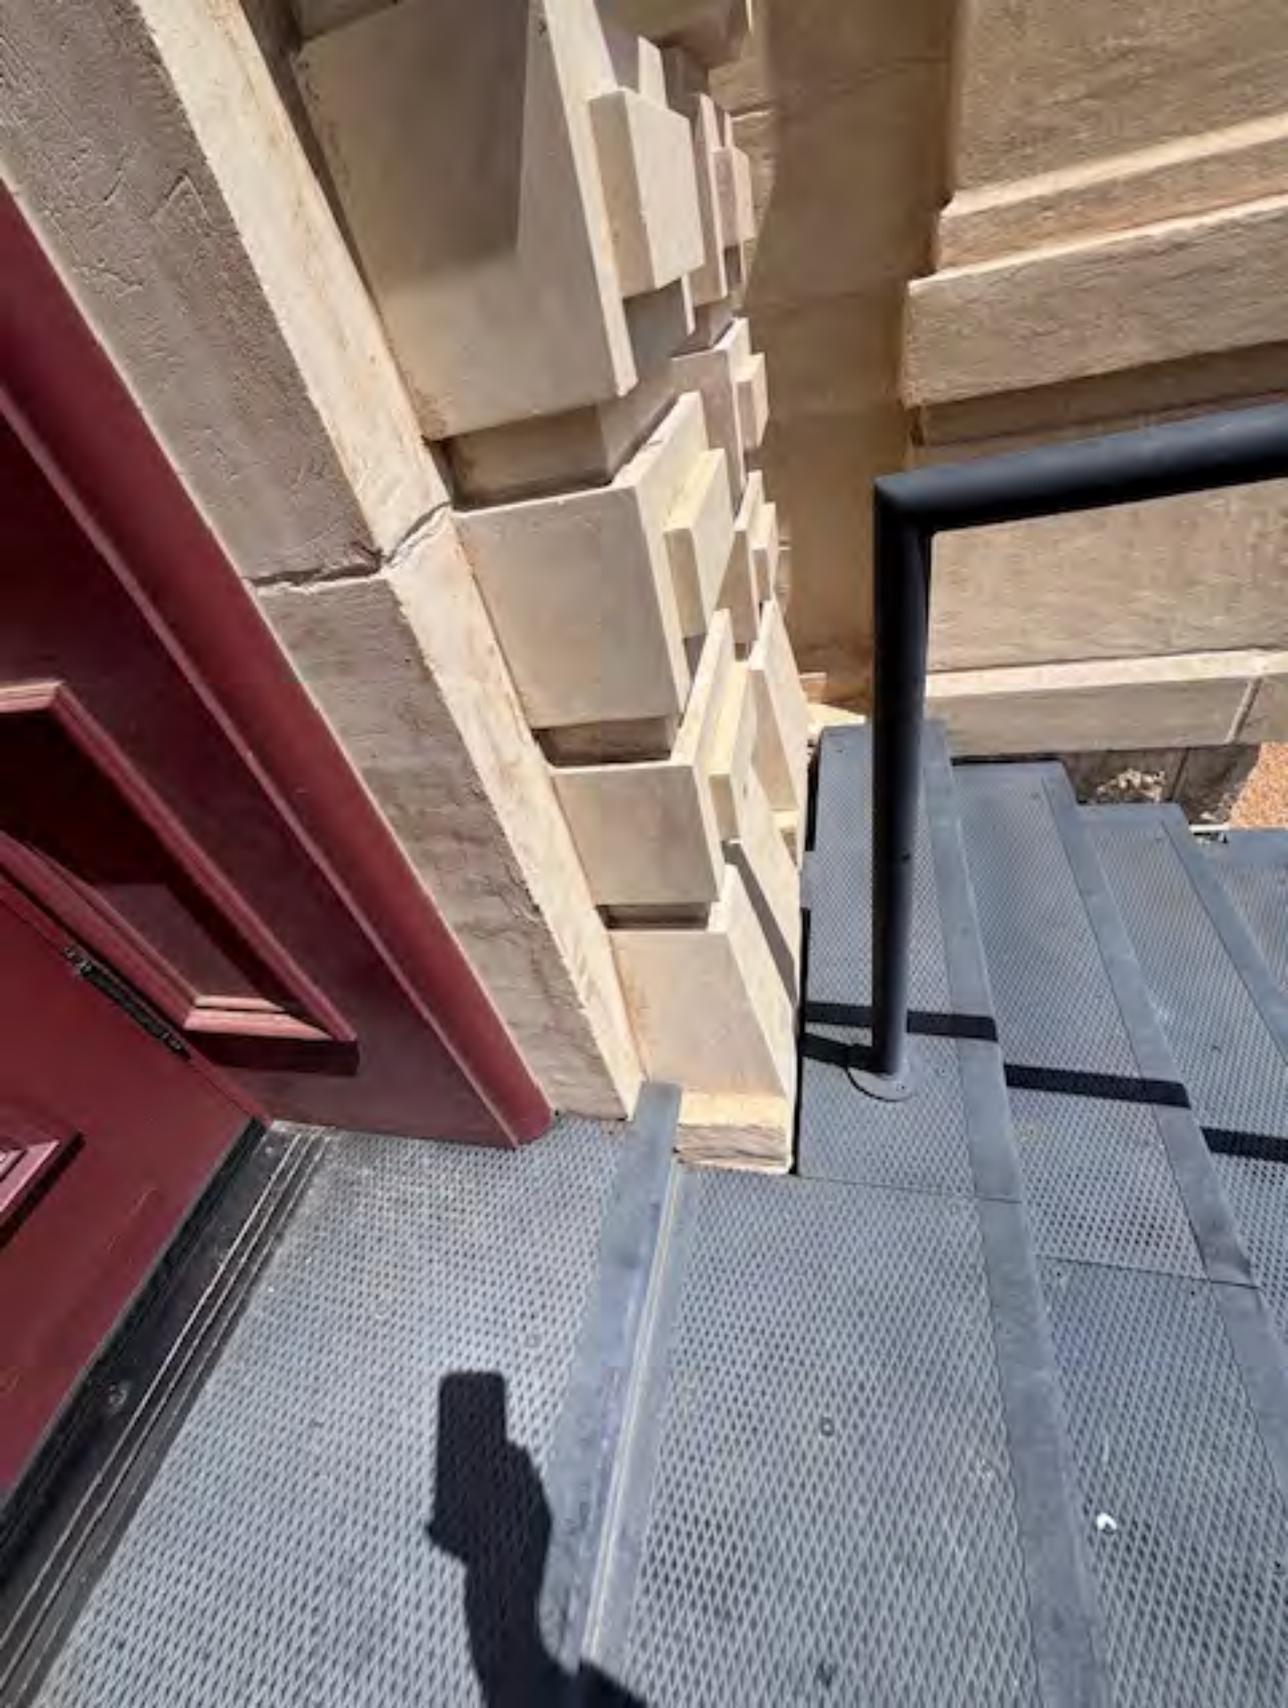
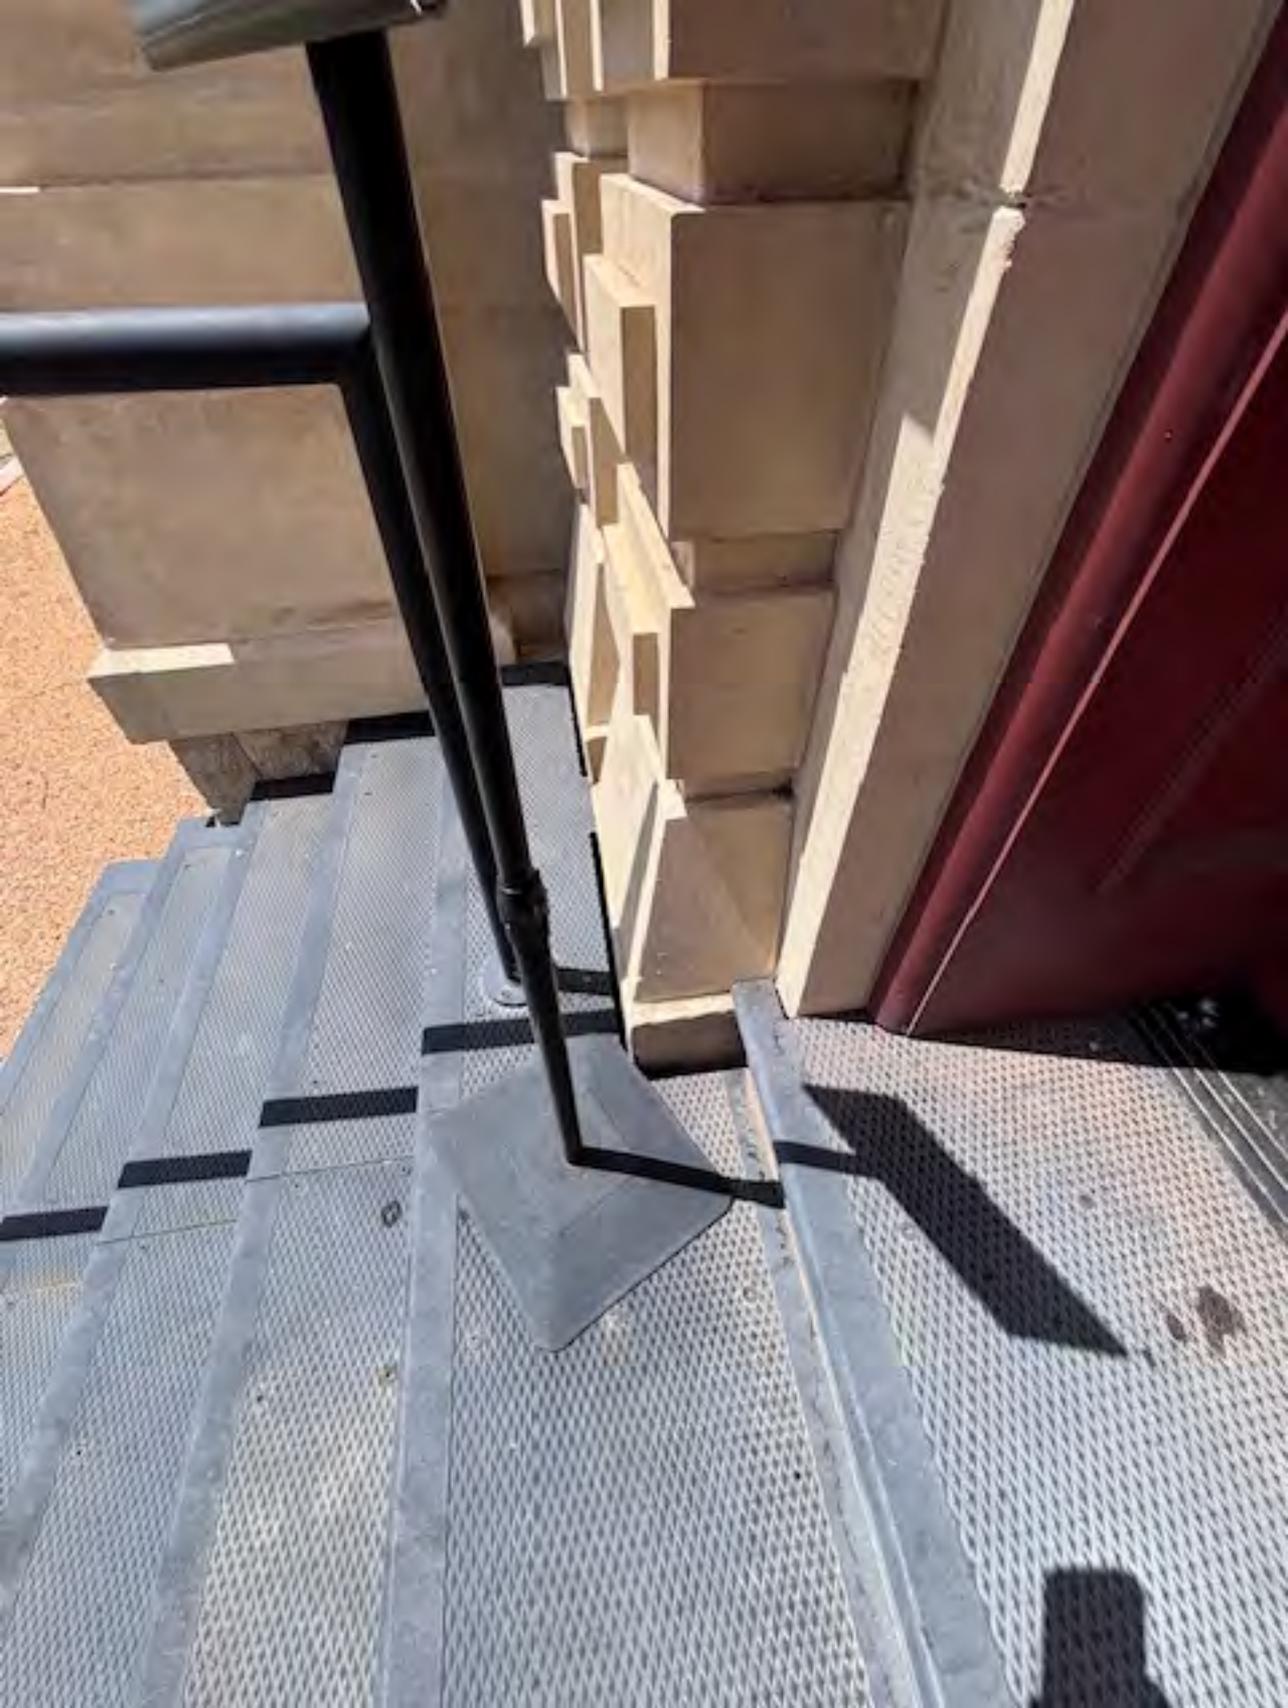
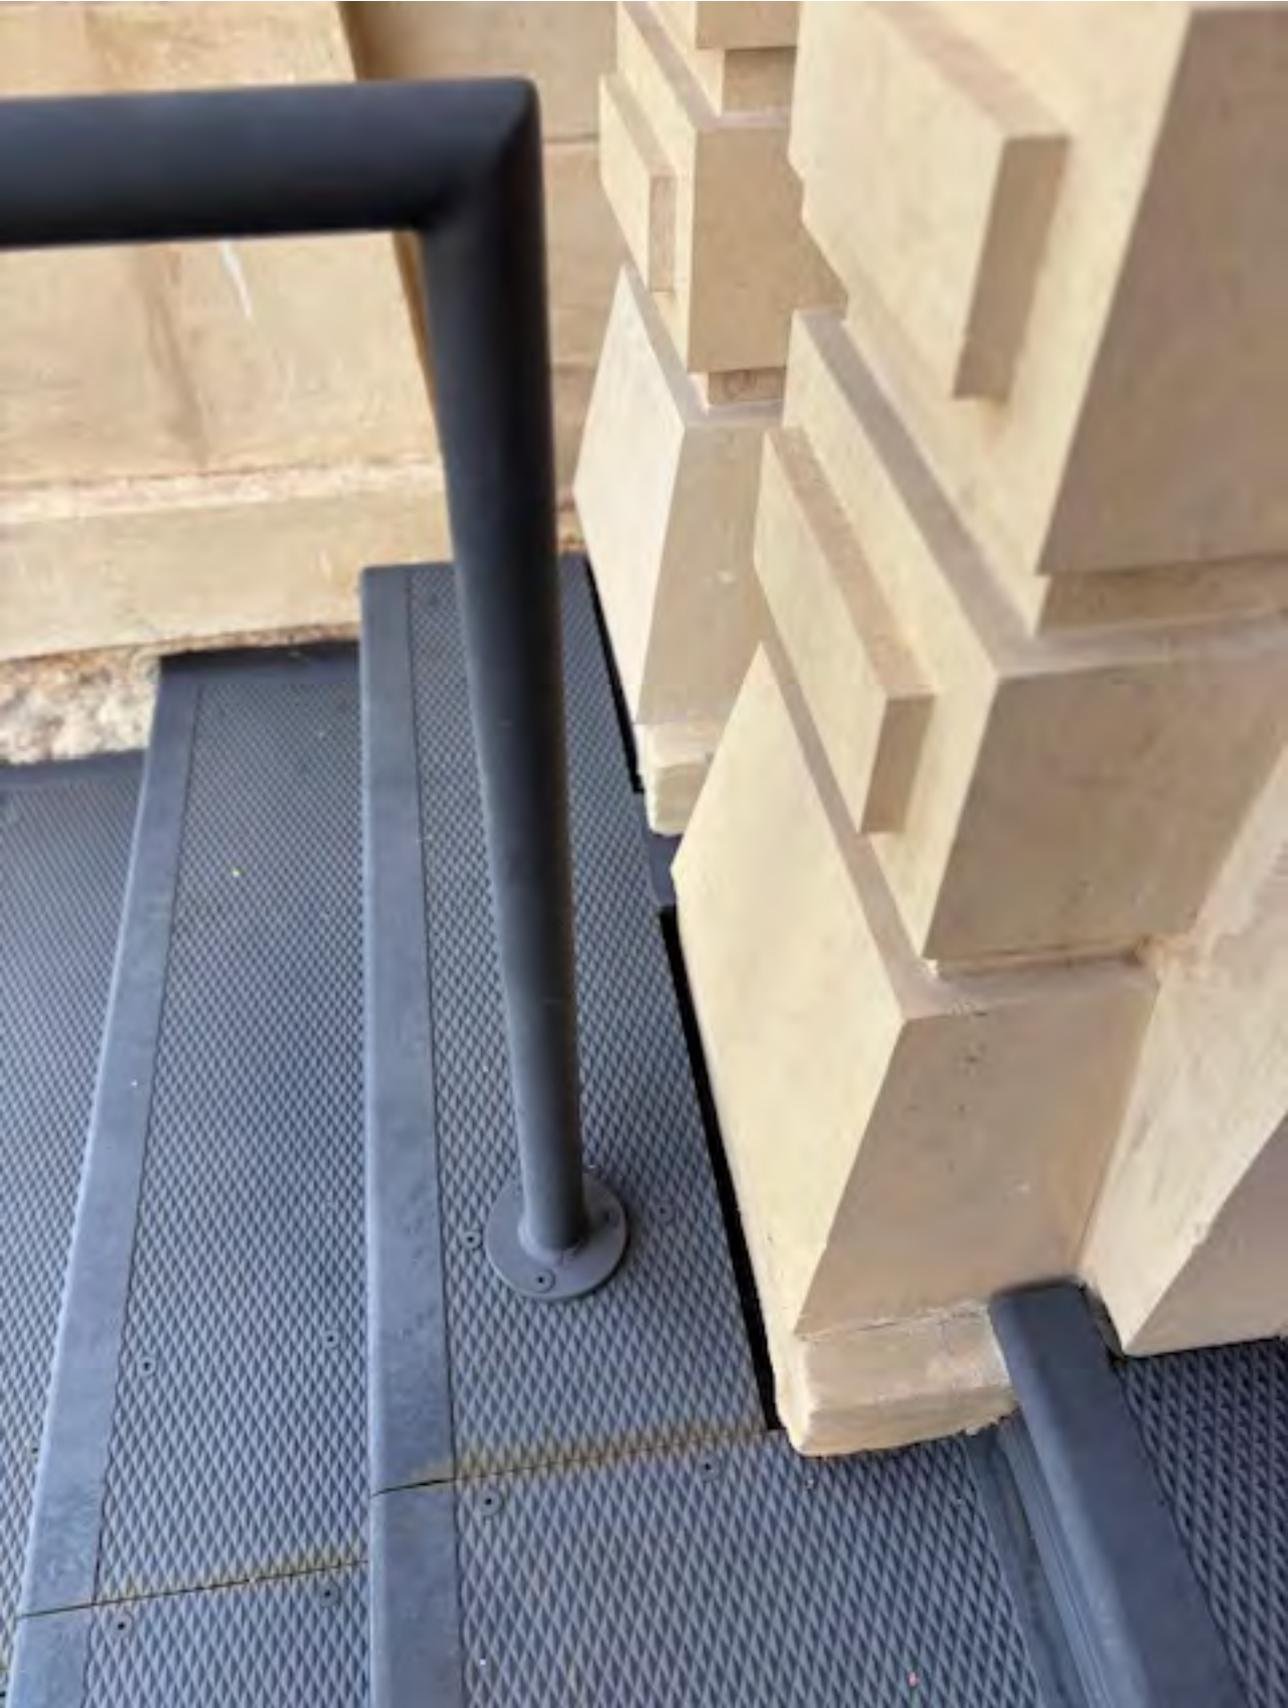
EXTERIOR
PHOTOS

1. Grouting drying out and cracking above South entrance
2. Outside North ledge over NW office could be missing grout or it is cracked. Because when it rains , water is on inside office floor, dripping from ceiling
3. Several lumps in grass areas from when they had heavy equipment on it
4. There are pieces of stone breaking off wall all around courthouse (no photo)
5. Gaps between entry stairs and building (all entrances)
