**SUPPLEMENTAL WATERSHED PLAN NO. I
and Environmental Assessment
for the Rehabilitation of
Floodwater Retarding Structures No. 4 & 5
of the
Kickapoo Creek Watershed
Coke County, Texas**

May 2024

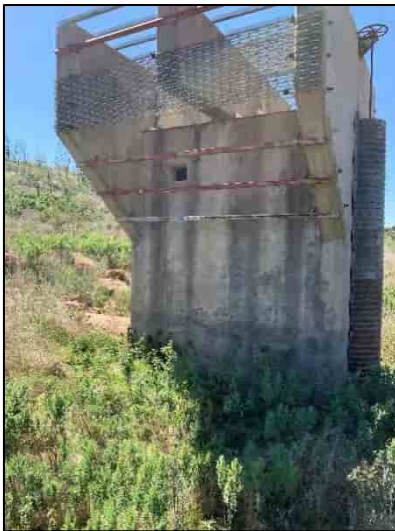
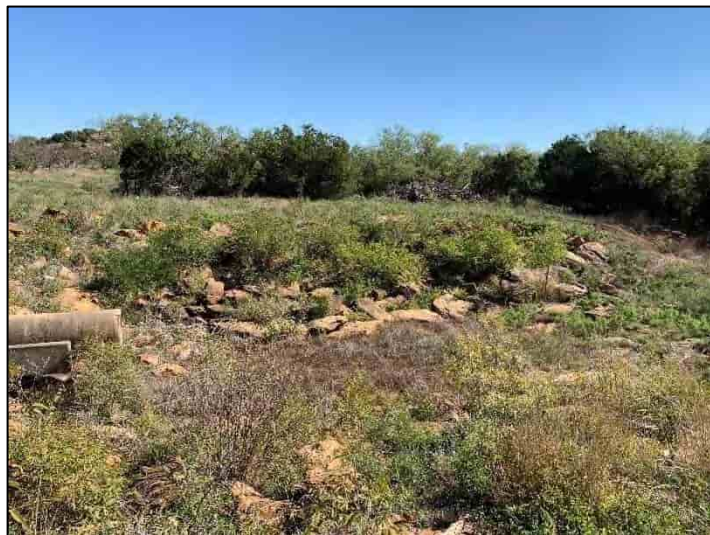
Figure 3-1. FRS No. 4 Principal Spillway Inlet and Outlet-

The principal spillway inlet structure is a drop inlet (30 inches x 100 inches x 12 feet, 1 inch tall) with a steel debris guard and a crest of 1985.3 feet. There is one low-level port on two sides of the riser (two ports total - each 8 inches tall x 12 inches wide) at elevation 1983.0 feet. The conduit is 220 feet of 30-inch-diameter prestressed, concrete lined, steel cylinder pipe with five anti-seep collars. The spillway riser is generally in good condition. Minor corrosion on the debris guard should be monitored and repaired as needed. The outlet conduit is in good condition. According to local reports from the Sponsors, the water level was above the principal spillway crest during a storm that occurred around August 2007. This is the only documented instance of the water level being above the principal spillway crest, although there are anecdotal reports that it may have also happened on a number of occasions during the first ten years after the dam was constructed. Photographs of the existing principal spillway system are provided in **Figure 3-1**.

Inlet structure (10/2020)

Outlet pipe and plunge pool (10/2020)

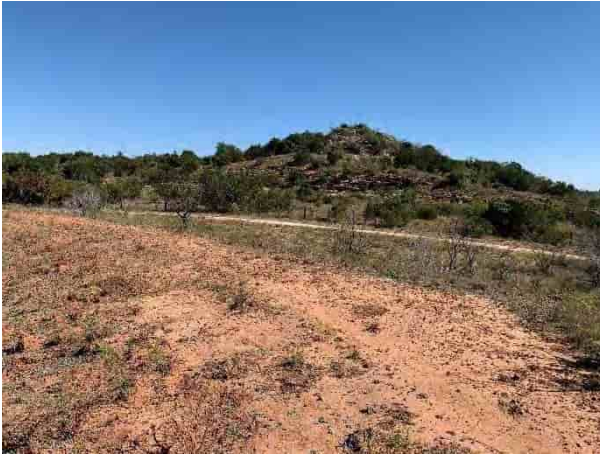
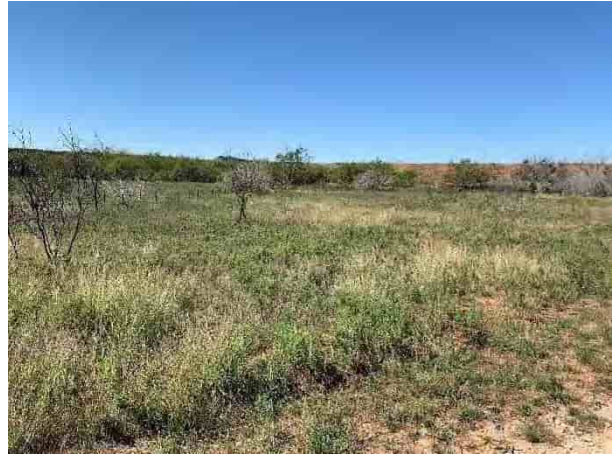
Figure 3-2. FRS No. 4 Auxiliary Spillway Condition

A 230-foot-wide, grass-lined auxiliary spillway was excavated at the left abutment. The auxiliary spillway has never experienced flows. The as-built drawings show a grassed inlet section sloping at a mild 0.5% up to the control section, a 50-foot-long control section, and an exit section at a 8.0% slope for a distance of about 190 feet before transitioning to a slope of 2.86% for about 790 feet before transitioning back to the original ground. According to the 2018 Dam Safety Inspection Report for FRS No. 4 (NRCS, 2019a) and observations made during the site visit performed for this plan, there is woody vegetation in all sections of the auxiliary spillway. All 3 sections of the auxiliary spillway appear to be in good dimensional condition and good vegetative cover exists in the exit slope. There is a private gravel driveway that travels through

the auxiliary spillway and through the control section. Photographs of the existing auxiliary spillway system are provided in **Figure 3-2**.

Auxiliary spillway control section (10/2020)

Auxiliary spillway exit section (10/2020)

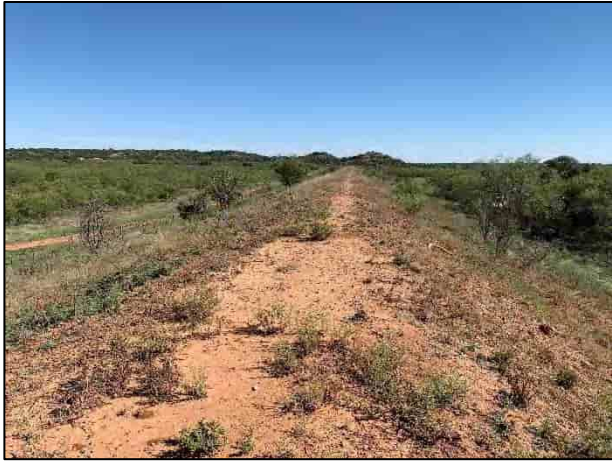
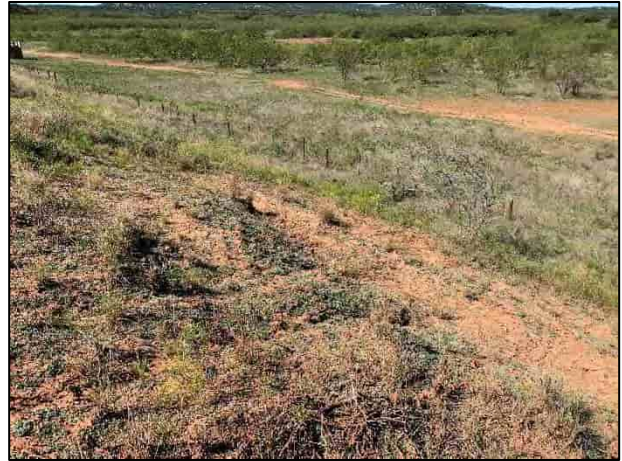
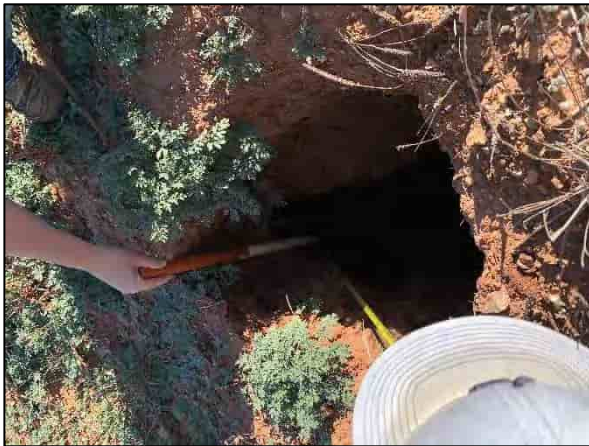
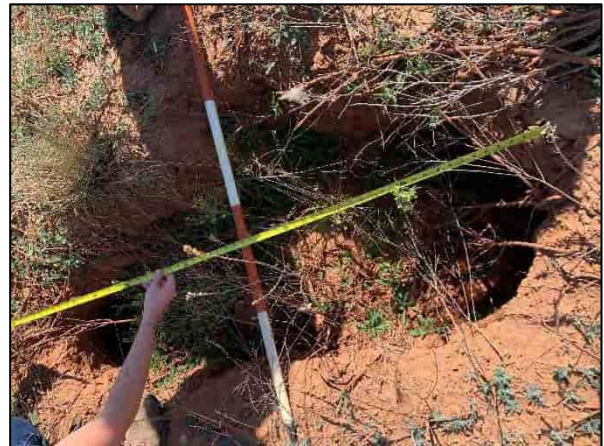
Figure 3-3. FRS No. 4 Embankment Condition

support prior assessments that collapsible foundation materials are the likely source of observed cracking/holes, and that continued episodic collapse settlement is likely during heavy rainfall.

Photos of the embankment and some areas of longitudinal cracking are provided in **Figure 3-3**.

Crown of dam and embankments (10/2020)

Upstream slope (10/2020)

Large hole resulting from longitudinal cracking.
(10/2020)

Significant cracking and open holes have been observed along the top of the dam embankment. The cracking/holes are concentrated within approximately the middle 2/3 of the embankment alignment, extending both left and right of the PSW conduit by several hundred feet. Approximately 80 individual holes were observed during AECOM's site visit on October 16, 2020. The holes range from about 2 inches in diameter to 3 feet wide at the ground surface, with measured depths ranging from approximately 3 feet to 10 feet deep. No transverse cracking has been observed to date, and no lateral cracking that would outlet to either slope has been observed. A deficiency report prepared in 1967 (USDA-SCS, 1967a) indicates the first crack was noticed in 1965, and subsequent inspections noted the crack was becoming more extensive with crack depths up to about 20 feet below surface. Survey measurements taken in 1966 indicated the centerline of the embankment in the area of cracking had settled about 0.8 feet. The 1967 report suggested the most plausible source of embankment cracking was differential settlement at the interface between the upstream shell and central core zones of the embankment due to hydro-collapsible foundations soils. Specifically, the 1967 report postulated that the sandy foundation materials under the upstream shell experienced collapse settlement after wetting due to initial reservoir filling, whereas the central zone experienced little settlement due to the excavation of the core through most of the upper collapsible soils, thereby producing cracking through the brittle embankment material in response to the differential settlement. A subsequent embankment repair report (USDA-SCS, 1967b) documented filling of the cracks that took place October 30 through November 3, 1967. According to the report, the cracks were filled to within 1.5 to 2 feet of the embankment crest using a slurry of soil and water mixed at the surface and poured into the crack, and the upper 2 feet was filled with soil and compacted by passes of a tractor wheel and/or dual wheel truck. However, recurrence of cracking has occurred in the years since the original 1967 repair. A 2014 field investigation report (NRCS, 2014) suggested that the cracking and development of holes along the crack line may have been caused by wet/dry cycles that allow intermittent settlement within the underlying collapsible/compressible soils that act as the foundation for the embankment. The 2014 report also indicates that it is suspected longitudinal cracking has not occurred on the downstream portion of the embankment as a result of the core trench. Supplemental investigation of cracking and potential sources of cracking was performed in a joint study by NRCS and Angelo State University in 2017, which reached similar conclusions as the prior work (i.e., settlement within collapsible foundation soils are responsible for cracking). A field investigation was performed in 2021 and generally confirmed the previous findings.

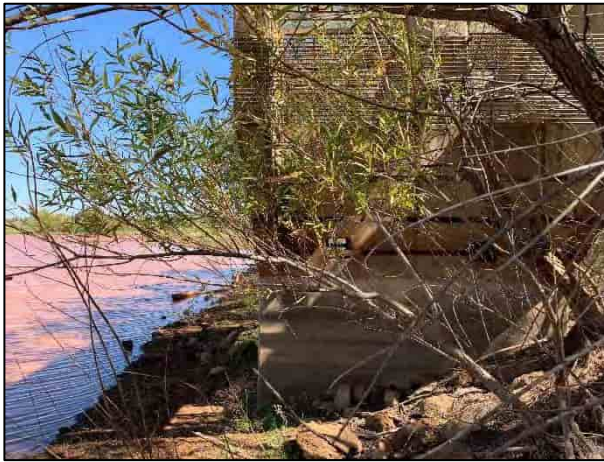
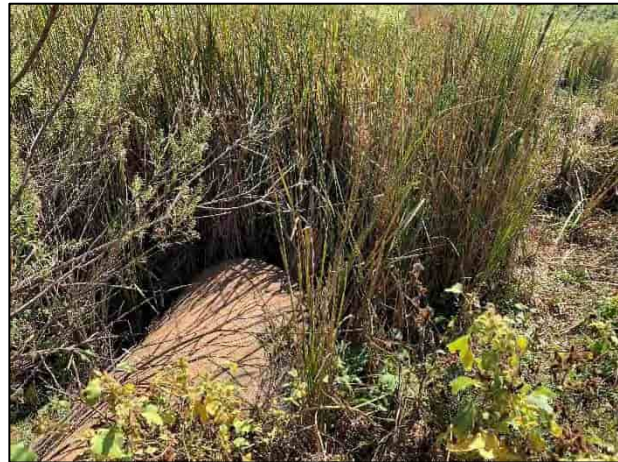
Figure 3-4. FRS No. 5 Principal Spillway Inlet and Outlet

The principal spillway inlet structure is a drop inlet (30 inches x 100 inches x 17 feet, 11 inches tall) with a steel debris guard and crest of 1899.0 feet. There are two low-level ports on two sides of the riser (four ports total - each 8 inches tall x 10 inches wide) at elevation 1894.5 feet. The as-built conduit is 220 feet of 30-inch-diameter prestressed, concrete lined, steel cylinder pipe with five anti-seep collars. The spillway is generally in good condition. Willow growth was observed around the principal spillway inlet and should be monitored until it can be removed. Minor corrosion was noted on the debris guard and should be monitored and repaired as needed. Some concrete deterioration was observed at the end of the outfall conduit. The conduit was partially submerged and was also blocked by vegetation. Photographs of the existing principal spillway system are provided in **Figure 3-4**.

Inlet structure

Outlet pipe.

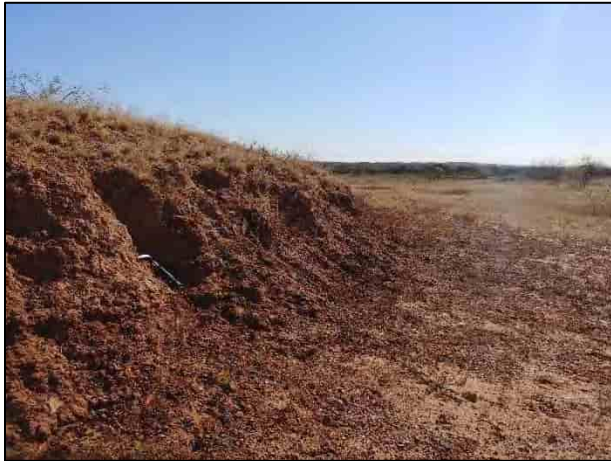
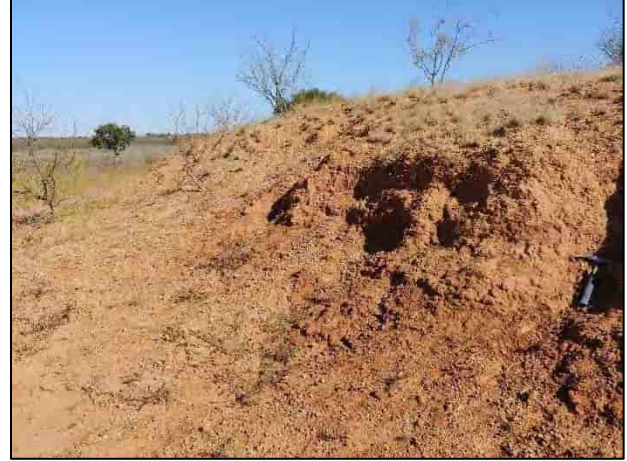
Figure 3-5. FRS No. 5 Auxiliary Spillway Erosion at Left Training Berm

The left berm of auxiliary spillway (adjacent to the right end of dam embankment) has eroded with possible damage by feral hogs, which is shown in **Figure 3-5**. Additionally, the right cut slope from natural ground upstream of the auxiliary spillway crest has severe erosion gullies, which is shown in **Figure 3-6**. The spillway channel currently has a fair to good protective grass cover and is in fair condition with no visible erosion.

At right end of embankment, looking downstream

At right end of embankment, looking upstream

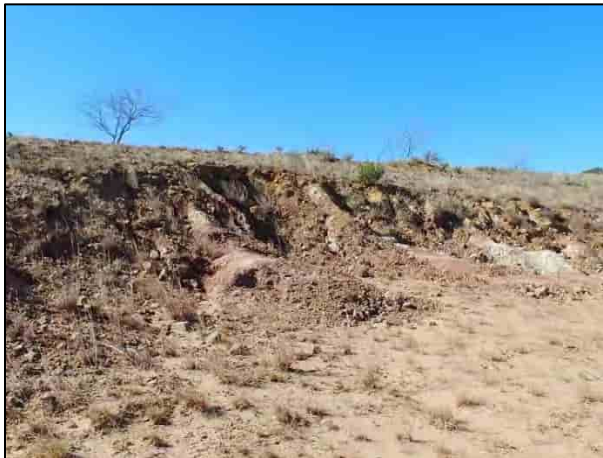
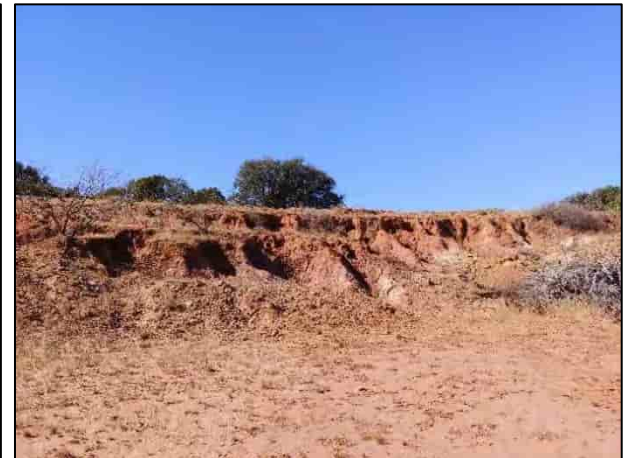
Figure 3-6. FRS No. 5 Auxiliary Spillway Erosion at Right Cut Slope

About 50 ft upstream of crest

About 200 ft upstream of crest

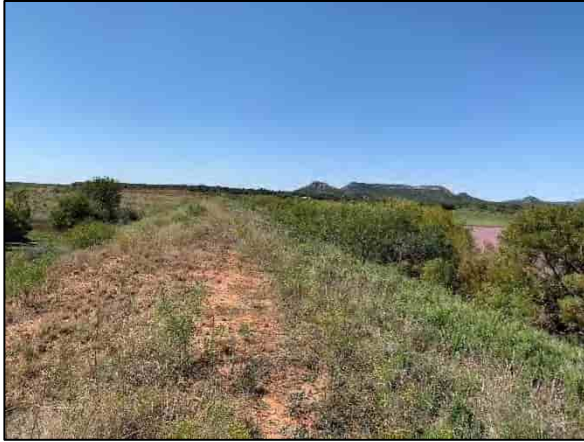
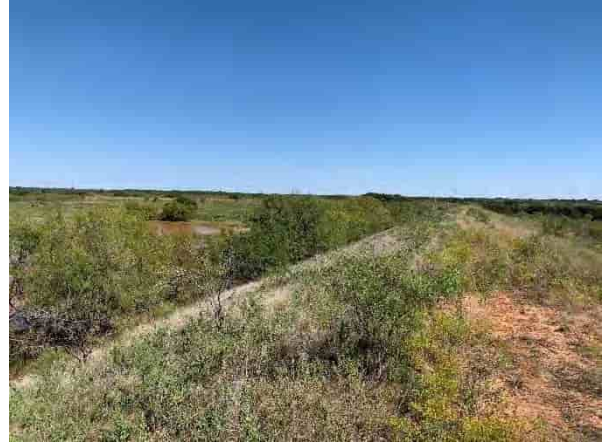
Figure 3-7. FRS No. 5 Embankment Condition

The embankment is generally in fair condition and has fair vegetative cover. Embankment erosion has lessened the cross-sectional area of the dam and in many locations most of the topsoil has eroded off the top of dam and slopes and is accumulating at the toes. Woody brush is growing at the left and right abutments and also along the fence on the front slope of the embankment. Photos of the embankment are provided in **Figure 3-7**.

Crest and embankments

Crest and upstream embankment
