**SUBJECT: Department of the Army Permit Application**  
U.S. Route 82 Reconstruction Project  
Bowie County, Texas  
USACE Identification No. SWT-2012-292; TxDOT CSJ 0046-04-057

Enclosed, please find the Application for a Department of the Army Permit and supporting documentation for the proposed improvements to U.S. Route 82 in Bowie County, Texas. The project consists of the construction of new concrete pavement from FM 1840 in De Kalb to SH 98 near New Boston, all within Bowie County, Texas. The future typical width of pavement will be 50 feet to allow for a passing lane section comprised of two twelve-foot lanes in the passing lane direction, and one ten-foot shoulder in the opposite direction. An existing 3-8'x7' reinforced concrete box culvert (RCB) at the US-82 crossing of Red Bayou will be extended and the future roadway embankment at this location will impact a forested wetland known as Wetland Complex 3 (WC 3).

Department of the Army Permit Application  
ENG Form 4345

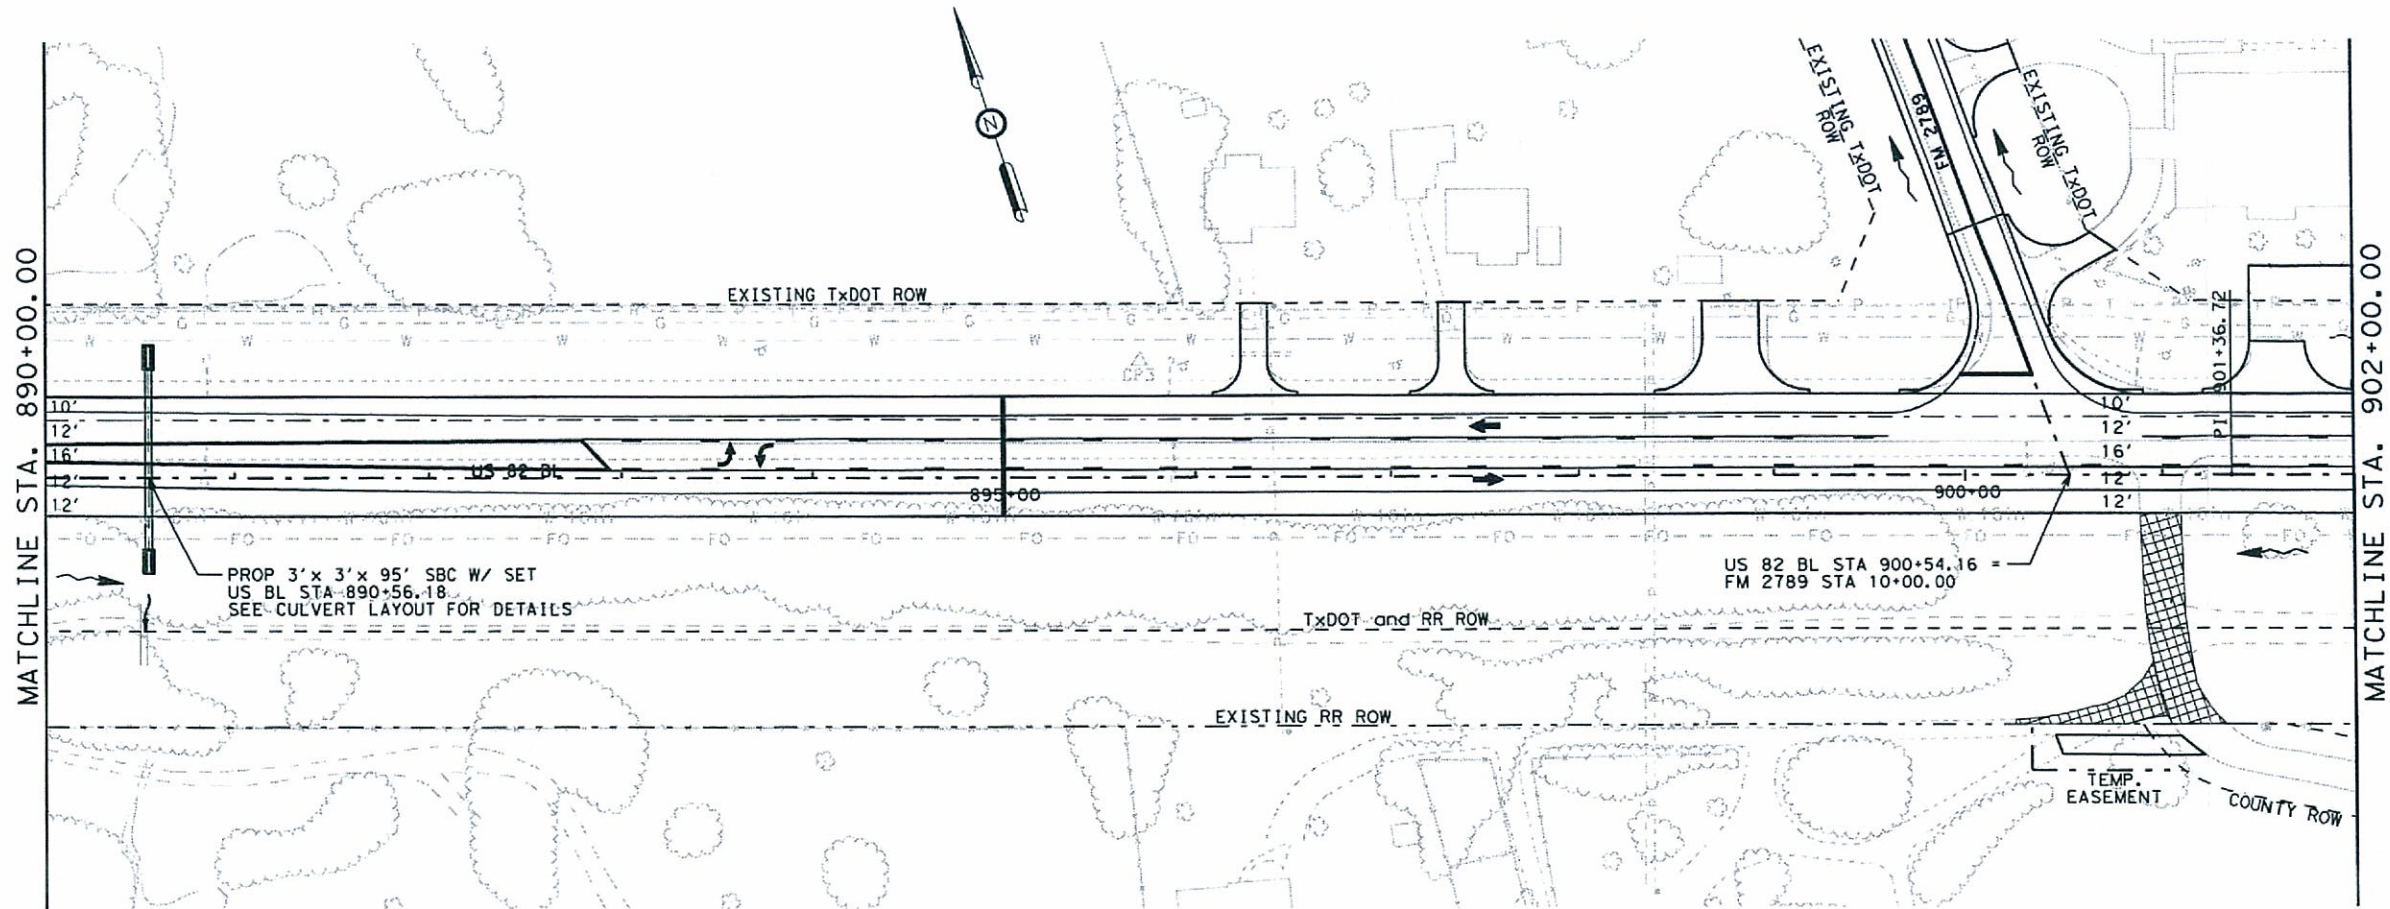
SHEET 24 OF 39

PROP 3' x 3' x 95' SBC W/ SET  
US BL STA 890+56.18  
SEE CULVERT LAYOUT FOR DETAILS

STA 890+56.18  
EXIST 3' x 3' x 51' (TO BE REMOVED)  
PROP 3' x 3' x 95' SBC W/SET  
4:1 US AND DS

**PLAN PROFILE  
US 82**

890+56.18	A-14	32.55	0.35	36.91	4.50	25	51.26	5.54	100	63.07	1-3'x3'x95' R.B.C.	0.0035	0.70	400.87	399.21	8.19	401.42	399.65	7.01	
905+07.00	A-15	27.00	0.35	39.26	4.33	25	40.94	5.33	100	50.37	1-3'x2'x112' R.B.C.	0.0070	0.70	410.38	407.46	8.72	411.52	407.73	9.13	
936+64.49	A-16	4.54	0.35	18.80	6.60	25	10.49	8.14	100	12.93	1-24"x114' R.C.P.	0.0043	0.70	405.14	403.83	5.55	405.39	404.01	6.01	
970+99.91	A-17	2.60	0.35	16.73	7.01	25	6.38	8.64	100	7.87	1-24"x80' R.C.P.	0.0128	0.70	390.19	388.43	7.14	390.36	388.51	7.47	
1008+89.54	A-19	85.25	0.35	62.22	3.23	25	96.31	3.97	100	118.45	2-4'x2'x91' R.B.C.	0.0284	0.70	375.3	370.19	13.35	376.18	370.31	14.02	
1050+33.20	A-20	3.31	0.35	18.51	6.66	25	7.71	8.21	100	9.51	1-18"x87' R.C.P.	0.0133	0.70	397.49	395.22	7.73	398.00	395.34	8.05	
1063+18.28	A-21	2.60	0.35	41.64	4.18	25	3.80	5.14	100	4.68	1-18"x110' R.C.P.	0.0035	0.70	396.89	396.09	4.34	397.05	396.2	4.66	
FM 1840 - 12+70.11	PC#19	18.86	0.35	45.10	3.97	25	26.22	4.90	100	32.36	2-24"x60' R.C.P.	0.0203	0.70	399.25	396.65	9.66	399.71	396.76	10.17

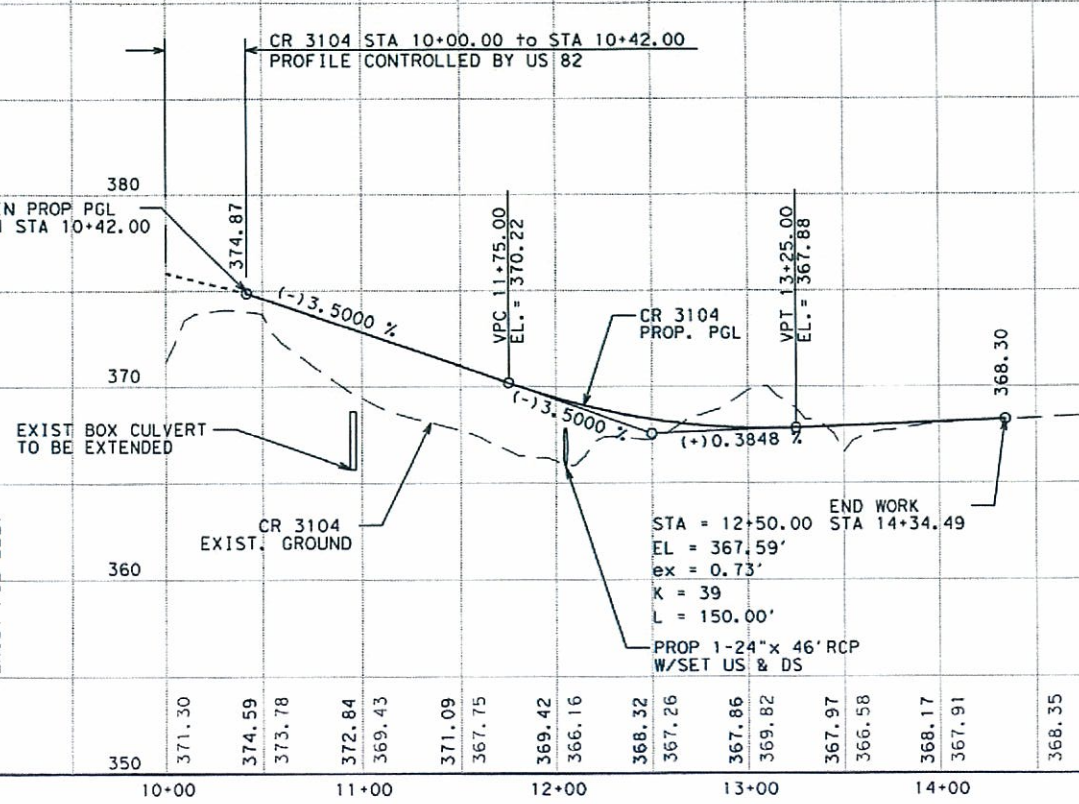
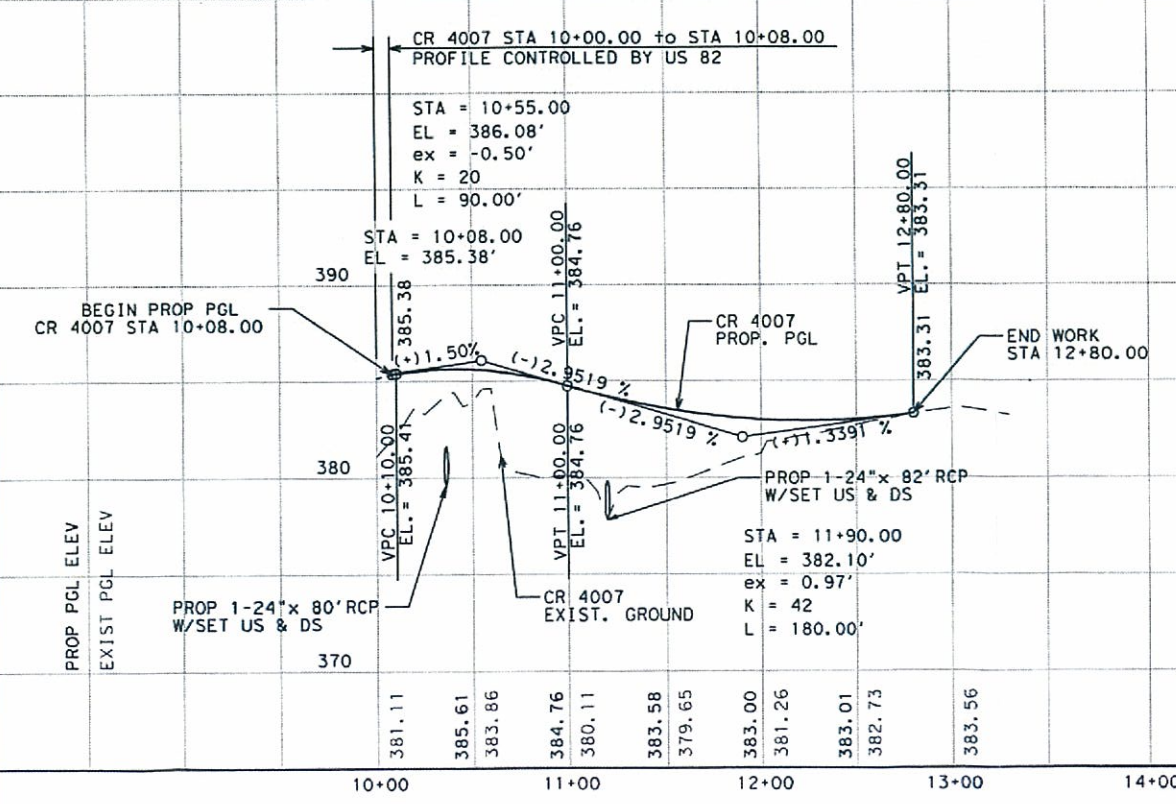
PLAN PROFILE  
 ACCESS ROADS  
 CR 3104 & CR 4007

PI STATION = 13+83.88  
 DELTA = 19° 31' 17.57" (LT)  
 DEGREE OF CURVE = 19° 05' 54.94"  
 TANGENT = 51.61  
 LENGTH = 102.21  
 RADIUS = 300.00  
 PC STATION = 13+32.27  
 PT STATION = 14+34.49

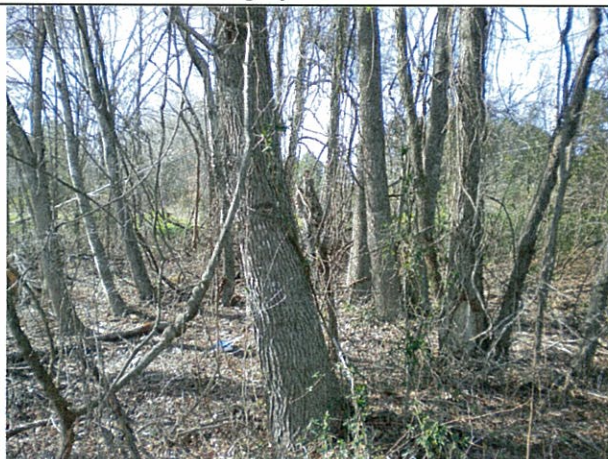
Red Bayou, viewed to northwest from south side of US-82 crossing.
